Re: Bowie Resources, LLC, Bowie No. 2 Mine
Instrumentation Monitoring,
Gob Pile #2 & #3
Permit C-1996-083

Subject: Summary of Instrumentation Monitoring
3rd Quarter 2020
Bowie Coal Waste Disposal Area No. 2
Paonia, Colorado

SUBJECT: Summary Report, 3rd Quarter 2020, Inclinator and Active Vibrating Wire Piezometer Data July – September 2020, Bowie Mine #2 Coal Waste Disposal Area (CWDA) #2

Subject: Summary of Instrumentation Monitoring
3rd Quarter 2020
Bowie Coal Waste Disposal Area No. 3
Paonia, Colorado

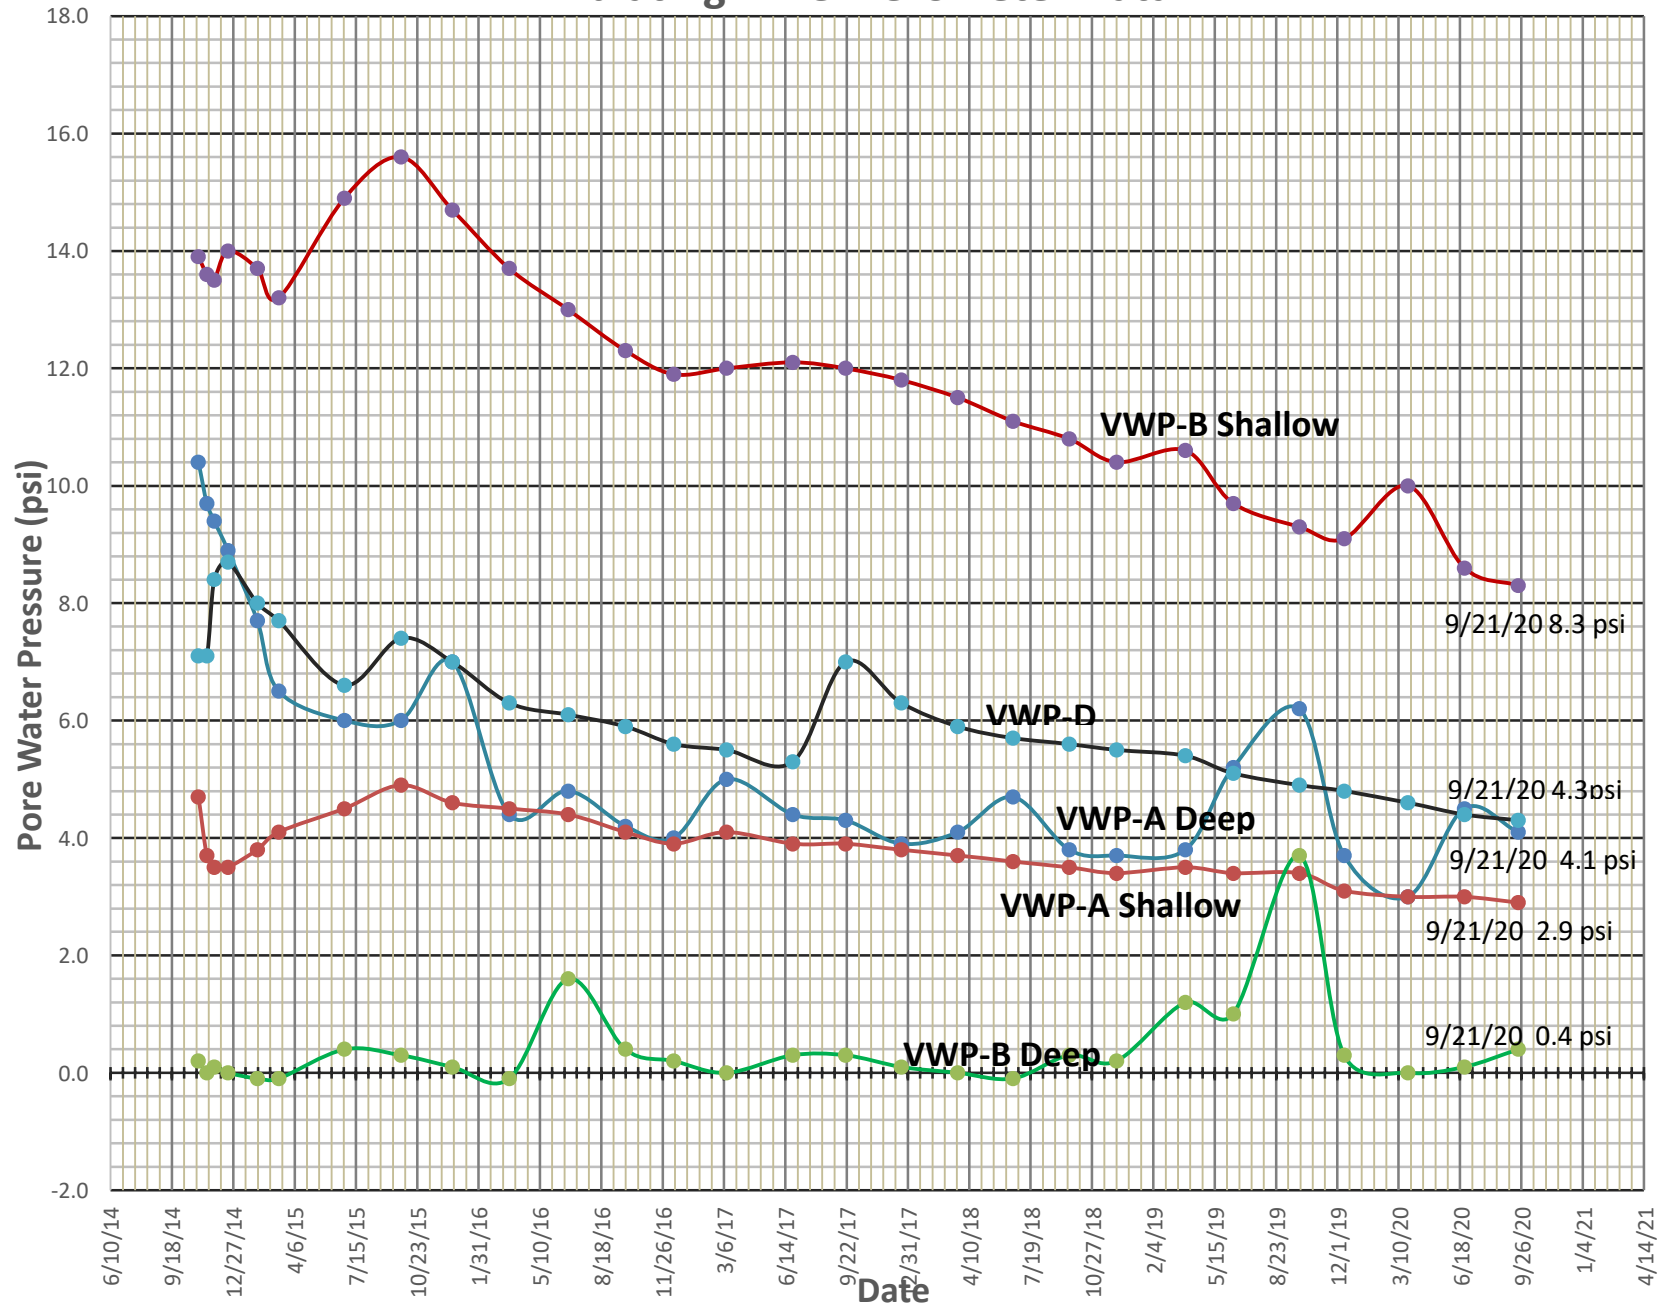
Figure 1 - Bowie Mine #2 - CWDA #3
Vibrating Wire Piezometer Data

As seen on Figure 1 and Table 1, when compared with the previous quarter, four of the five VWP's decreased in pore pressure and when compared to the 3rd quarter of last year, all five VWP's decreased in pore pressure since last year (a wetter year) and since installation. Although there is a general trend of decreasing pore pressure over time, three of the piezometers (VWP-A Deep, VWP-B-Deep and VWP-B Shallow) have more recent erratic behavior.

VWP-A Deep was installed on October 6, 2014 near the northern edge of CWDA No. 3. VWP-A Deep was installed in the foundation soil approximately eight feet below the bottom of the gob. The pore pressures recorded at VWP-A Deep generally decreased since installation until September 2015. After that, the pore pressures fluctuated within a narrow range until the 2nd and 3rd Quarters of 2019 where increases were reported. However, the 1st Quarter 2020 pore pressure was down before another slight increase in the 2nd Quarter. The pore pressures again decreased in the 3rd Quarter. In general, HBET does not believe that the pore pressure changes in VWP-A Deep are an indication of instability in CWDA No. 3.

VWP-A Shallow was installed on October 6, 2014 near the northern edge of CWDA No. 3. VWP-A Shallow was installed approximately ten feet above the base of the gob. After installation, the pore pressures dropped until November 2014. Between November 2014 and September 2015, increases in the pore pressures were recorded at VWP-A Shallow. However, between September 2015 and December 2016, the pore pressures decreased. Since then, the data have fluctuated within a narrow range. In general, HBET does not believe that the pore pressure changes in VWP-A Shallow are an indication of instability in CWDA No. 3.

VWP-B Deep was installed on October 6, 2014 in the west-central portion of CWDA No. 3. VWP-B Deep was installed in the foundation soil approximately ten feet below the bottom of the gob. Since installation, the pore pressures recorded at VWP-B Deep have fluctuated within a narrow range. However, the 3rd Quarter 2019 reading showed a significant increase in pore pressures prior to coming back down in the 4th Quarter 2019 and remaining low in 2020. In general, HBET does not believe that the pore pressure changes in VWP-B Deep are an indication of instability in CWDA No. 3.

VWP-B Shallow was installed on October 6, 2014 in the west-central portion of CWDA No. 3. VWP-B Shallow was installed approximately ten feet above the base of the gob. Since installation, the pore pressures recorded at VWP-B Shallow have fluctuated with periods of slight increase and slight decrease. In general, HBET does not believe that the pore pressure changes in VWP-B Shallow are an indication of instability in CWDA No. 3.

VWP-D was installed on October 7, 2014 in the east-central portion of CWDA No. 3. VWP-D was installed approximately ten feet above the base of the gob. Since installation, the pore pressures recorded at VWP-D have fluctuated. The pore pressures increase slightly during the 3rd Quarter of 2017. However, this likely reflects the activity at CWDA No. 3 during the monitoring period and the pore pressures have decreased since September 2017. In general, HBET does not believe that the pore pressure changes in VWP-D are an indication of instability in CWDA No. 3.
