MINERALS PROGRAM INSPECTION REPORT
PHONE: (303) 866-3567

MINE NAME: Windy Ridge Pit	MINE/PROSPECTING ID#: M-2003-052	MINERAL: Sand and gravel	COUNTY: Prowers
INSPECTION TYPE: Monitoring	INSPECTOR(S): Amy Eschberger	INSP. DATE: September 17, 2020	INSP. TIME: 12:00
OPERATOR: J. E. Cattle, LLC	OPERATOR REPRESENTATIVE: Justin Emick	TYPE OF OPERATION: 112c - Construction Regular Operation

M-2003-052 / Windy Ridge Pit / J.E. Cattle, LLC / (112c)

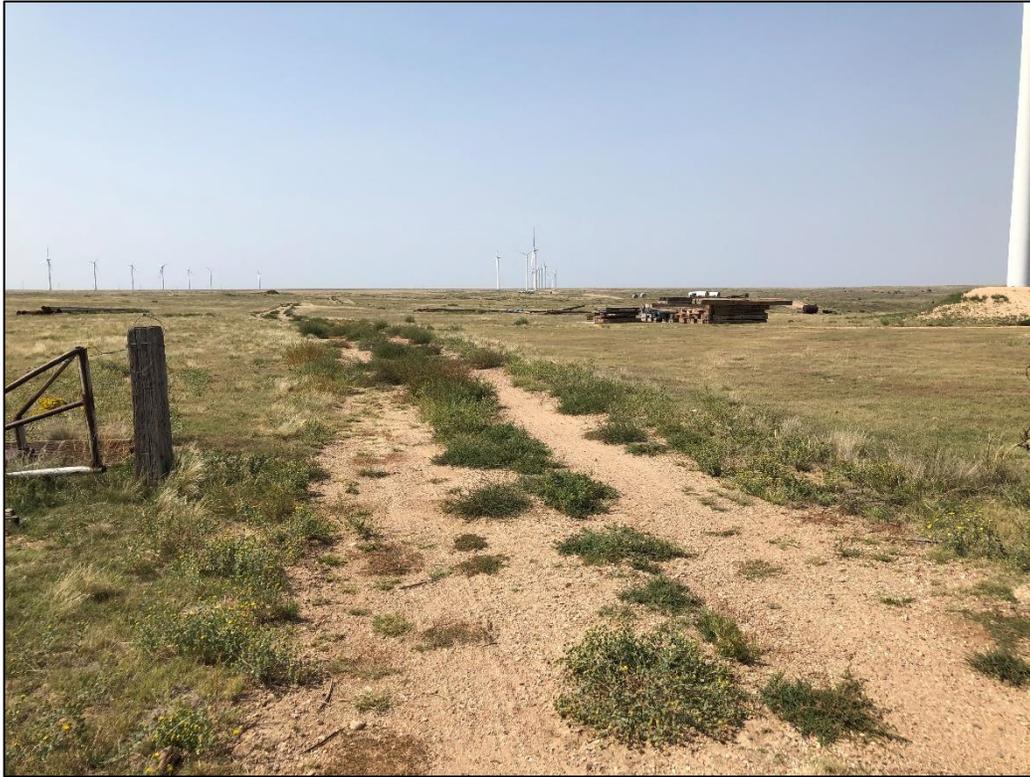
Photo 1. View looking west at existing ranch road which crosses permit area. This road will remain after reclamation.

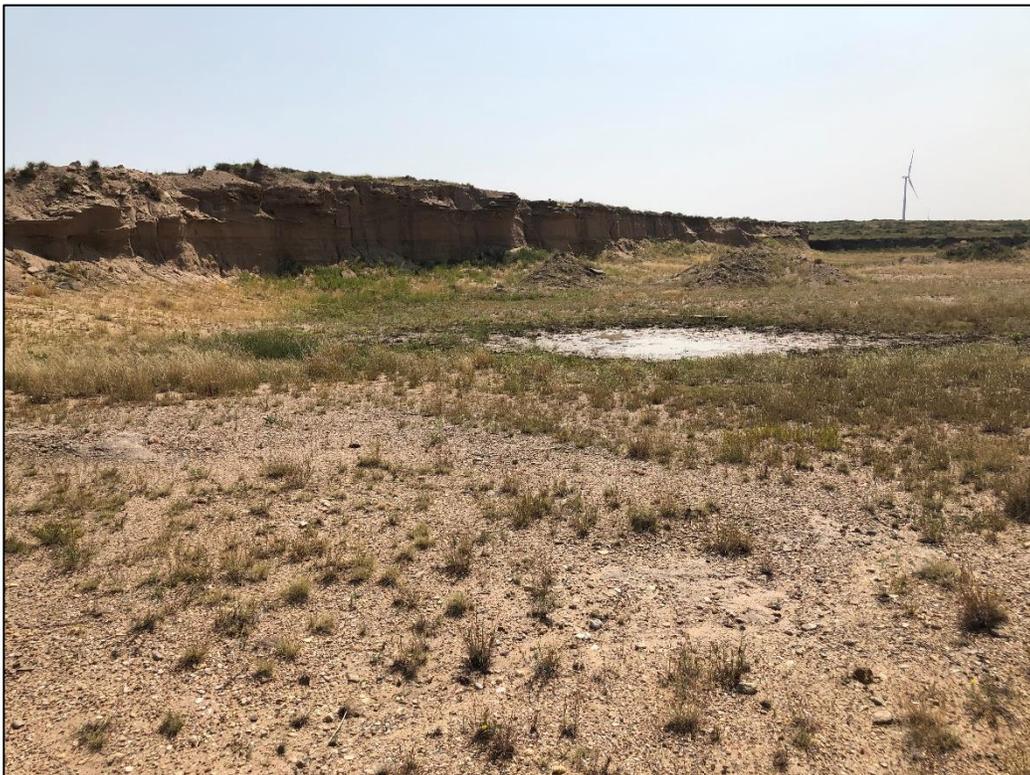
Photo 2. View looking southeast across pit showing eastern pit wall in background. Note grasses volunteering across pit floor.

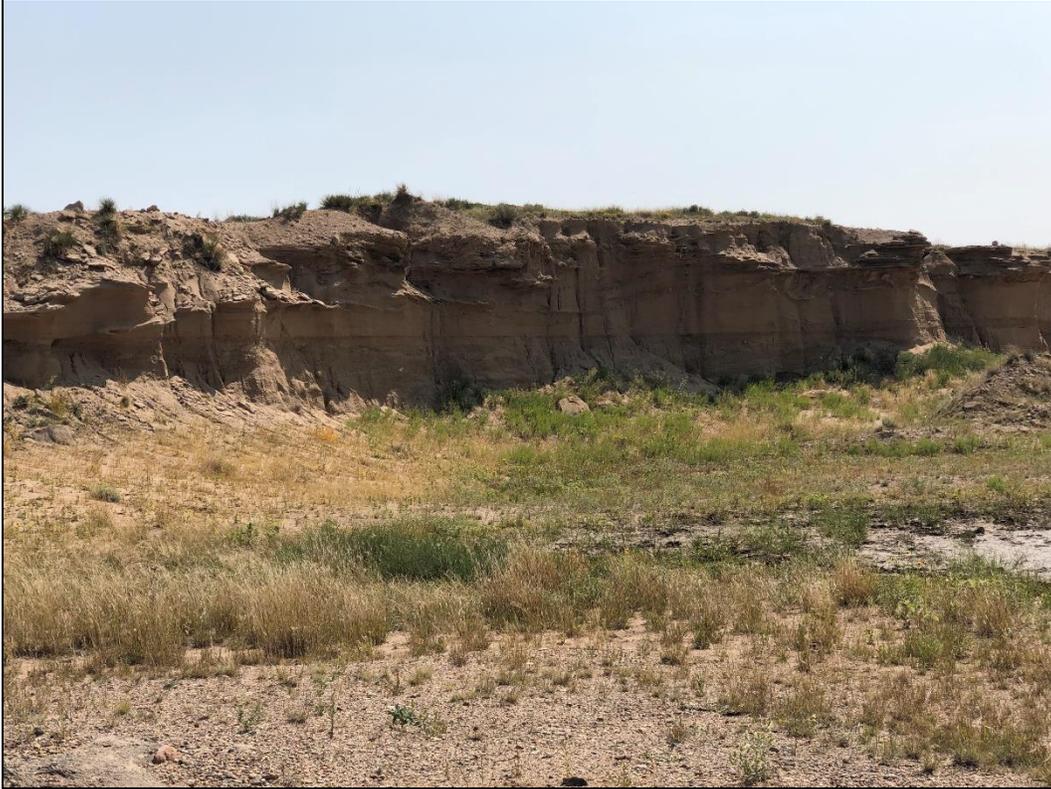
Photo 3. Closer view of eastern pit wall, approximately 15 feet in height with near vertical slopes. Note grasses volunteering across pit floor.

The Division currently holds a financial warranty for the site in the amount of \$33,000.00. After conducting this inspection, the Division reassessed the required financial warranty for completing reclamation of the site in accordance with the approved plan. This estimate includes grading approximately 775 feet of highwall at an average height of 10 feet to 3H:1V, replacing topsoil on 12.5 acres, and revegetating 12.5 acres with the approved seed mixture. The Division's bond estimate (see enclosed cost estimate) shows the required financial warranty to be in the amount of \$36,545.00, which is \$3,545.00 more than the currently held amount.

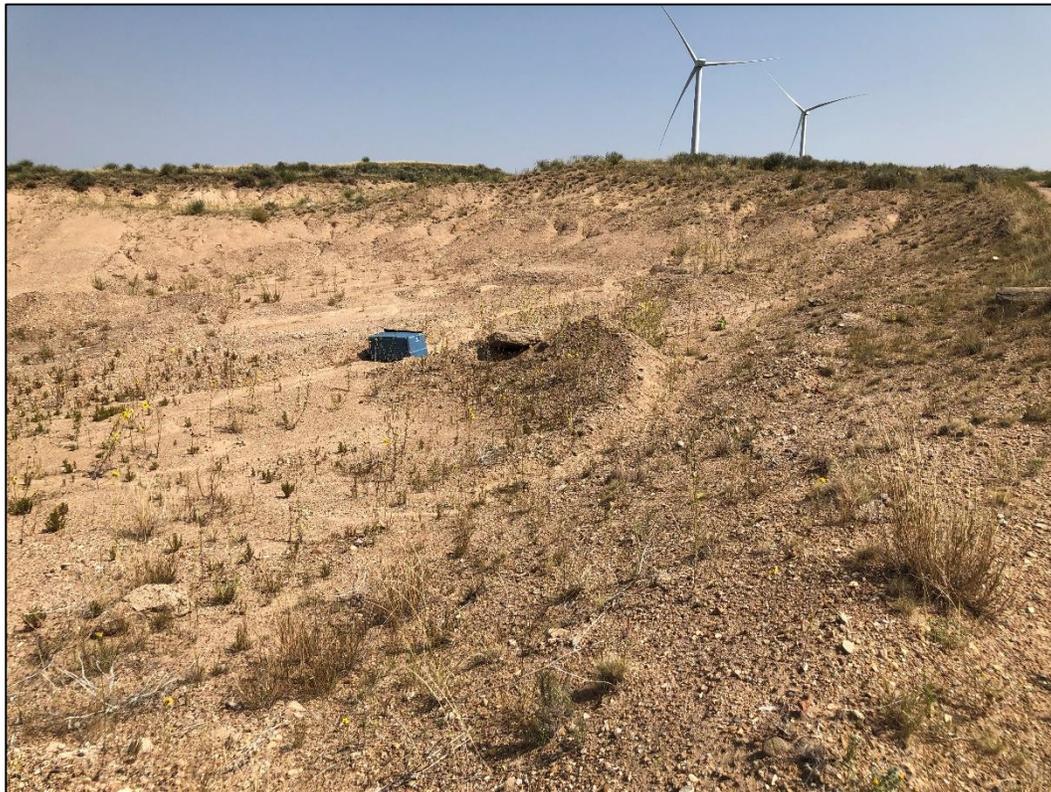
Photo 4. View looking north across eastern pit wall located north of access road which has been graded to 3H:1V or flatter.

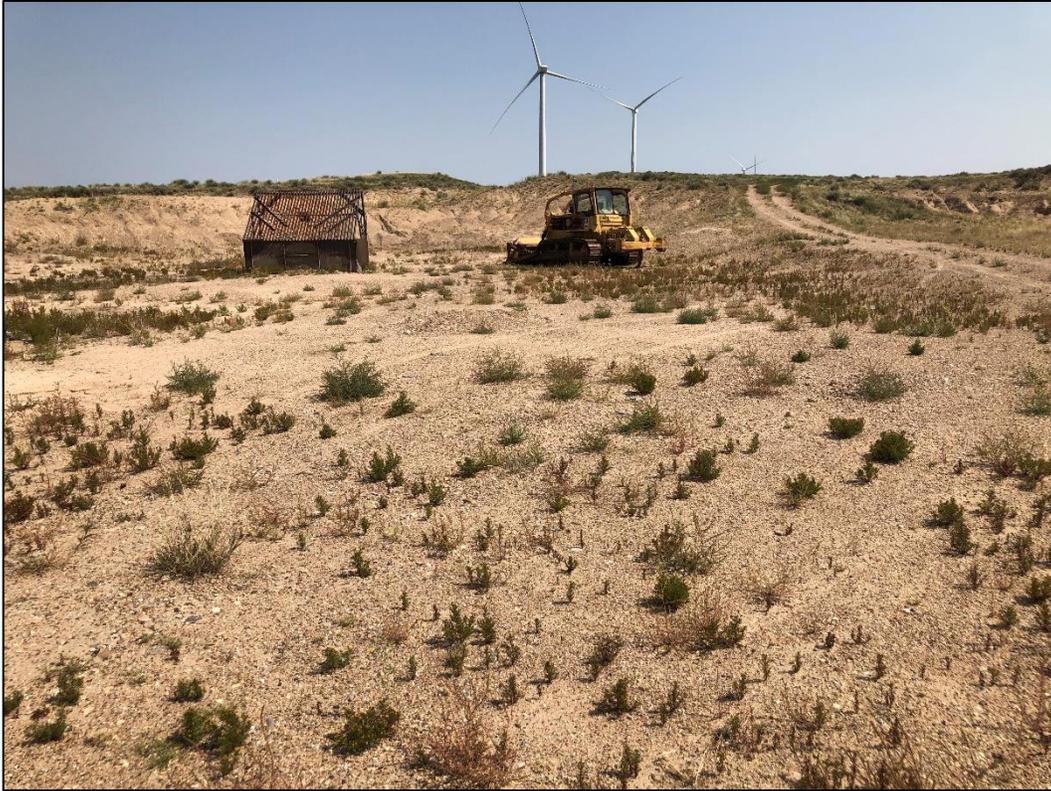
Photo 5. View looking east across northern portion of pit located north of access road which is currently used for stockpiling, processing, and equipment storage.

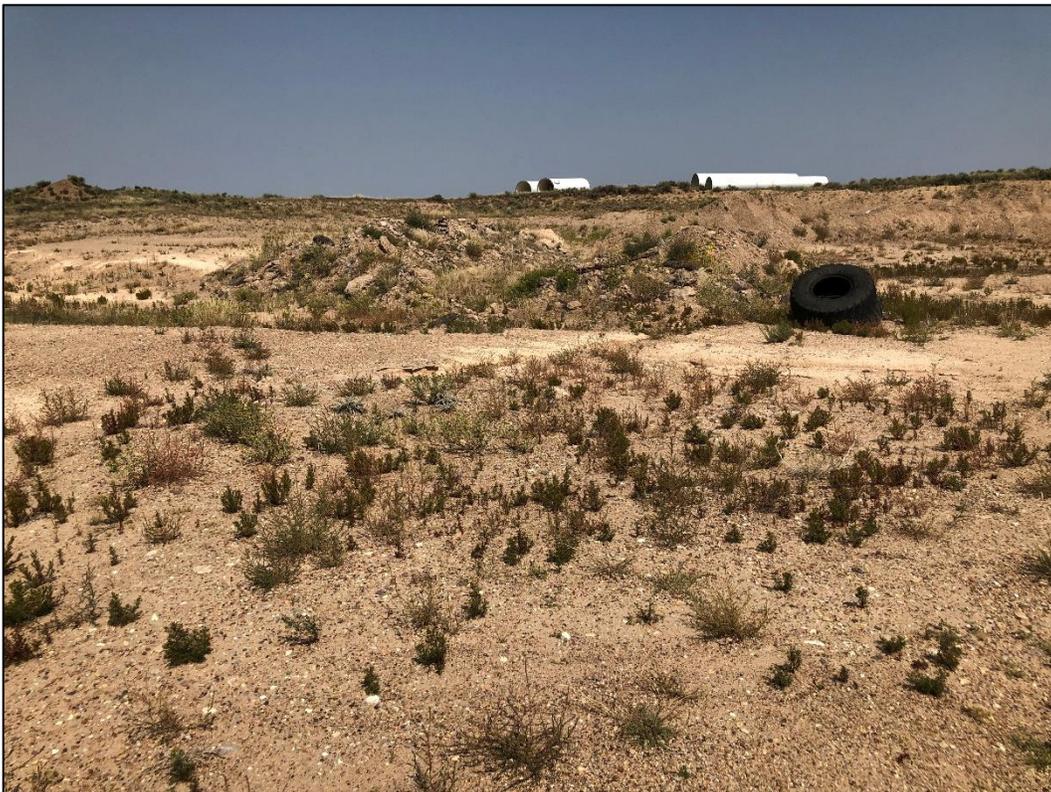
Photo 6. View looking east across northern portion of pit located north of access road, showing material stockpiled in this area.

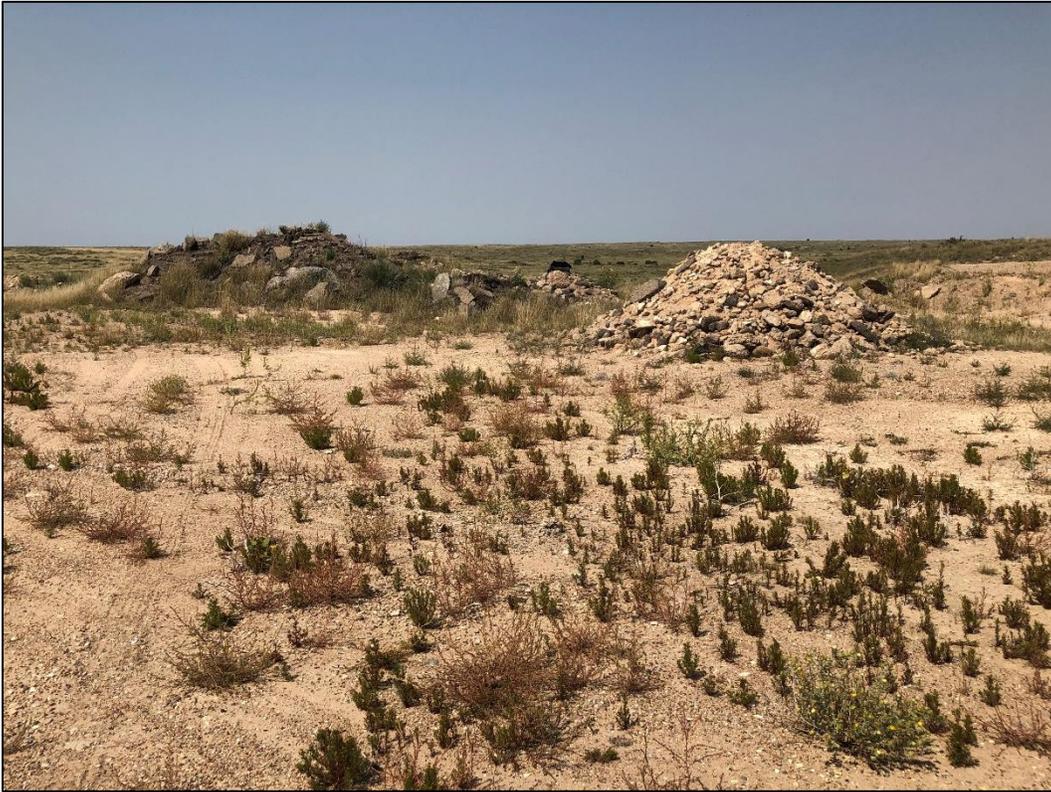
Photo 7. View looking west across northern portion of pit located north of access road, showing material stockpiled in this area.

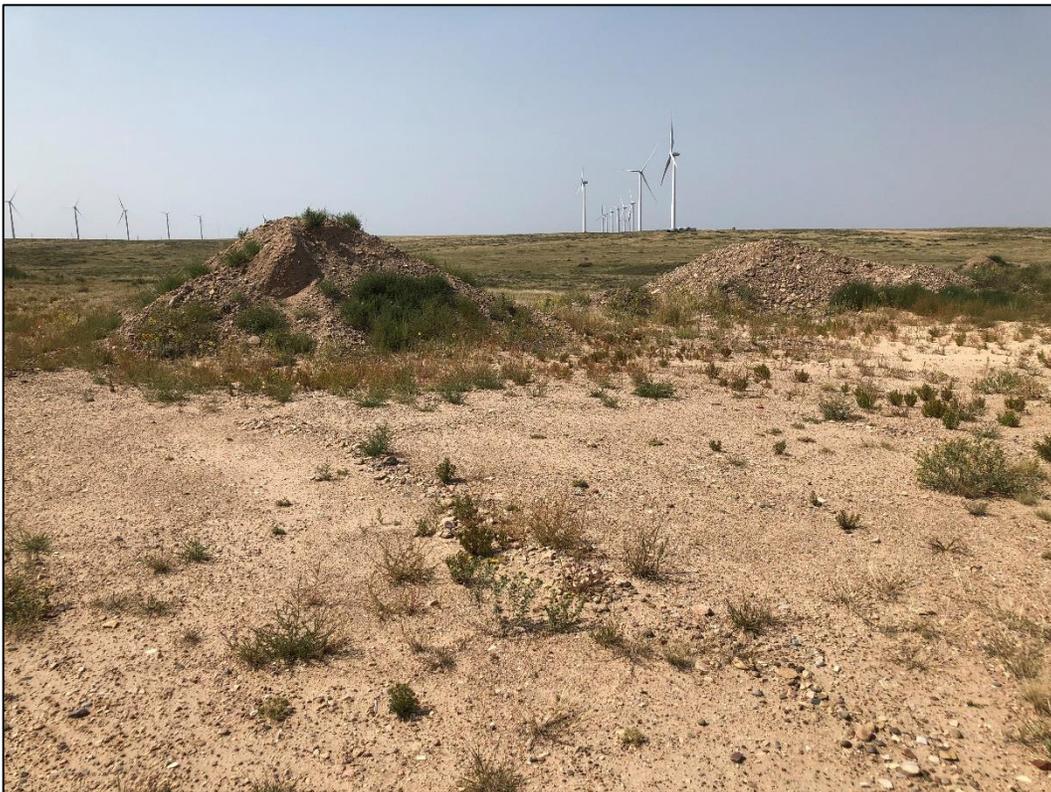
Photo 8. View looking west across northern portion of pit located north of access road, showing material stockpiled in this area.

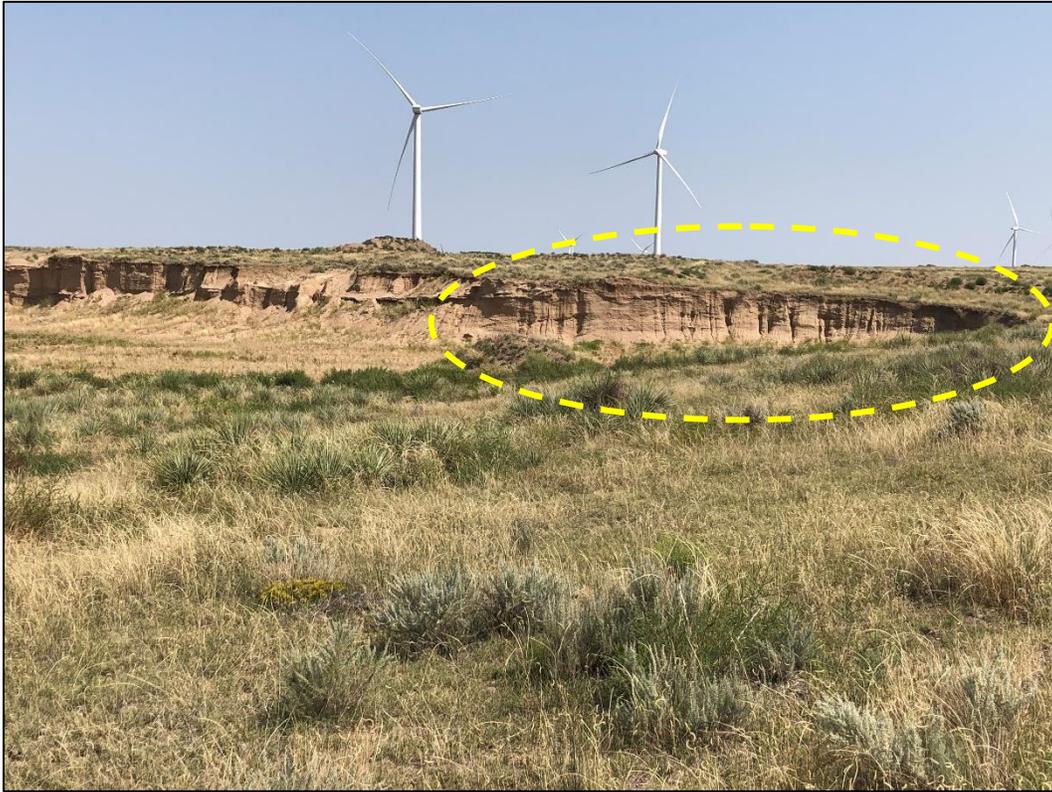
The Division last inspected the site on April 9, 2015 while reviewing a Succession of Operators application (SO-1) to transfer the permit from Carder, Inc. to the current operator. Since that time, the new operator has expanded the pit slightly at its southeastern edge. The southern pit wall is approximately 5-8 feet in height with near vertical slopes. According to the operator, mined material is primarily used to maintain roads on their property, but is also used to construct/maintain roads and pad sites for nearby wind farms. No significant erosion problems were observed. Additionally, very few weeds (no noxious weed species) were observed in the disturbed area. The topsoil stockpiles appeared to be stable with good vegetative cover. Native grasses and shrubs are volunteering across much of the disturbed area.

Photo 9. View looking northeast at southeastern portion of pit (circled) which has been expanded slightly since the Division's last inspection in 2015.

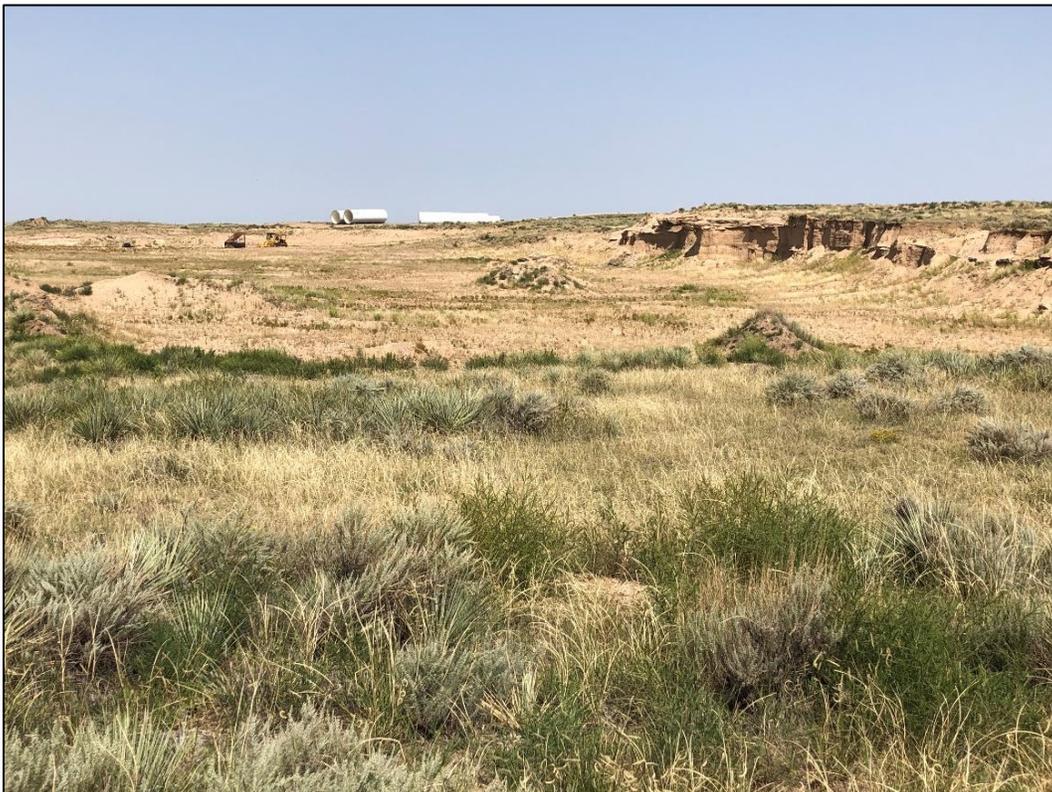
Photo 10. View looking north across main pit area from south of pit.

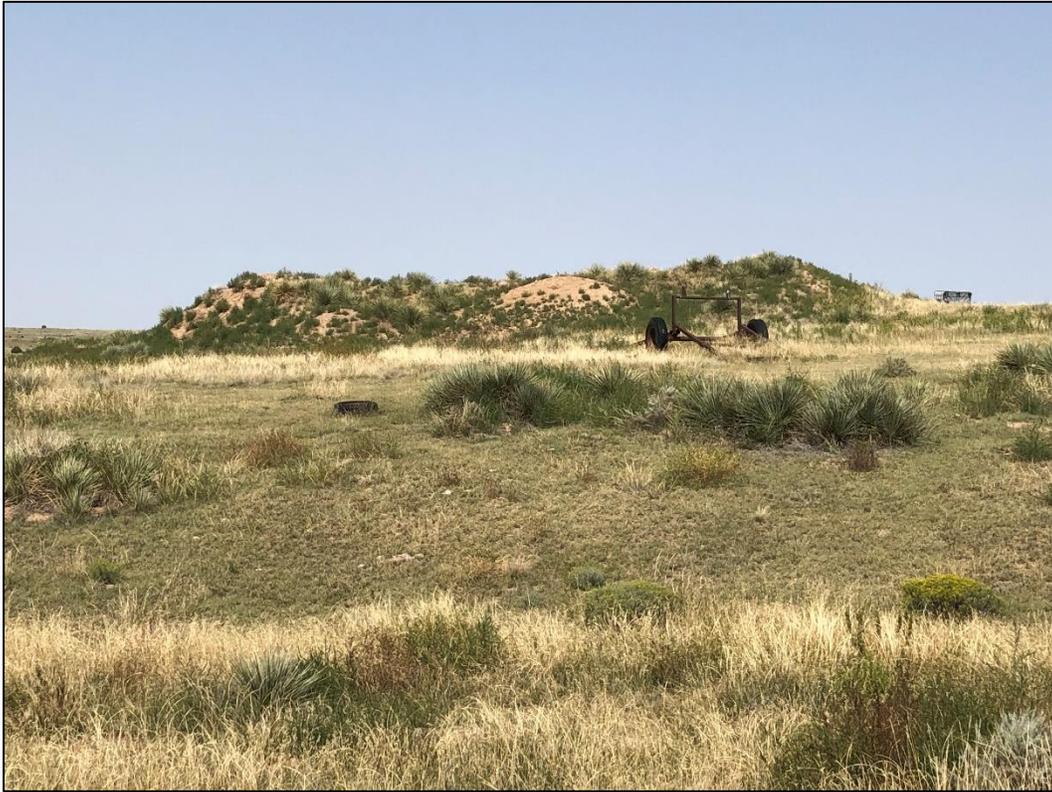
Photo 11. View looking west at large topsoil stockpile stored at western edge of pit. Note stockpile stable with good vegetative cover.

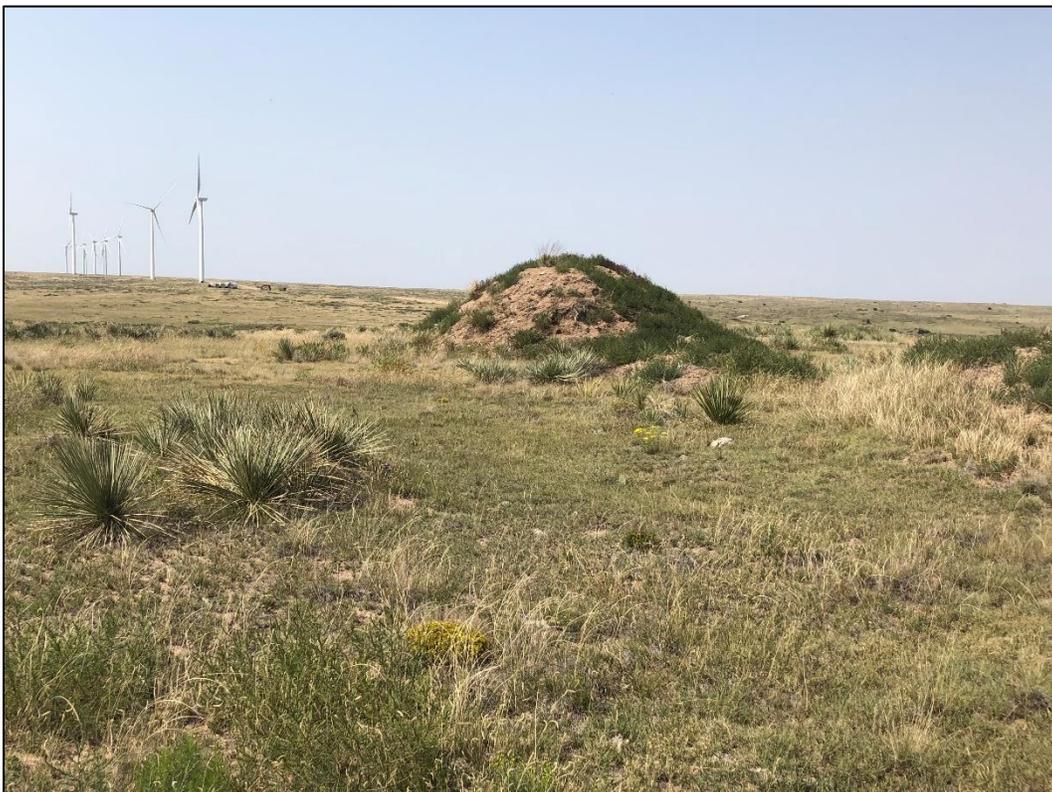
Photo 12. View looking northwest at small topsoil stockpile stored at eastern edge of pit, above highwall. Note stockpile stable with good vegetative cover.

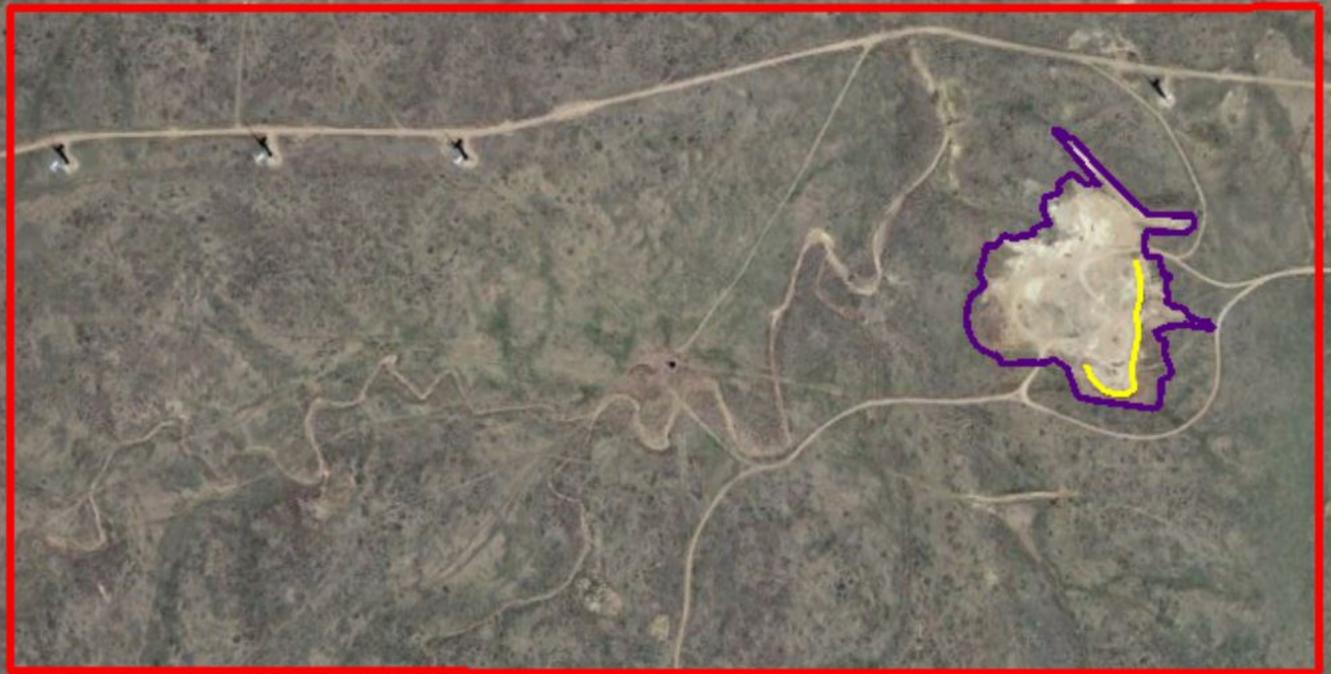
Red outline = 320 acres = Approved permit area (location approximated based on approved maps)
Purple outline = 12.5 acres = Disturbed area (as of 9/17/2020 inspection)
Yellow line = 775 feet = Approximate length of highwall requiring reclamation grading
(Image data from 6/12/2017)

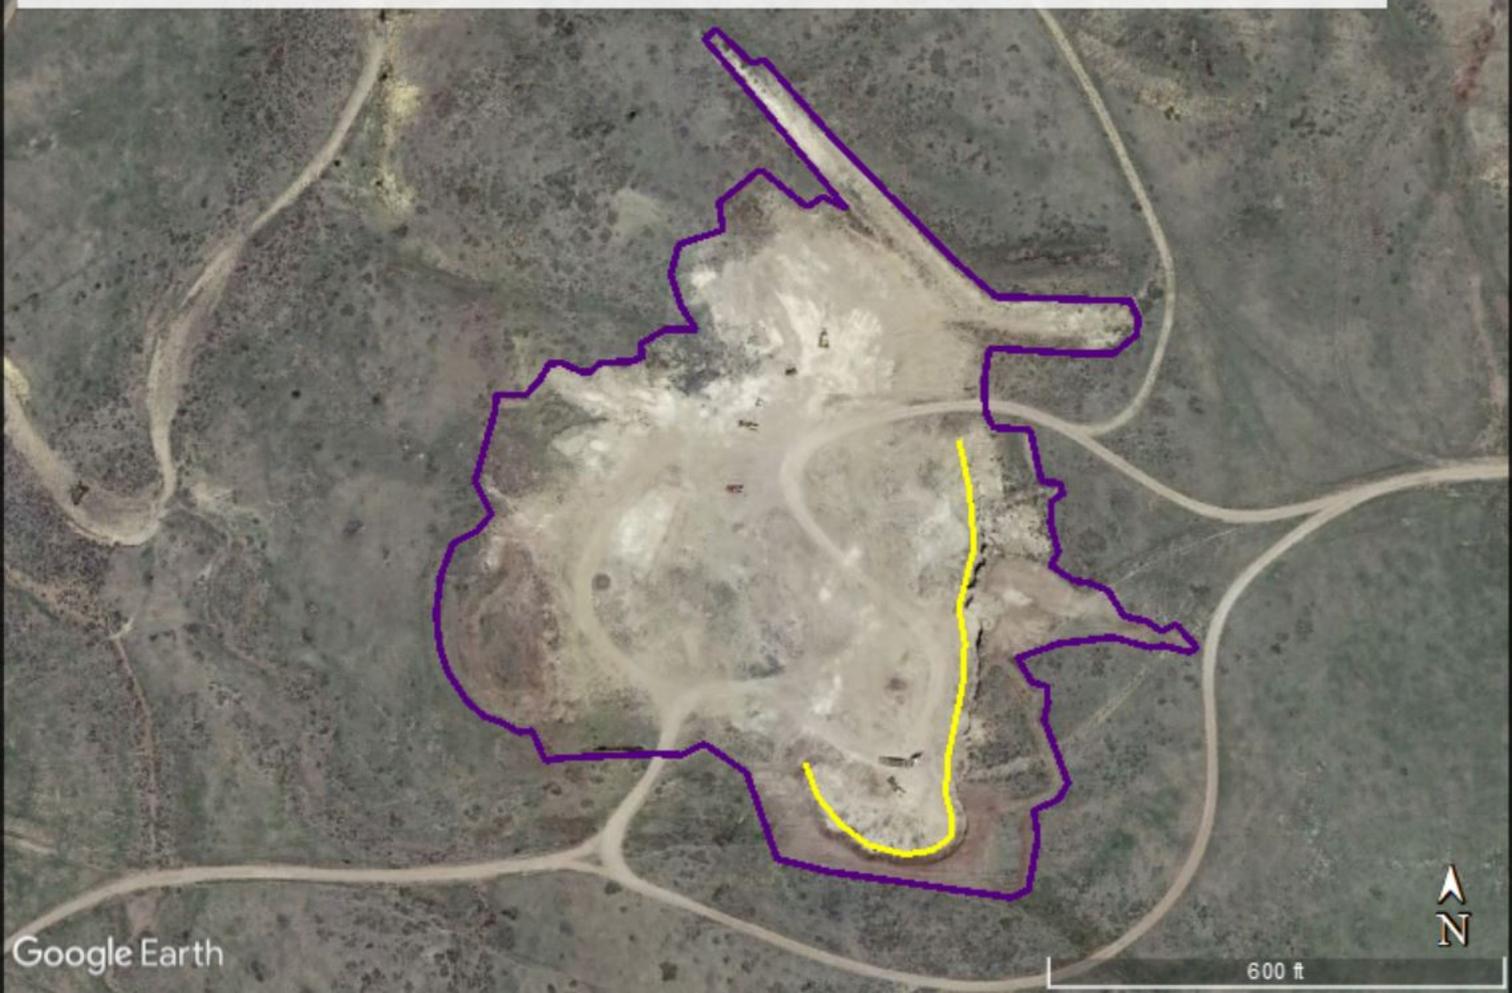
M-2003-052 / Windy Ridge Pit / J.E. Cattle, LLC / (112c) Close-Up of Disturbed Area

Approved permit area = 320 acres (boundary not shown)

Purple outline = 12.5 acres = Disturbed area (as of 9/17/2020 inspection)

Yellow line = 775 feet = Approximate length of highwall requiring reclamation grading
(Image data from 6/12/2017)
