MINERALS PROGRAM INSPECTION REPORT
PHONE: (303) 866-3567

MINE NAME: Bromley Lakes	MINE/PROSPECTING ID#: M-1987-049	MINERAL: Sand and gravel	COUNTY: Adams
INSPECTION TYPE: Surety-Related Inspection	INSPECTOR(S): Patrick Lennberg	INSP. DATE: October 28, 2020	INSP. TIME: 09:00
OPERATOR: Ready Mixed Concrete Company, LLC	OPERATOR REPRESENTATIVE: Joe Lamanna	TYPE OF OPERATION: 112c - Construction Regular Operation	
REASON FOR INSPECTION: Surety Related	BOND CALCULATION TYPE: None	BOND AMOUNT: \$4,168,740.00	
DATE OF COMPLAINT: NA	POST INSP. CONTACTS: None	JOINT INSP. AGENCY: None	
WEATHER: Clear	INSPECTOR'S SIGNATURE:

This was a surety-related inspection of the Bromley Lakes (Permit No. M-1987-049) site conducted by Patrick Lennberg of the Division of Reclamation, Mining and Safety (Division/DRMS) in response to a Succession of Operators application (Revision No. SO-01) that was received by the Division on September 9, 2020. A representative from both the current and successor operator, Joe Lamanna with Ready Mixed Concrete Company, LLC and Brett Sherman with the City of Brighton were present during the inspection.

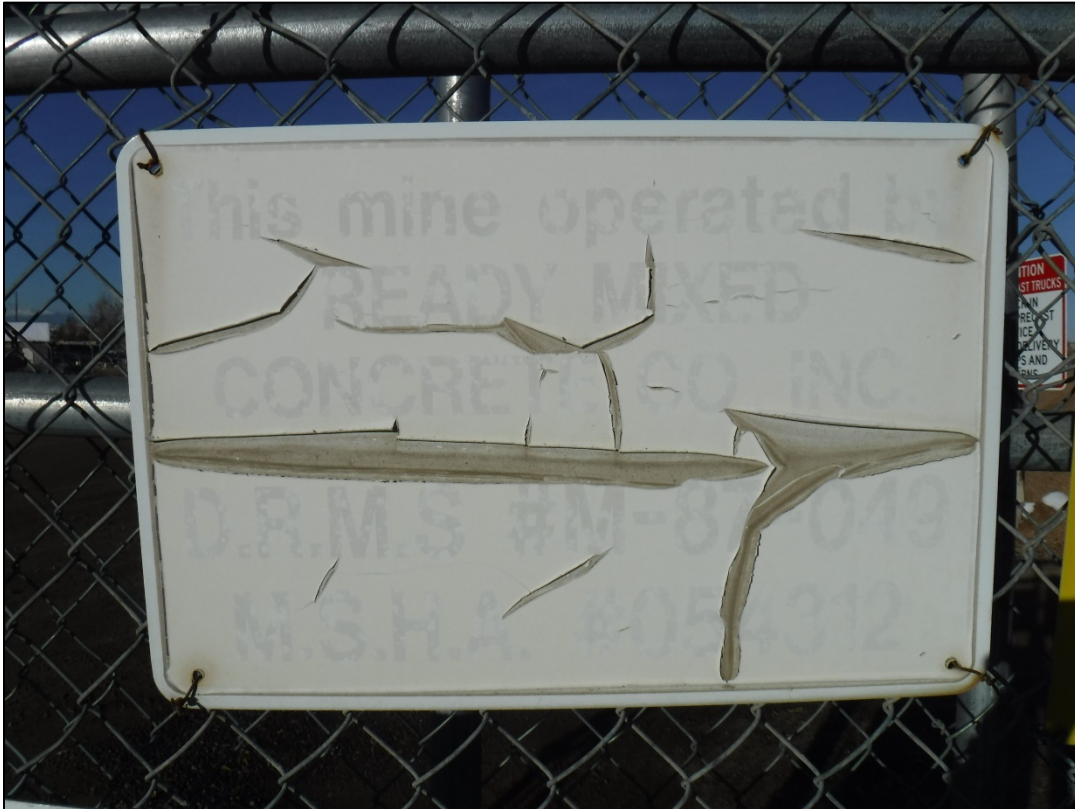
The Division did note that the current mine sign is faded and unreadable. The new permittee will have to erect a new mine sign at the mine entrance. The following are the specifications for the new mine sign according to Rule 3.1.12,

Photo 1: Mine sign at entrance to mine site

At the entrance of the mine site the Operator shall post a sign, which shall be clearly visible from the access road, with a minimum size equaling one hundred and eighty-seven (187) square inches, such as eleven (11) inches in height and seventeen (17) inches in width, with appropriate font size, with the following:

- (a) the name of the Operator and the operation name;
- (b) a statement that a reclamation permit for the operation has been issued by the Colorado Mined Land Reclamation Board; and
- (c) the permit number.

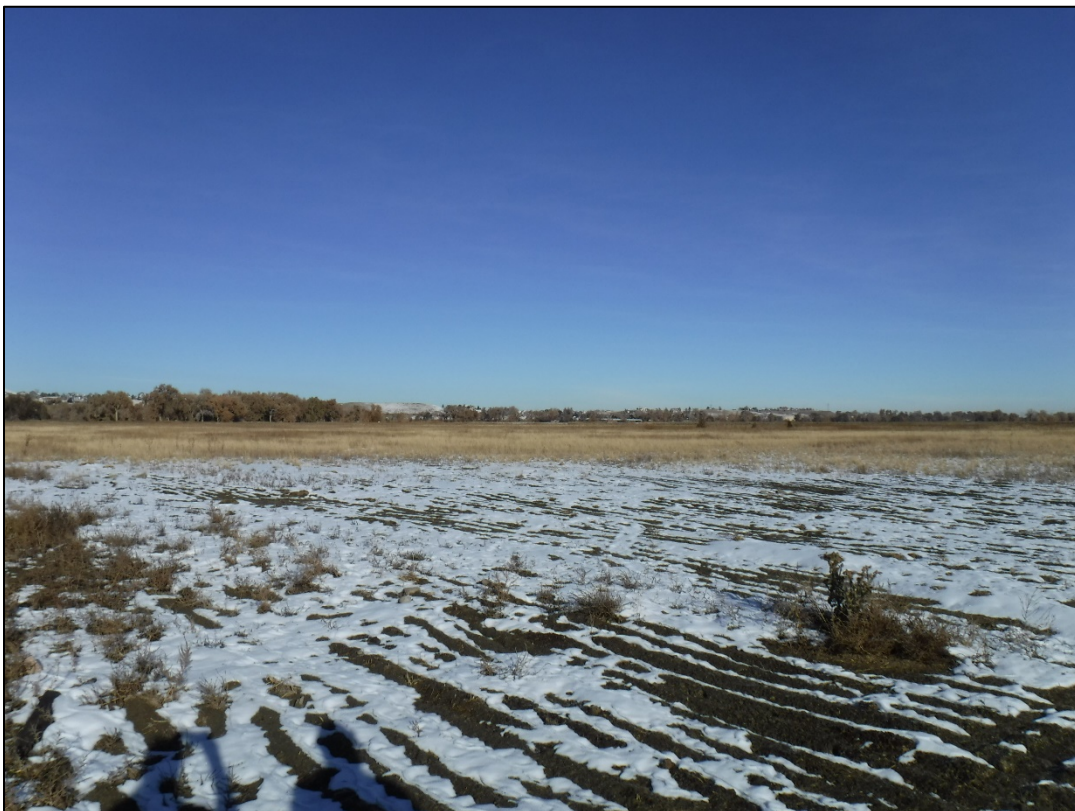
The Cell No. 2 area has been backfilled and graded to a relatively level area. Vegetation in this area appears to be establishing well.

Photo 2: Cell No. 2 vegetation becoming established

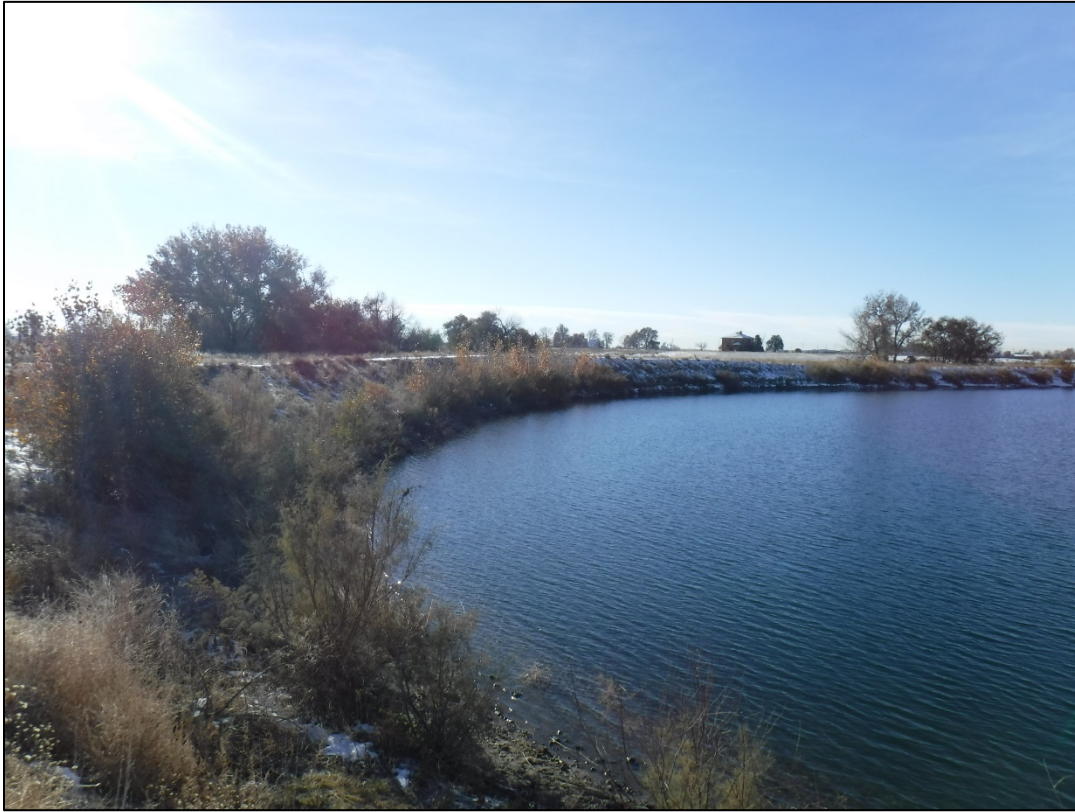
Photo 3: Cell No. 3 northeastern corner, note tamarisk trees and steep slopes

As mentioned in the previous inspection report the side slopes surrounding Cell No. 3 need repair and treatment of tamarisk trees. Repairs will consist of grading slopes to 3H:1V and installation of rip-rap to prevent future erosion. The City acknowledge that repairs will begin when the current water lease of the reservoir expires in three years. When the lease is over the water level will be drawn down to allow access to complete the repairs. Upon completion of the repairs the reservoir will be filled for use by the City.

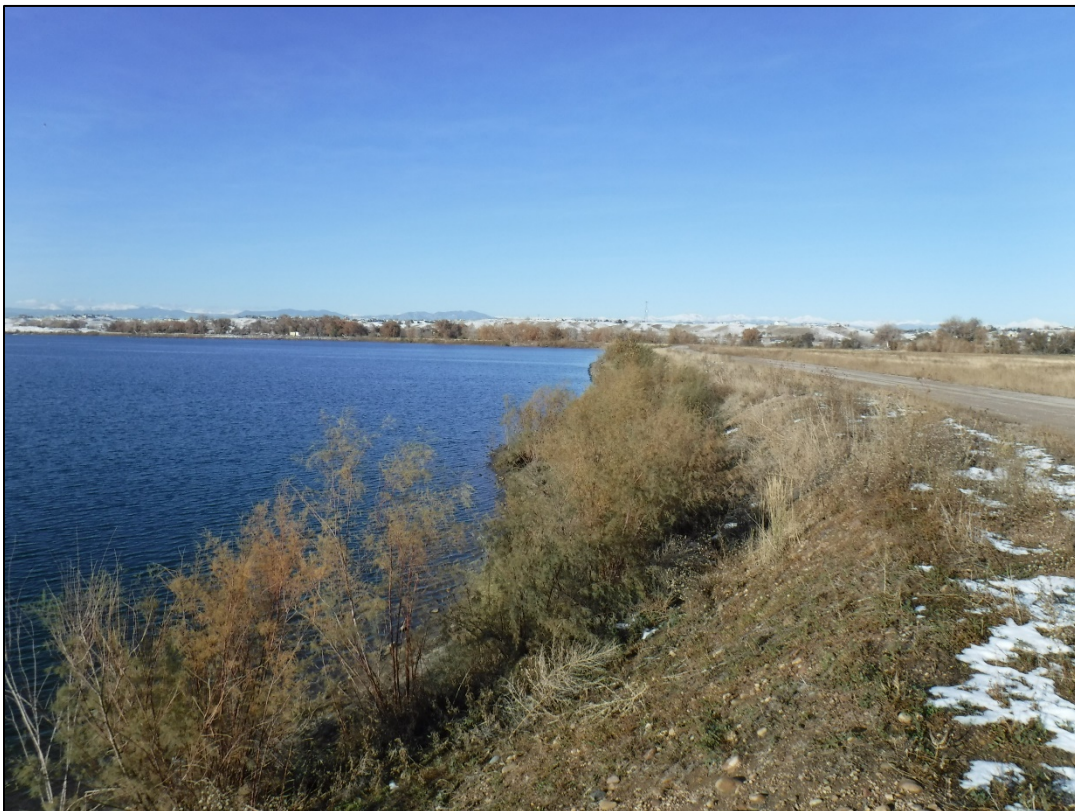
Photo 4: Cell No. 3 northeastern corner looking west

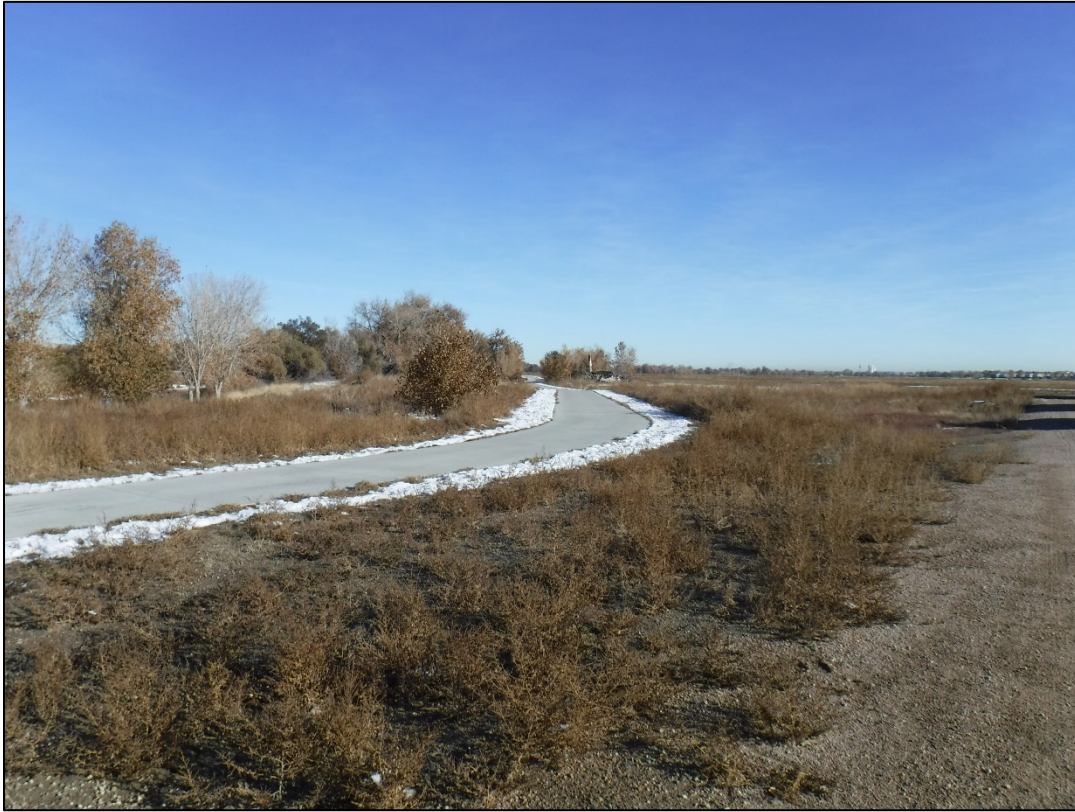
Photo 5: Cell No. 3 northwestern corner looking at paved trail

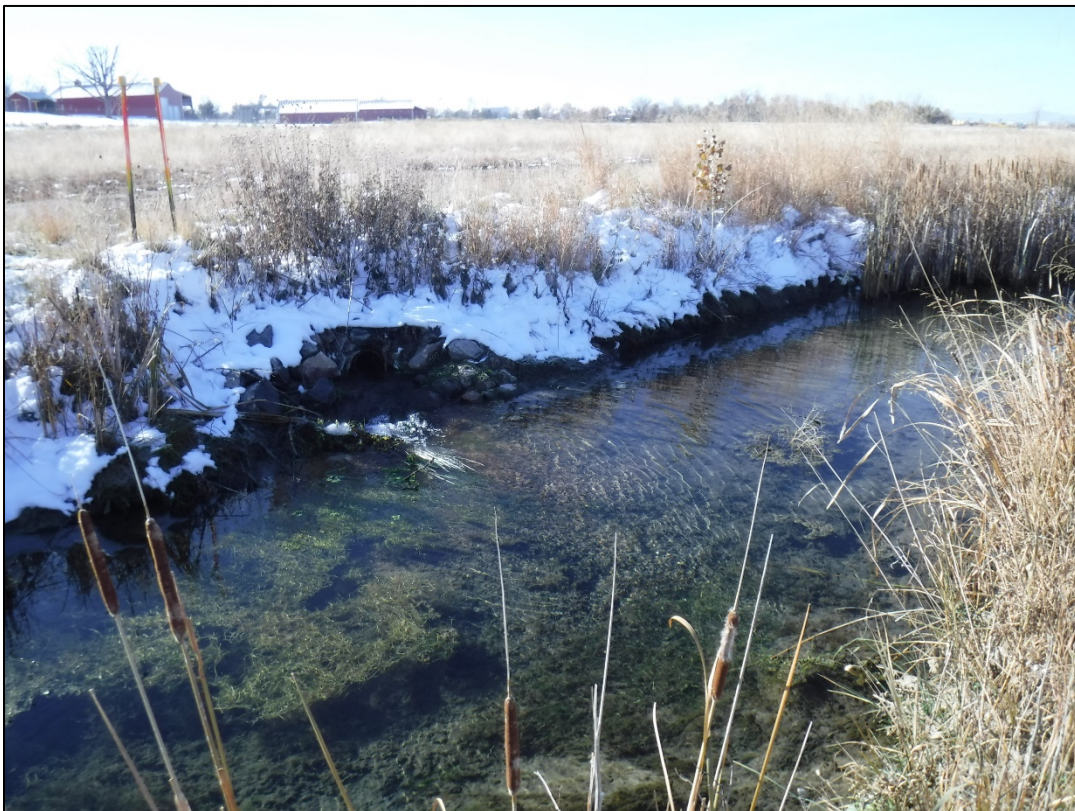
The relocated McCanne Ditch was observed to be flowing and functional. The French Drain installed adjacent to the Spier Property was observed discharging water into the McCanne Ditch. The two cleanout areas were observed on the northwest side of the Spier property

Photo 5: French drain flowing into McCanne Ditch
