Inspection Report / Schwartzwalder Mine / M-1977-300

Letter of Transmittal

SUPPLEMENT TO THE SCHWARTZWALDER MINE PHASE 2 ALLUVIAL FILL AREA CHARACTERIZATION AND LONG-TERM RECLAMATION PROJECT

USACE FILE NUMBER NOW-2011-1353DEN

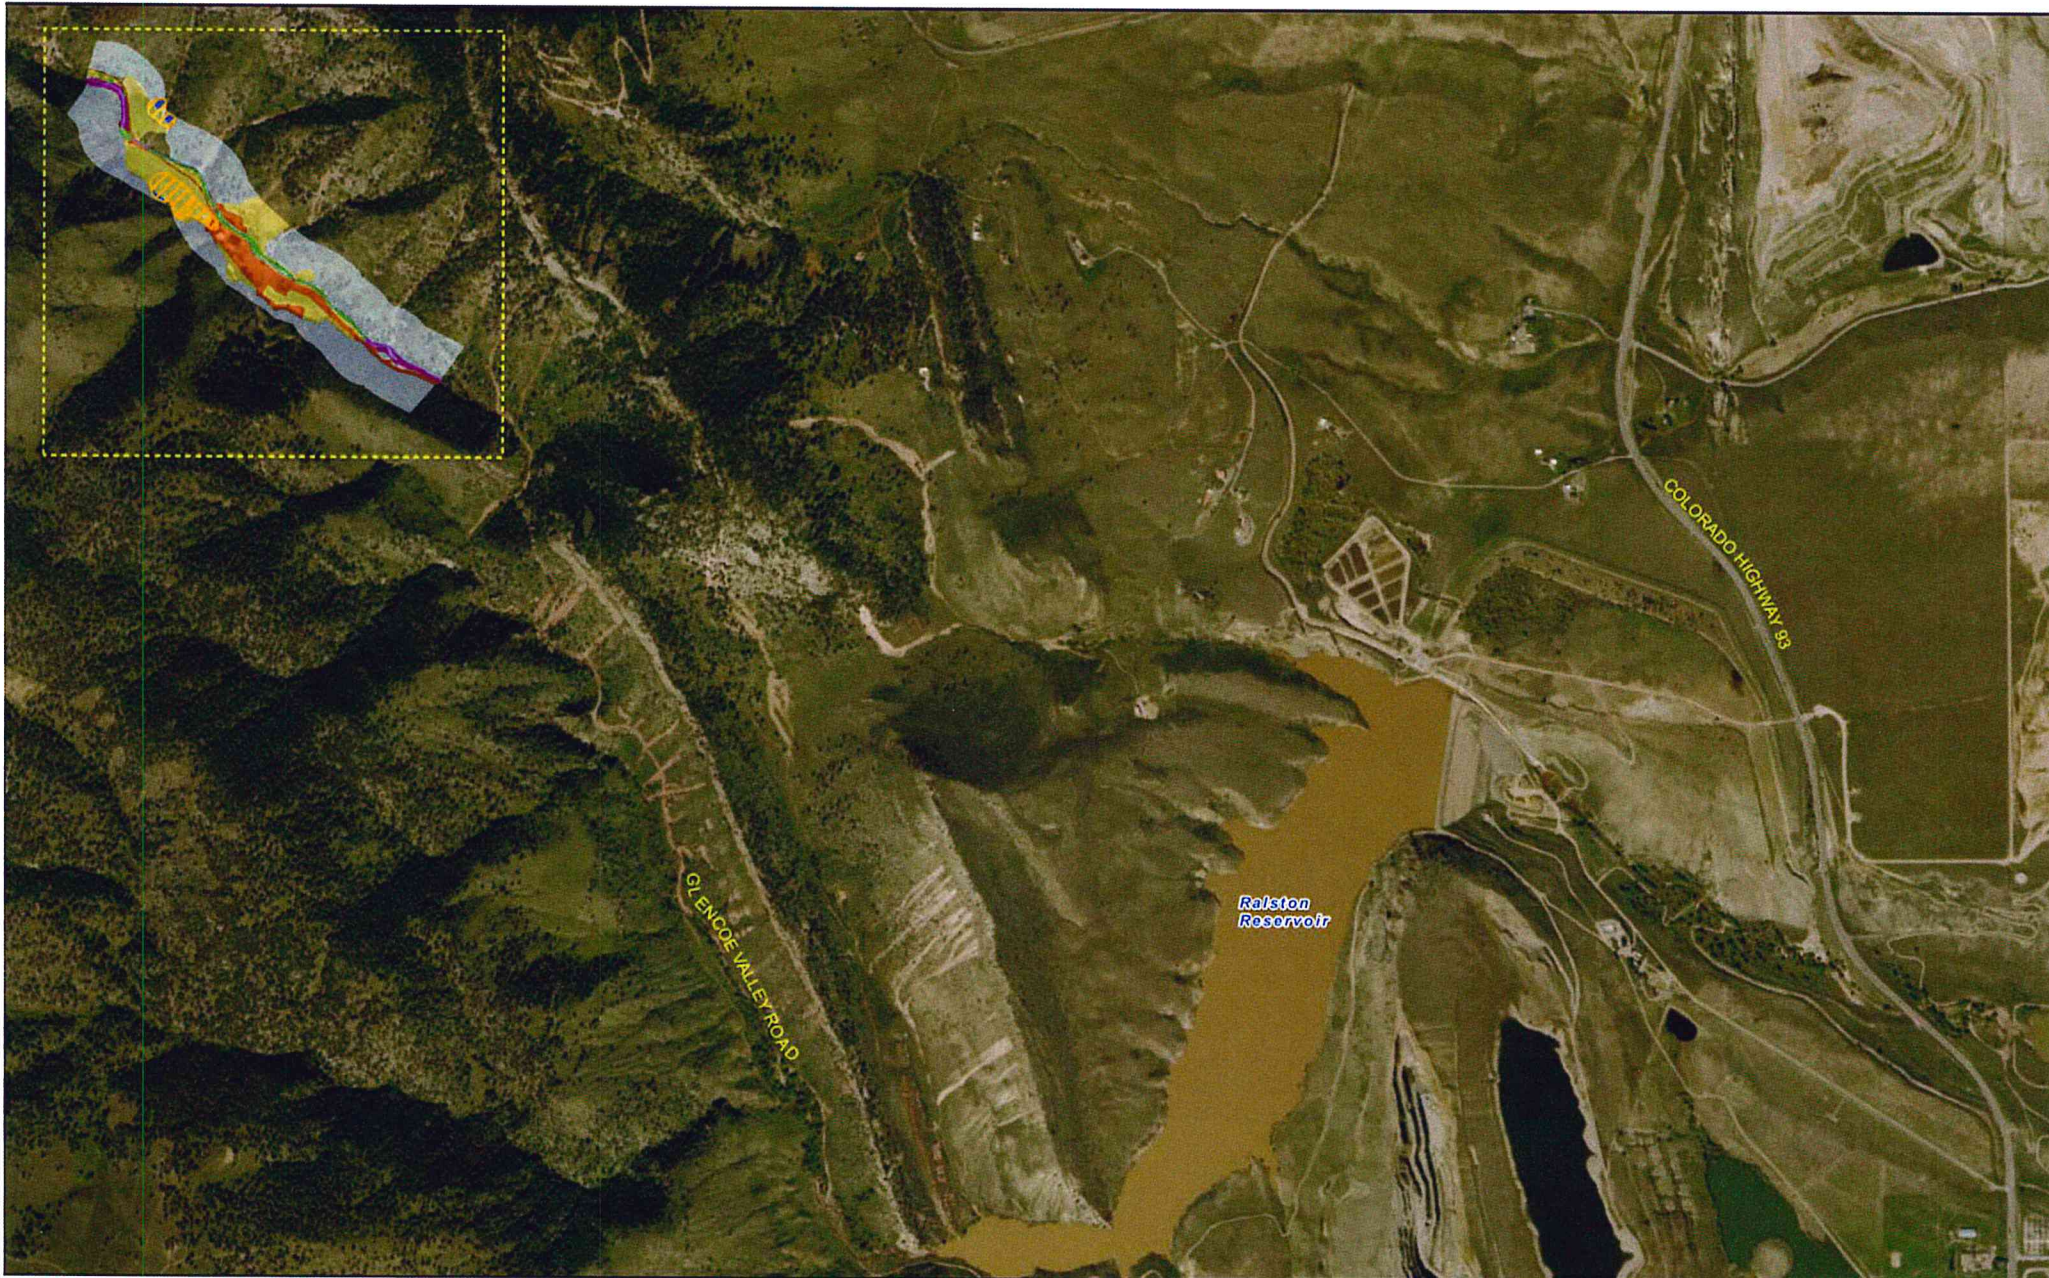
FIGURE
1

SITE LOCATION
SCHWARTZWALDER MINE SITE

Jefferson County, Colorado
SECTION 25, T2S, R71W, 6TH PM
& SECTION 30 T2S, R70W, 6TH PM

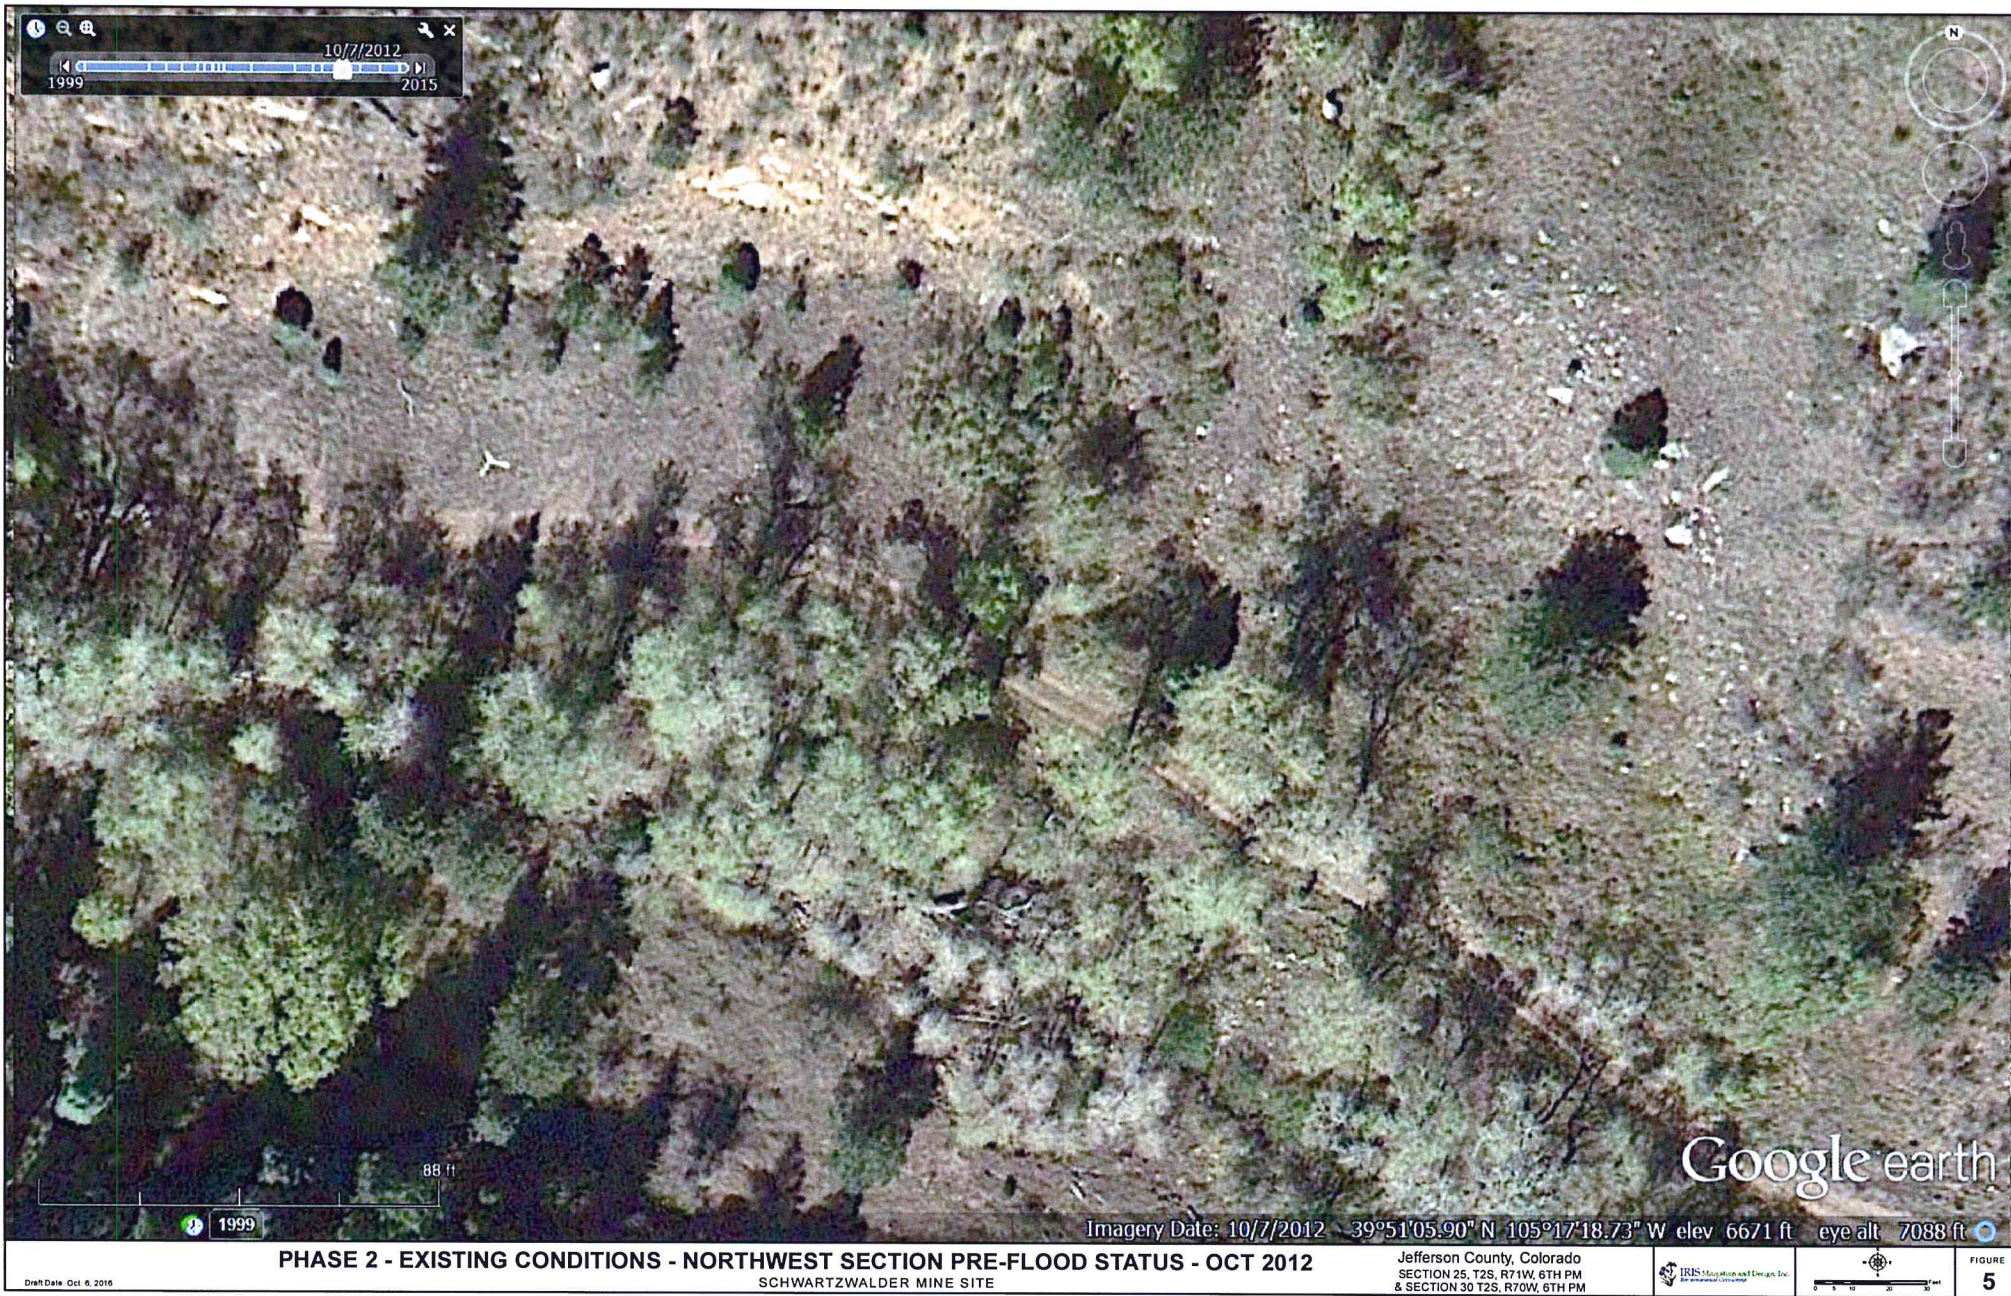
FIGURE
3

PHASE 2 - EXISTING CONDITIONS - LANDSLIDE AREA - POSTFLOOD STATUS - OCT 2013
SCHWARTZWALDER MINE SITE

On behalf of Cotter, IRIS Mitigation and Design Inc. ("IRIS") Senior Scientist Blair Leisure and Christopher Rice, a GPS survey technician, visited the site in September 2016 to survey the existing dirt road. This survey information later helped to identify where within the 394 foot PMJM set-back the road is located, as shown on Figures 3 and 4. Approximately 643 linear feet of the existing dirt road is within the PMJM set-back and has been mapped as previously disturbed upland non-habitat as it is heavily disturbed due to past and on-going mining activities (see Figure 3).

Site characterization and reclamation along the Creek will have permanent and temporary impacts to both previously disturbed and undisturbed PMJM riparian and upland habitat along the Creek (see 2016 BA: Figure 3 – Existing Conditions and Figure 6 – Phase 2 Project Impact and this Project Supplement Figures 4 and 7).

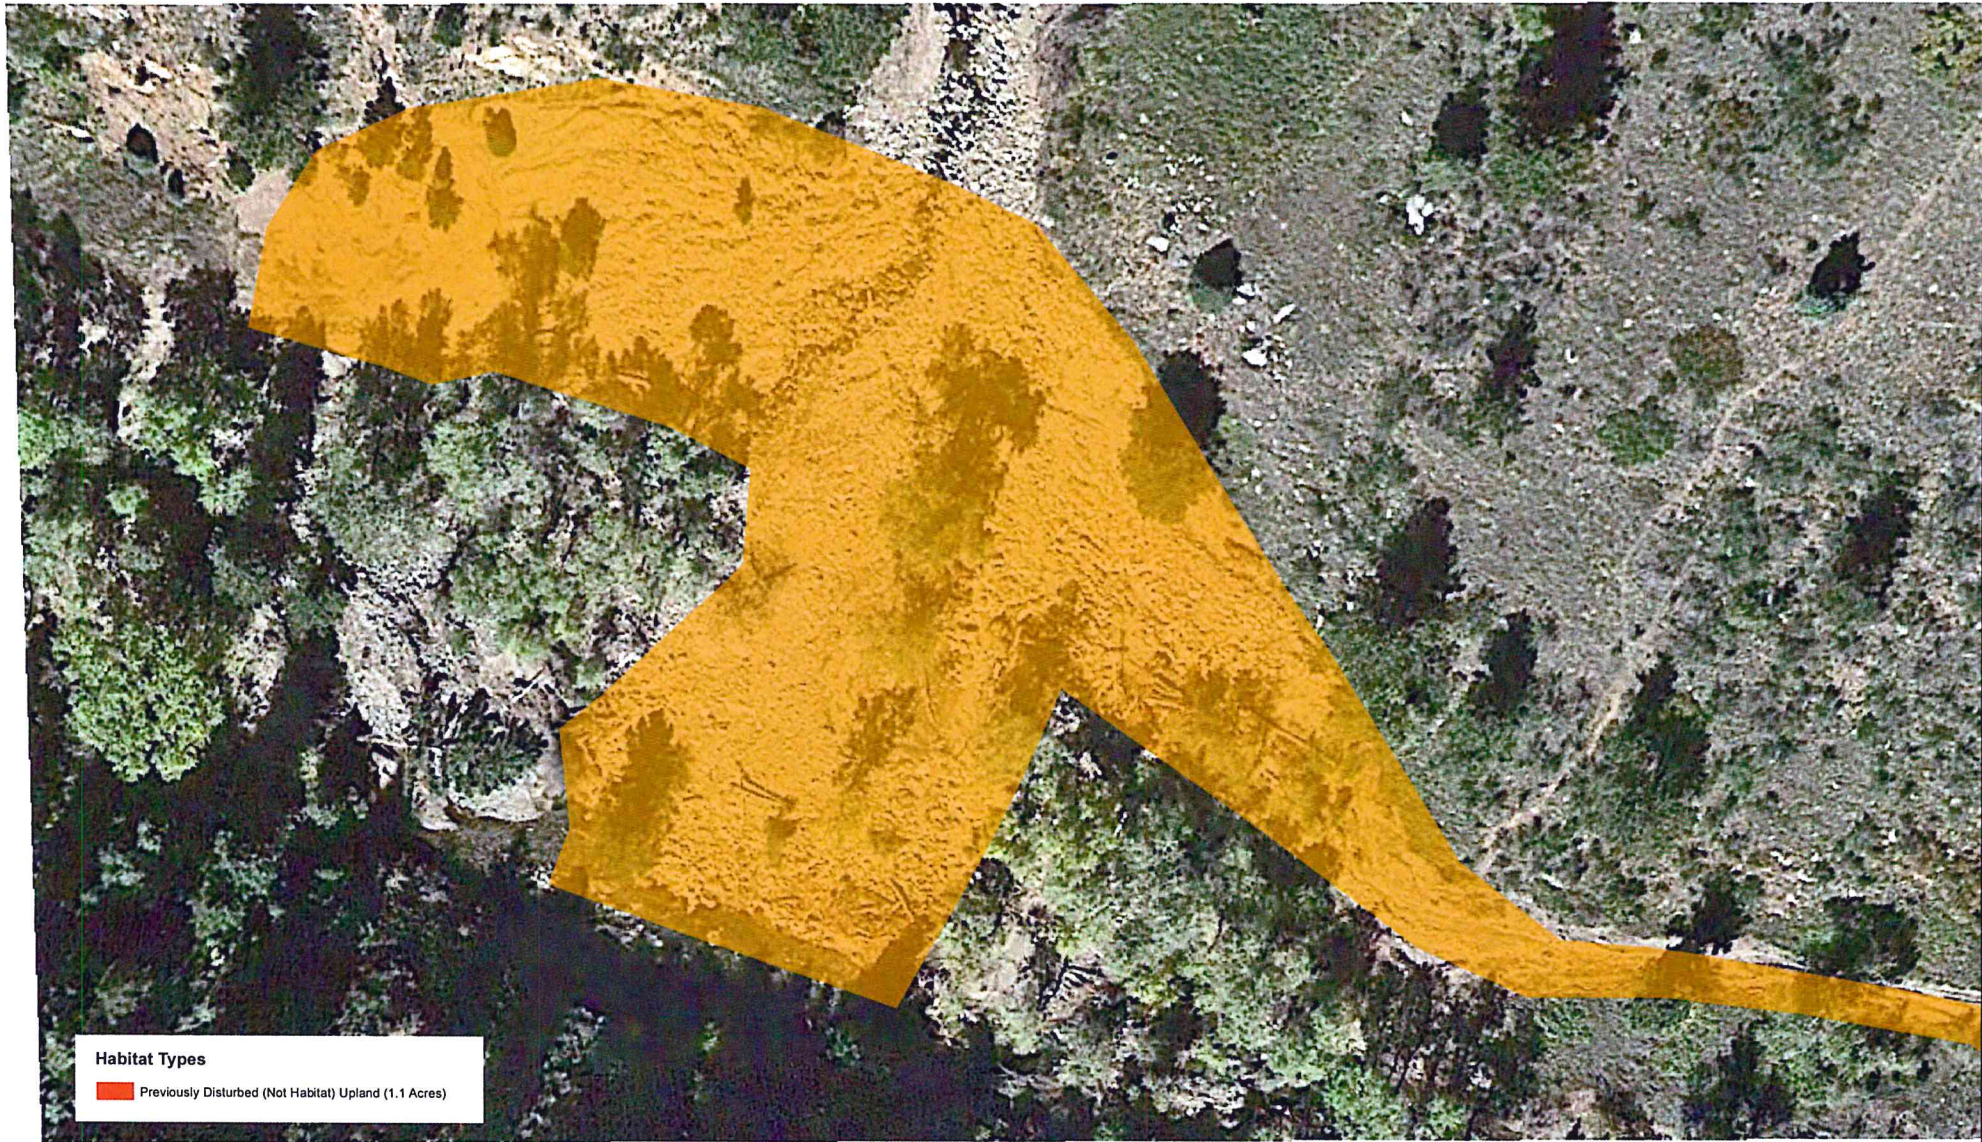
FIGURE
6

Previously Disturbed (Not Habitat) Upland (1.1 Acres)

The September 2013 Flood event brought enormous amounts of material including silt, cobble and rock down into the Schwartzwalder mine valley from adjacent steep side slopes. Some material came down in such concentrated amounts and at such velocities as to create a landslide into the valley below. One such location is shown on Figures 5 and 6 both before and after the Flood. This large amount of debris covered existing upland habitat up to 20 feet deep and ripped out many of the existing trees and shrubs. Some of the trees were partially to totally buried under this rock and debris causing trees to die over the next one to two year time period (see Figures 5 and 6). IRIS has determined that this 1.1 acre area was so heavily impacted in September 2013 as to be considered previously impacted upland non-habitat for PMJM (see Figures 5 and 6). A portion of this rock, cobble and silt were used in 2014 and 2015 to help re-build the access road to the site which was also destroyed during the Flood. Another portion of this area is currently re-establishing with upland grasses, trees and shrubs (0.22 acre) so that it now could be considered previously disturbed upland habitat for PMJM (see Figure 7).

On behalf of Cotter, we request that the remaining 0.22 acre of rock, silt and cobble be utilized to partially cap the waste rock piles once the Phase 2 excavated material is placed on the existing waste rock piles. Therefore, we expect a total of 0.22 acre of impact to previously disturbed upland habitat.

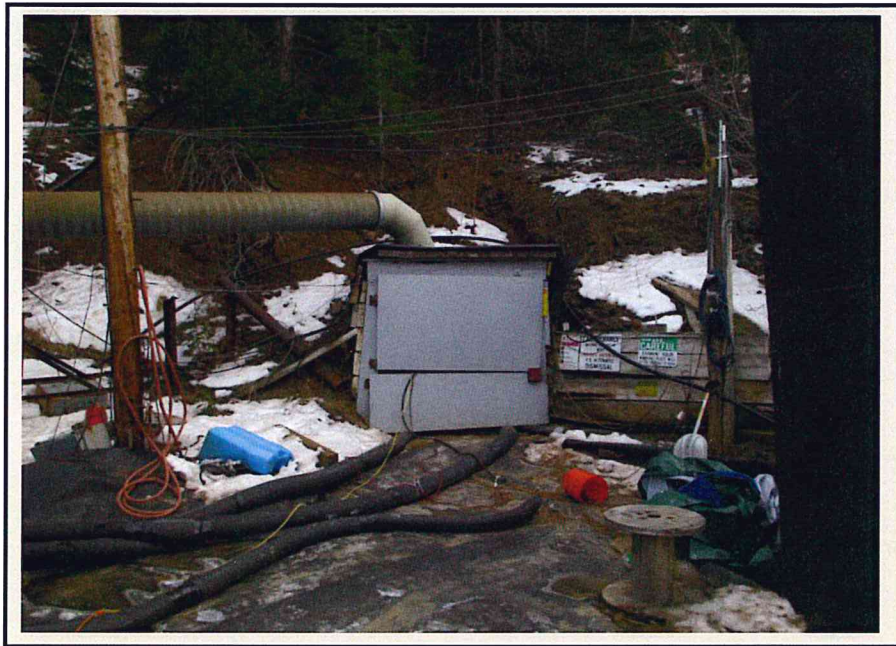
5JF.6954 (Schwartzwald Mine): Steve Level Portal, looking south. Photographed by J. F. Hoffecker on 29 January 2016.

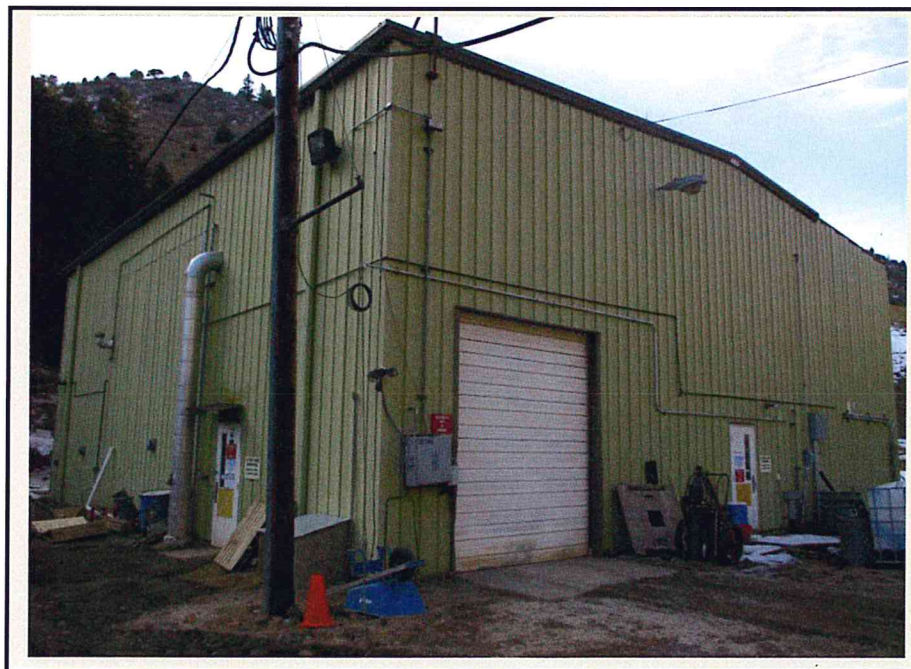
5JF.6954 (Schwartzwalder Mine): water treatment plant building, looking southwest. Photographed by J. F. Hoffecker on 29 January 2016.

Water Treatment Plant Building: A rectangular metal frame one-story building on a concrete slab foundation occupying a total area of 4,135 square feet. The exterior walls are composed of metal siding and the low-pitched roof is composed of metal sheeting. There are single metal personnel doors at the north end of the east elevation, and near the center of the north elevation. There is a metal roller-type garage door on the east end of the north elevation. There are no windows on the building (other than on the doors).

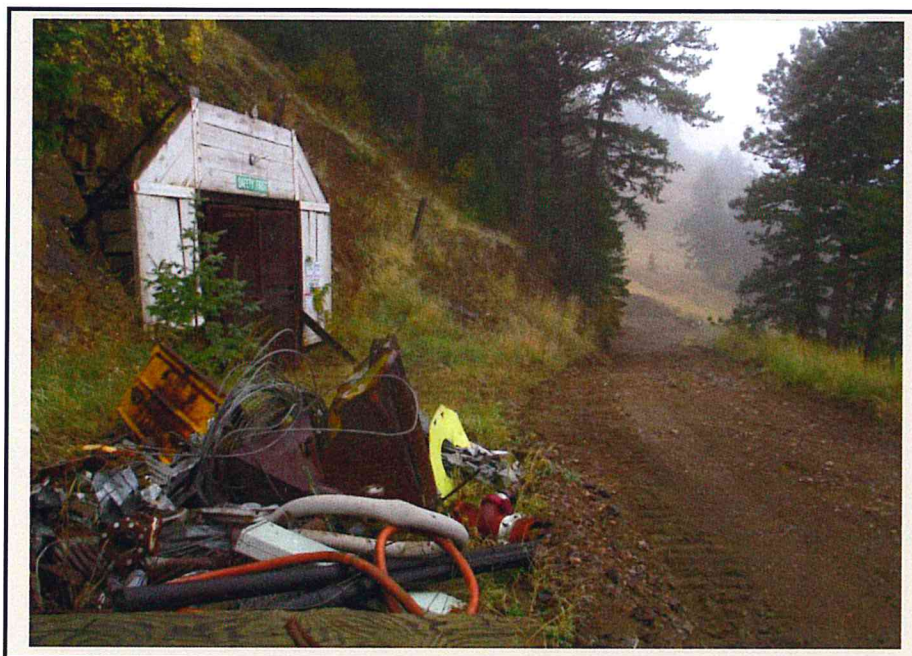
5JF.6954 (Schwartzwalder Mine): Minnesota Portal and access road, looking west. Photographed by J. F. Hoffecker on 12 October 2016.

excavated waste rock will be placed into a vertical mine hole ("Glory Hole"). The Glory Hole is accessible through the Minnesota adit located along this dirt road. Heavy construction equipment will need to utilize this dirt road, which is now approximately 7-8 feet wide except at several bends where the road is widened (see Figures 3 and 4). The dirt road will need to be widened by approximately 3 feet to enable its safe use by heavy equipment.

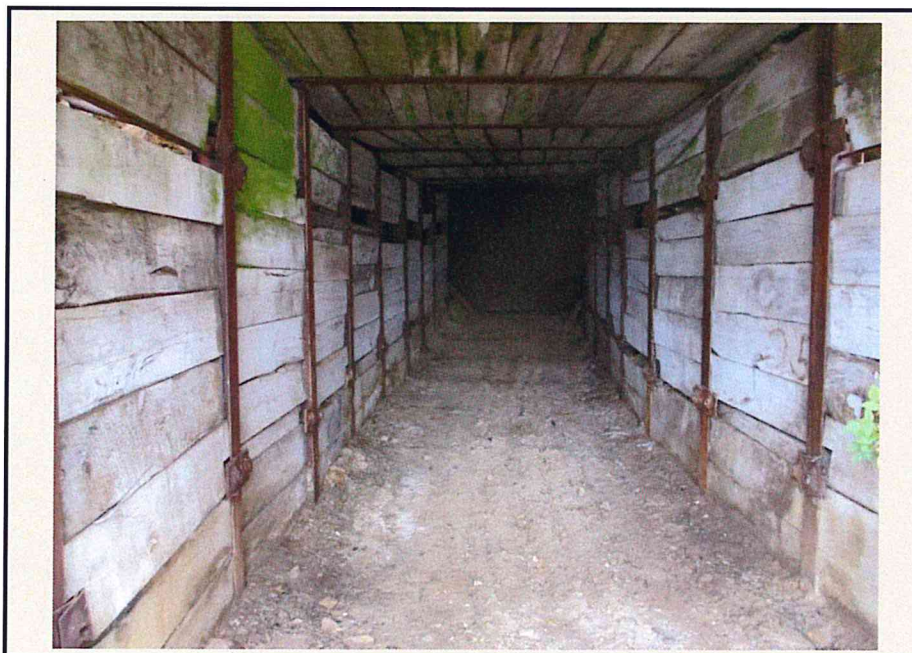
5JF.6954 (Schwartzwalder Mine): Minnesota Portal interior, looking south towards "glory hole." Photographed by J. F. Hoffecker on 12 October 2016.
