**MINERALS PROGRAM INSPECTION REPORT**  
**PHONE: (303) 866-3567**

| <b>MINE NAME:</b><br>Daniels Sand Pit 2 | <b>MINE/PROSPECTING ID#:</b><br>M-1973-007-SG | <b>MINERAL:</b><br>Sand and gravel | <b>COUNTY:</b><br>El Paso |
| <b>INSPECTION TYPE:</b><br>Monitoring | <b>INSPECTOR(S):</b><br>Timothy Cazier, P.E. | <b>INSP. DATE:</b><br>November 5, 2020 | <b>INSP. TIME:</b><br>12:35 |

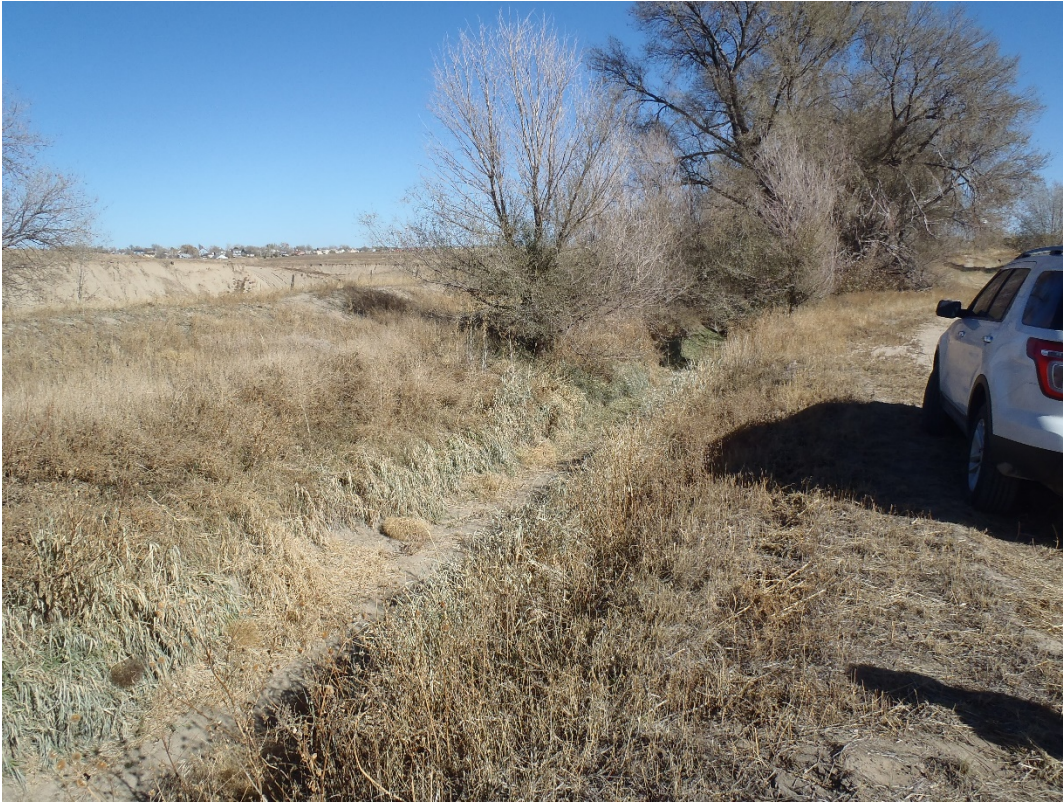
All parties met near the irrigation ditch northwest of the new wash pond. The potential exposed groundwater was discussed first. It was noted FMIC's ditch was dry at the time of the inspection (see **Photos 1** and **2**). Mr. Steen indicated the ditch would start flowing the week of November 16<sup>th</sup>. The wash pond to the south has water in it as that is where fines are disposed and is not considered exposed groundwater. Mr. Smith indicated water was present in the pit north of the ditch only when the ditch had water in it.

Photo 1. Dry FMIC ditch (looking east, subject highwall to the right of photo).

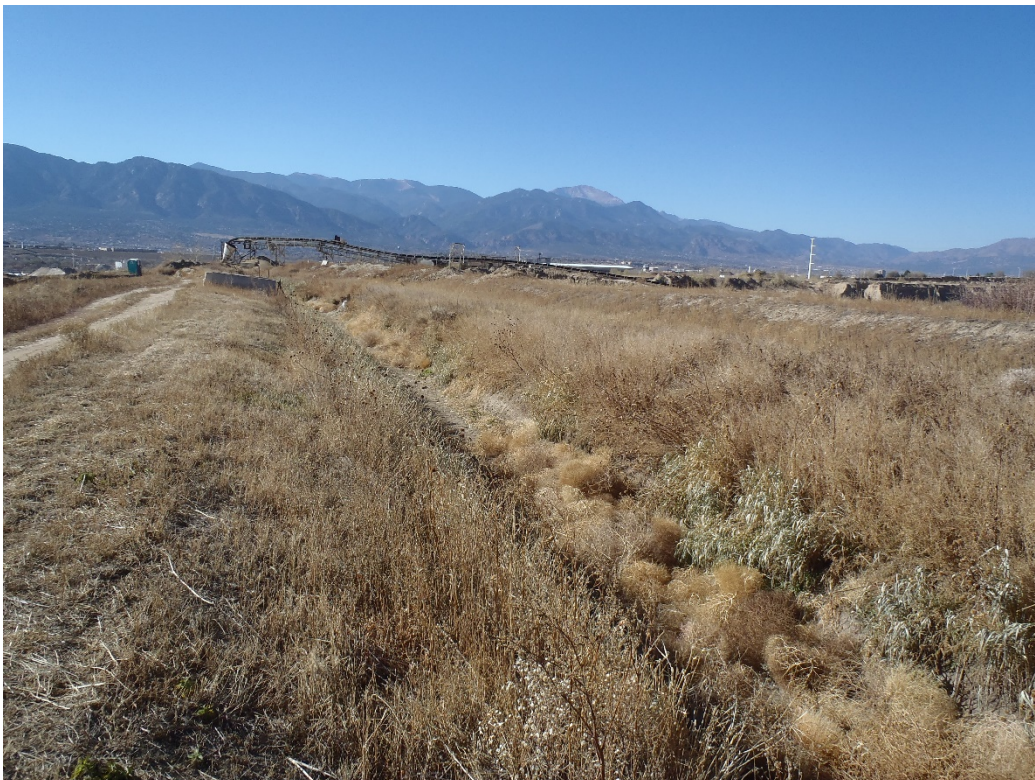
Photo 2. Dry FMIC ditch (looking west, subject highwall to the left of photo).

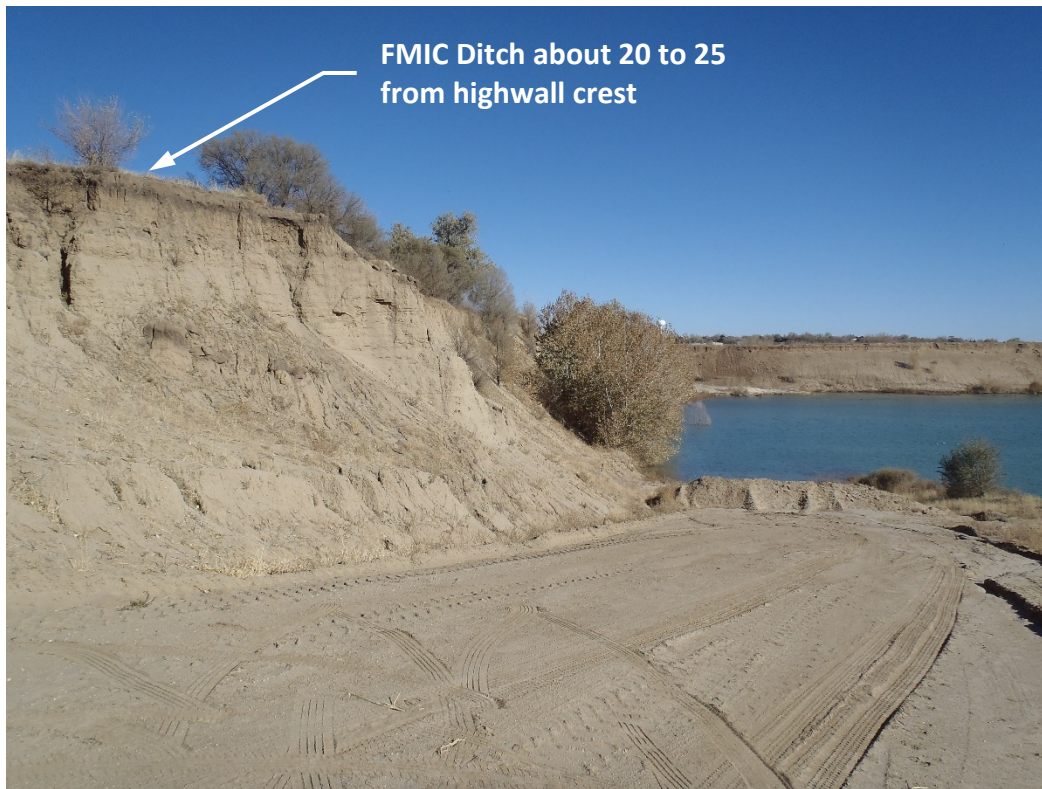
The condition of the highwall was observed (see **Photos 3** and **4**). Mr. Steen was briefed on technical revision TR-09 approved by the DRMS on September 4, 2020. This TR specifically addressed the need for 3H:1V slopes in this area between the new wash pond and the FMIC ditch, and the area to the west, between the FMIC ditch and the recharge pond near S. Academy Blvd. Mr. Steen was made aware the designs for the slope stabilization effort were accessible through the DRMS website Laserfiche WebLink (<https://dnrweblink.state.co.us/drms/search.aspx?cr=1>). AI agreed to provide the DRMS with an updated schedule for the mitigation effort, which we received on November 12<sup>th</sup> (see **Attachment A**); and clarification on the monitoring and reporting set forth in TR-09, which we received the final version on November 23<sup>rd</sup> (see **Attachment B**)

Photo 3. Highwall slope steeper than 1H:1V (looking east from NW corner of new wash pond).

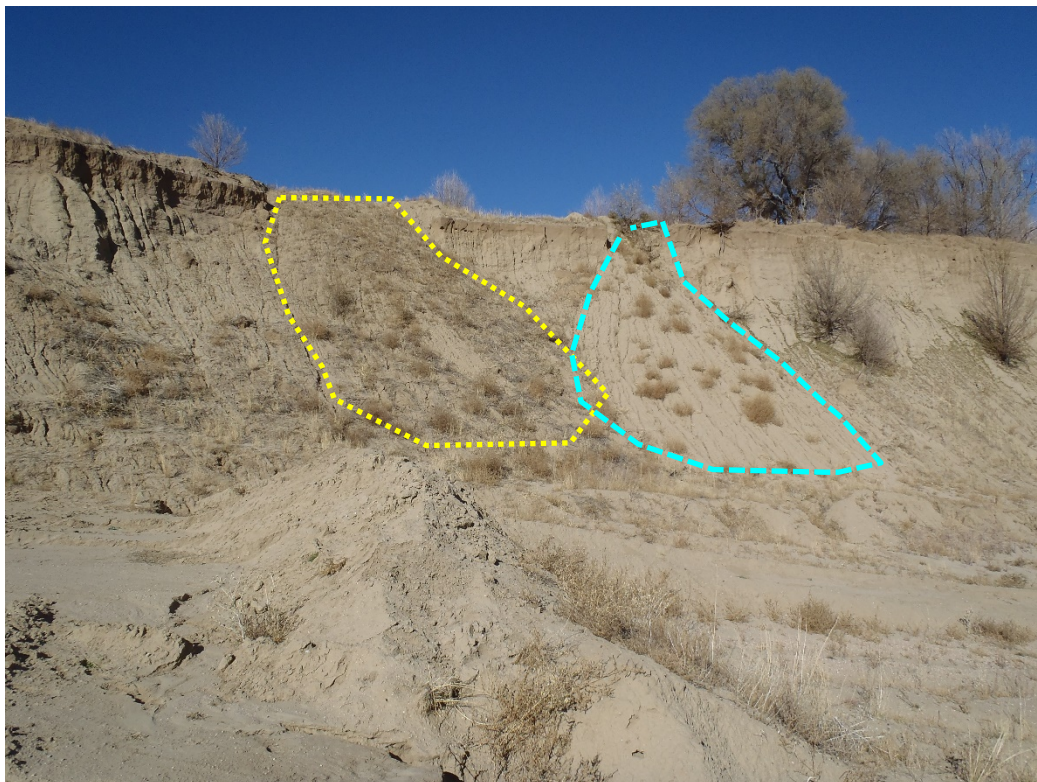
Photo 4. Previously repaired area (yellow) next to newer eroded area (blue) (looking north from NW corner of new wash pond [FMIC ditch just beyond highwall crest]).
