**MINERALS PROGRAM INSPECTION REPORT**  
**PHONE: (303) 866-3567**

<b>MINE NAME:</b> White Sand & Gravel Pit #1	<b>MINE/PROSPECTING ID#:</b> M-2010-062	<b>MINERAL:</b> Borrow material for gravel and sand	<b>COUNTY:</b> Baca
<b>INSPECTION TYPE:</b> Monitoring	<b>INSPECTOR(S):</b> Daniel Cunningham	<b>INSP. DATE:</b> November 2, 2020	<b>INSP. TIME:</b> 13:00
<b>OPERATOR:</b> White Sand & Gravel, LLC	<b>OPERATOR REPRESENTATIVE:</b> Tim White	<b>TYPE OF OPERATION:</b> 112c - Construction Regular Operation

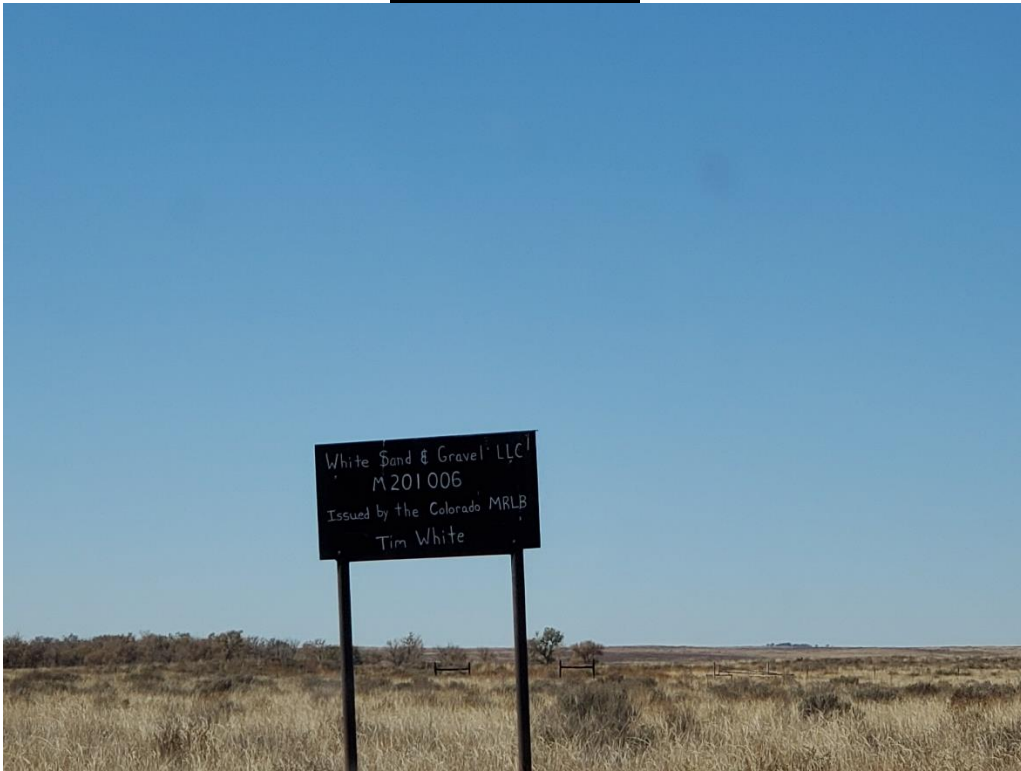
**PROBLEM:** The permit number on the entrance sign was incorrect. This is noted as a problem at this time for failure to maintain the required mine entrance sign in accordance with Rule 3.1.12.

The site identification sign was posted at the mine entrance and the boundary was marked. However, the mine entrance sign is incorrect. It has the permit number listed as M201006, when it should read M2010062. This is cited as a problem at the beginning of the report. The Operator will need to submit evidence that the entrance sign has been corrected.

Mine site entrance missing the number 2

**CORRECTIVE ACTIONS:** Submit evidence that the sign has been replaced with a new sign that is in corrected with the approved permit number (M-2010-062).

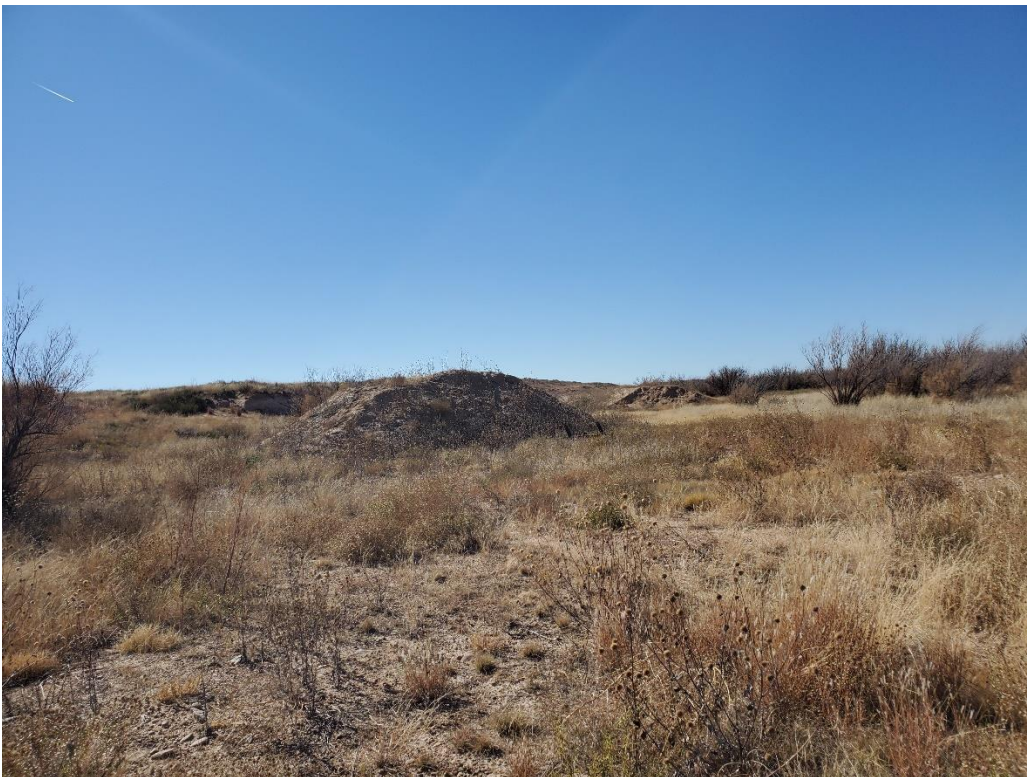
Two small stock pile was located onsite, the Operator indicated that the land owner wanted this pile left onsite for road maintenance. The Operator will need to obtain a letter from the land owner indicating that they want stock pile left.

Stockpile

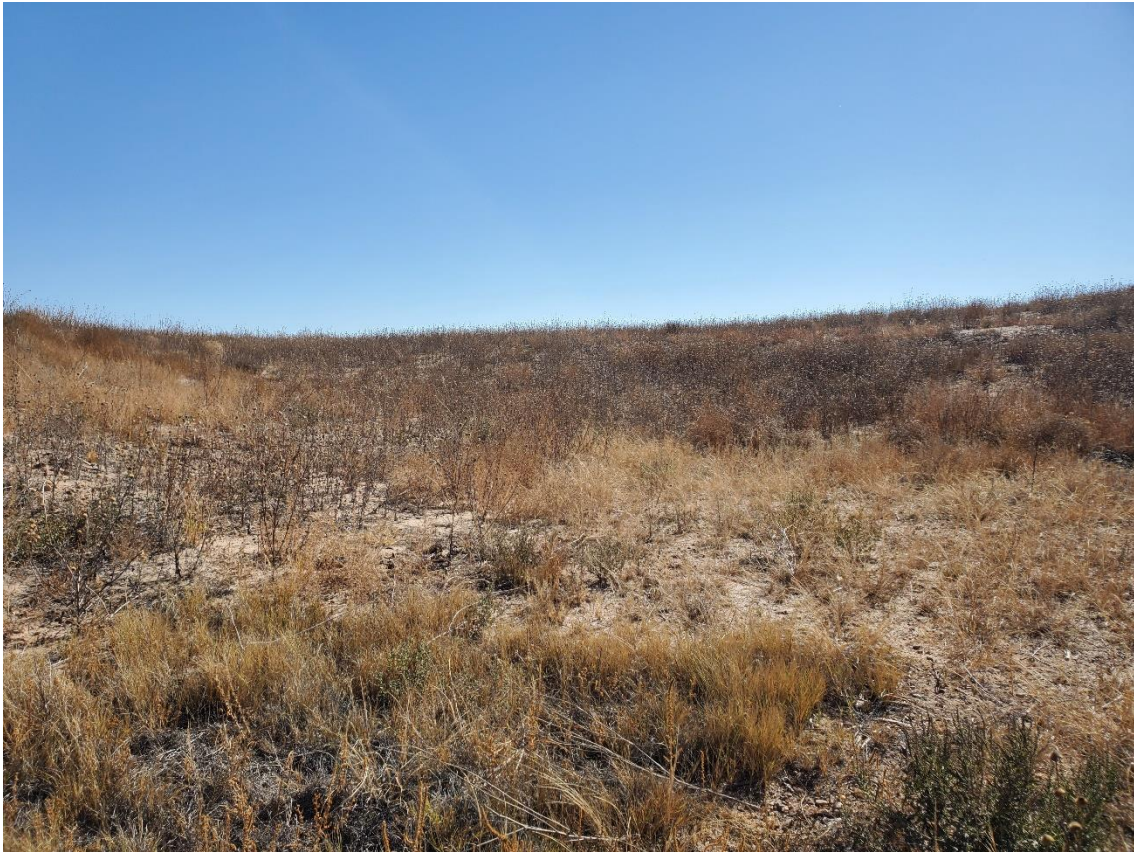
Reclaimed slope

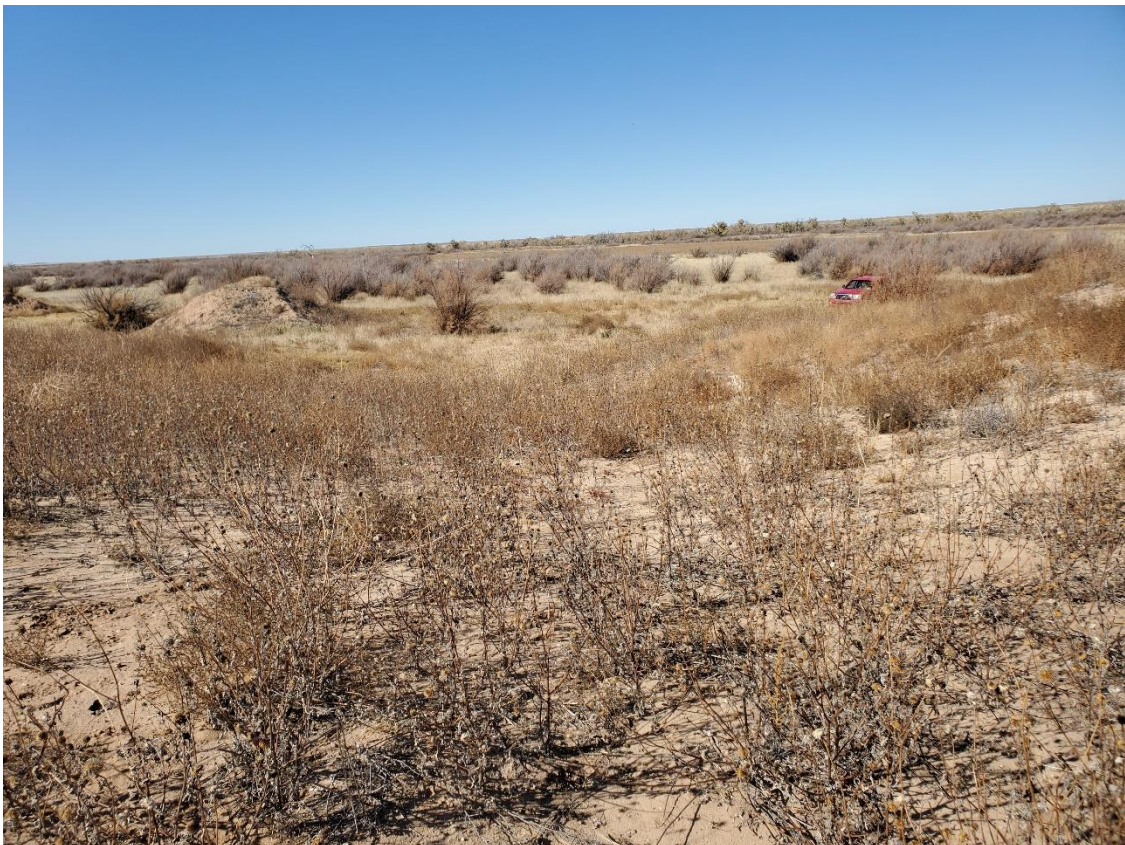
The land is showing good progress towards complete revegetation. The Operator is encourage to seed the affected area one more time and monitor it. The Operator may at any time submit photos to the Environmental Protection Specialist to ask for advice and if the site may be ready for release.

Revegetation
