**MINERALS PROGRAM INSPECTION REPORT**  
**PHONE: (303) 866-3567**

<b>MINE NAME:</b> Klement Pit	<b>MINE/PROSPECTING ID#:</b> M-2007-076	<b>MINERAL:</b> Gravel and sand	<b>COUNTY:</b> Cheyenne
<b>INSPECTION TYPE:</b> Surety Release Inspection	<b>INSPECTOR(S):</b> Timothy Cazier, P.E.	<b>INSP. DATE:</b> December 8, 2020	<b>INSP. TIME:</b> 10:45
<b>OPERATOR:</b> Cheyenne County	<b>OPERATOR REPRESENTATIVE:</b> Jim Brown	<b>TYPE OF OPERATION:</b> 110c - Construction Limited Impact	
<b>REASON FOR INSPECTION:</b> Surety Release Requested	<b>BOND CALCULATION TYPE:</b> None	<b>BOND AMOUNT:</b> \$0.00	
<b>DATE OF COMPLAINT:</b> NA	<b>POST INSP. CONTACTS:</b> None	<b>JOINT INSP. AGENCY:</b> None	
<b>WEATHER:</b> Clear	<b>INSPECTOR'S SIGNATURE:</b>

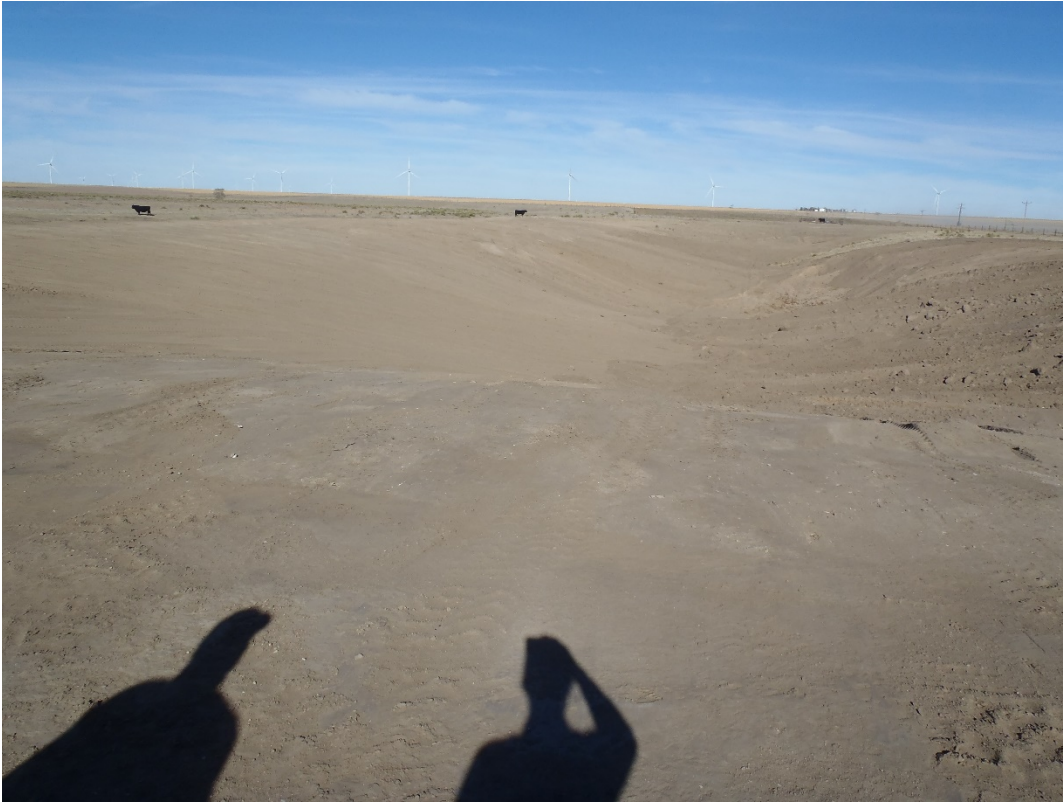
Grading has not been completed. Some slopes are steeper than 3H:1V (see **Photo 1**) and other areas remain to be graded (see **Photos 2** and **3**). Post mine gradients will be no steeper than 3H:1V [*Reference: 11/16/2007 PAR response - revised reclamation map*]. Erosion rills were observed on the north end (see **Photo 4**). These will need to be repaired prior to release.

Photo 1. Regraded portion near 3H:1V on left, incomplete grading on right (looking north).

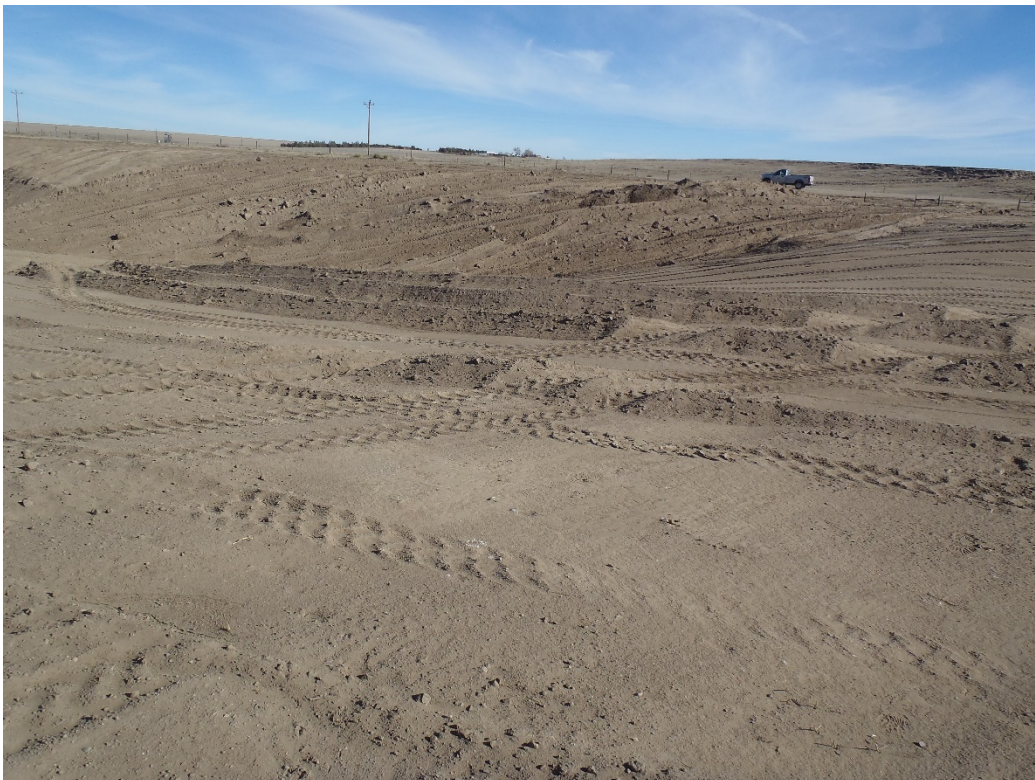
Photo 2. Incomplete grading in SE corner of pit (looking NE).

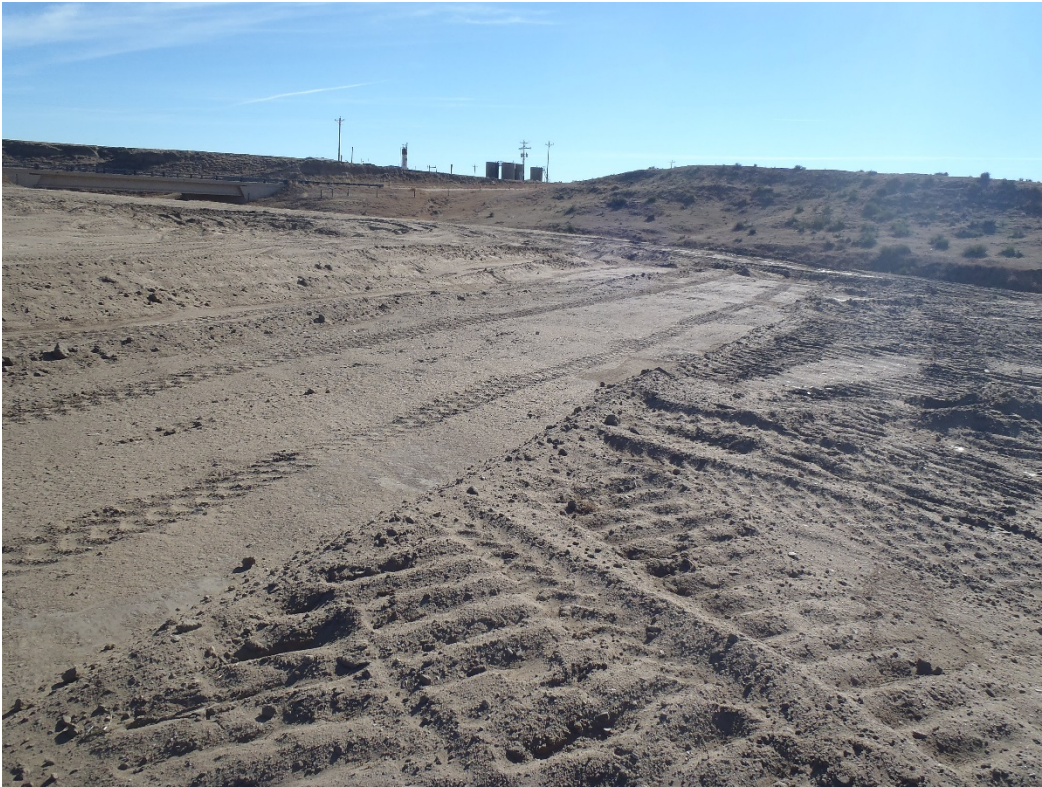
Photo 3. Incomplete grading on south end of pit (looking south).

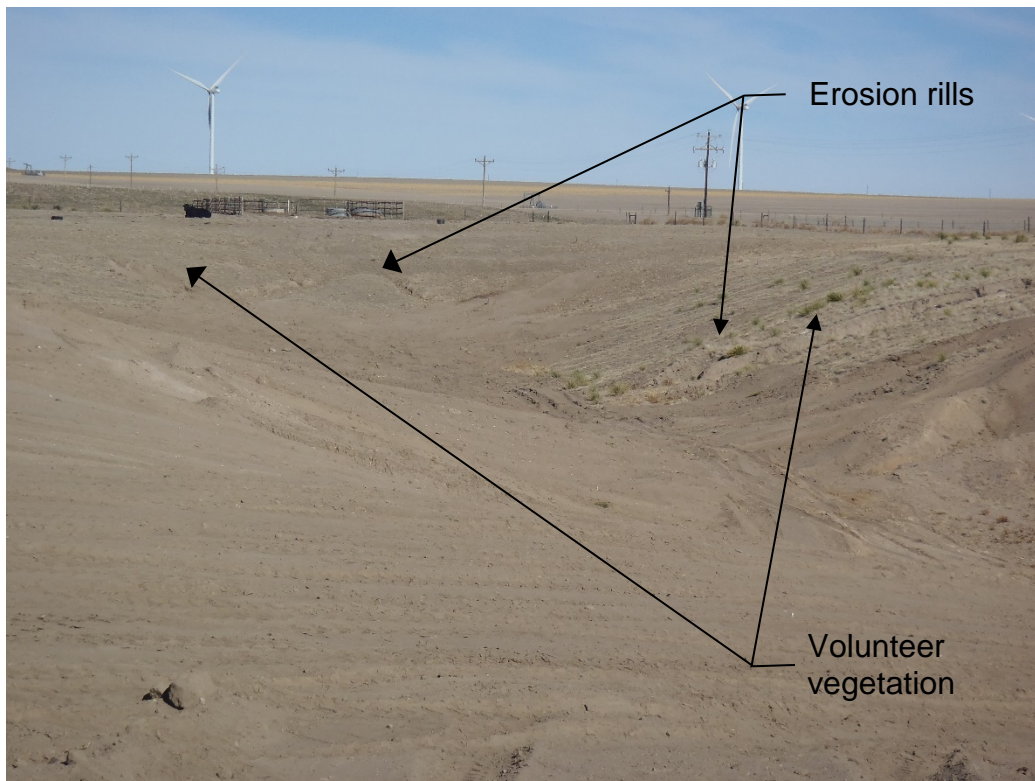
Vegetation has not been established. Some volunteer growth was observed on the north end of the pit (see **Photo 4**). I advised Mr. Brown the DRMS prefers to see the result of the seeding effort after at least two growing seasons to be assured the perennial cover is being established prior to release. The Natural Resource Conservation Service recommended the following seed mixture which was approved by the DRMS:

Photo 4. Erosion rills and volunteer vegetation on north end (looking NNE).

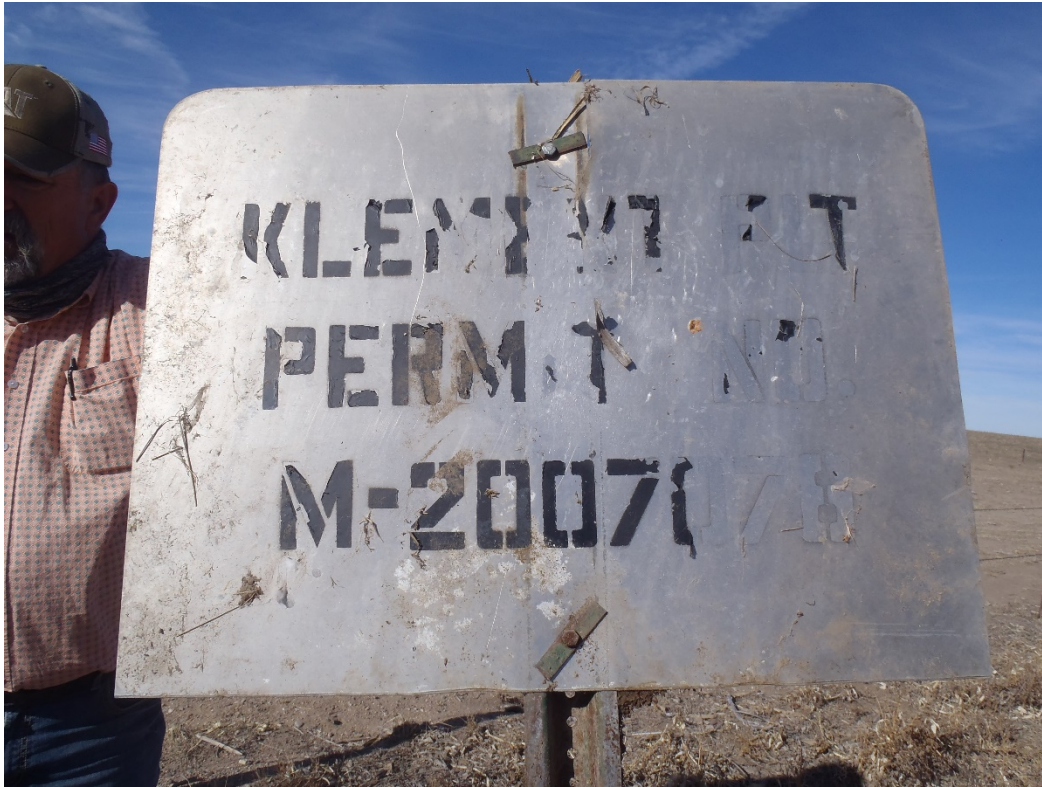
**Signs and Markers:** The permit sign had been knocked face down making the permit number unreadable (see **Photo 5**). I recommended to Mr. Brown the number be re-painted on the sign and replace the sign near the entrance gate rather than closer to the north end of the pit where it had been. The sign will need to be present until the DRMS releases the site from reclamation responsibility.

Photo 5. Permit sign needing repair.
