MINERALS PROGRAM INSPECTION REPORT
PHONE: (303) 866-3567

MINE NAME: Rother Pit #2	MINE/PROSPECTING ID#: M-2019-036	MINERAL: Sand and gravel	COUNTY: Cheyenne
INSPECTION TYPE: Surety Release Inspection	INSPECTOR(S): Timothy Cazier, P.E.	INSP. DATE: December 8, 2020	INSP. TIME: 10:00
OPERATOR: Cheyenne County	OPERATOR REPRESENTATIVE: Jim Brown	TYPE OF OPERATION: 110c - Construction Limited Impact	
REASON FOR INSPECTION: Surety Release Requested	BOND CALCULATION TYPE: None	BOND AMOUNT: \$0.00	
DATE OF COMPLAINT: NA	POST INSP. CONTACTS: None	JOINT INSP. AGENCY: None	
WEATHER: Clear	INSPECTOR'S SIGNATURE:

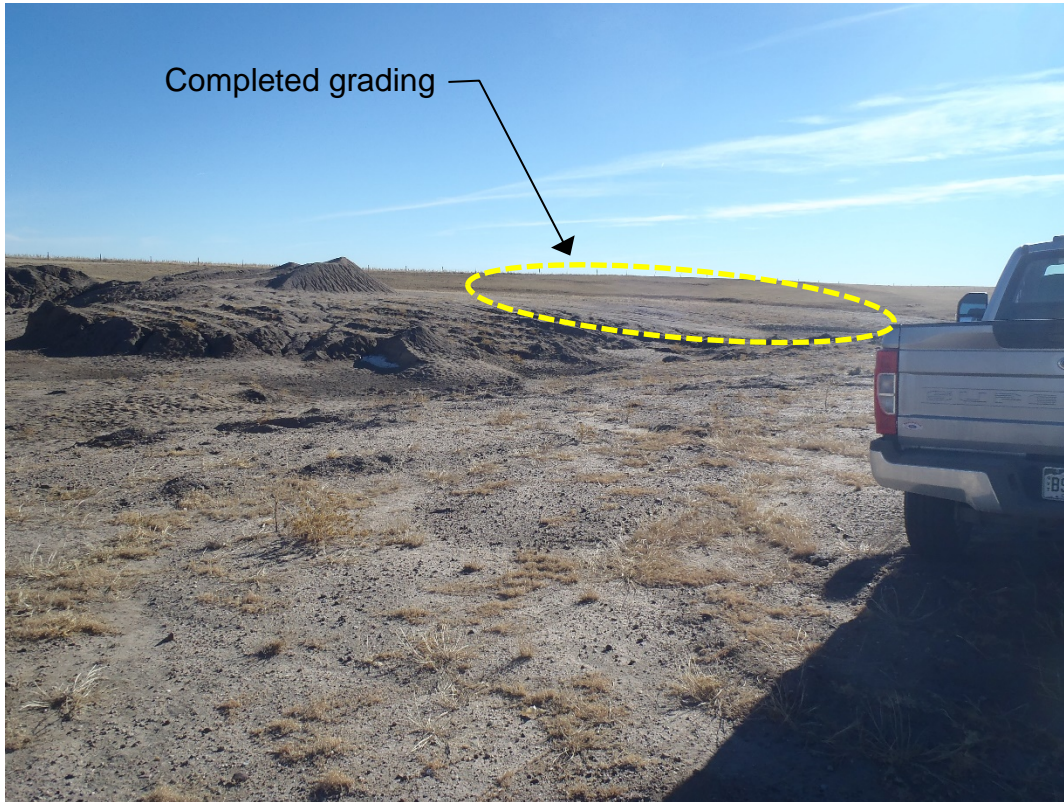
Grading has not been completed. Although some grading has been completed on the SE corner of the pit (see **Photo 1**), most highwalls observed during the June inspection remain (see **Photo 2**). Post mine gradients will be no steeper than 3H:1V [*Reference: 2019 Reclamation Plan*]. Mr. Brown pointed out a material stockpile that will be used by the County (see **Photo 3**). This will need to be removed or used as backfill prior to spreading the topsoil.

Vegetation has not been seeded or established in the affected area (see **Photo 1**). I advised Mr. Brown the DRMS prefers to see the result of the seeding effort after at least two growing seasons to be assured the perennial cover is being established prior to release. The Natural Resource Conservation Service recommended the following seed mixture which was approved by the DRMS:

Photo 1. Grading on SE corner and lack of established vegetation (looking SE).

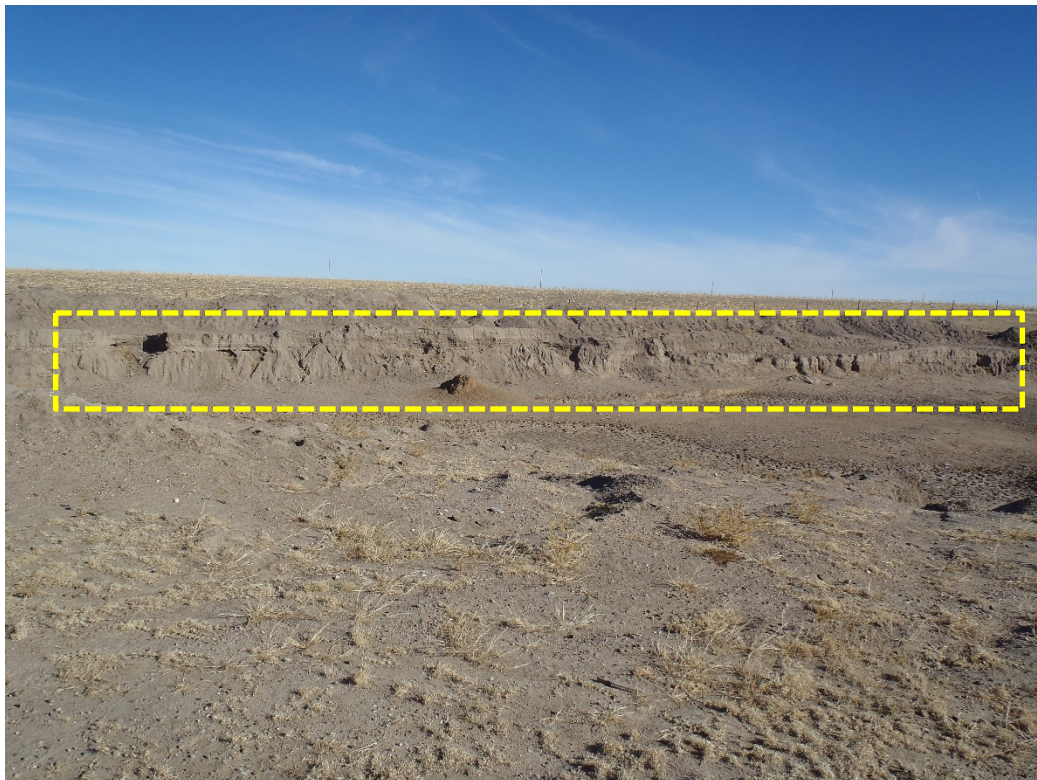
Photo 2. Highwalls remaining (looking NE).

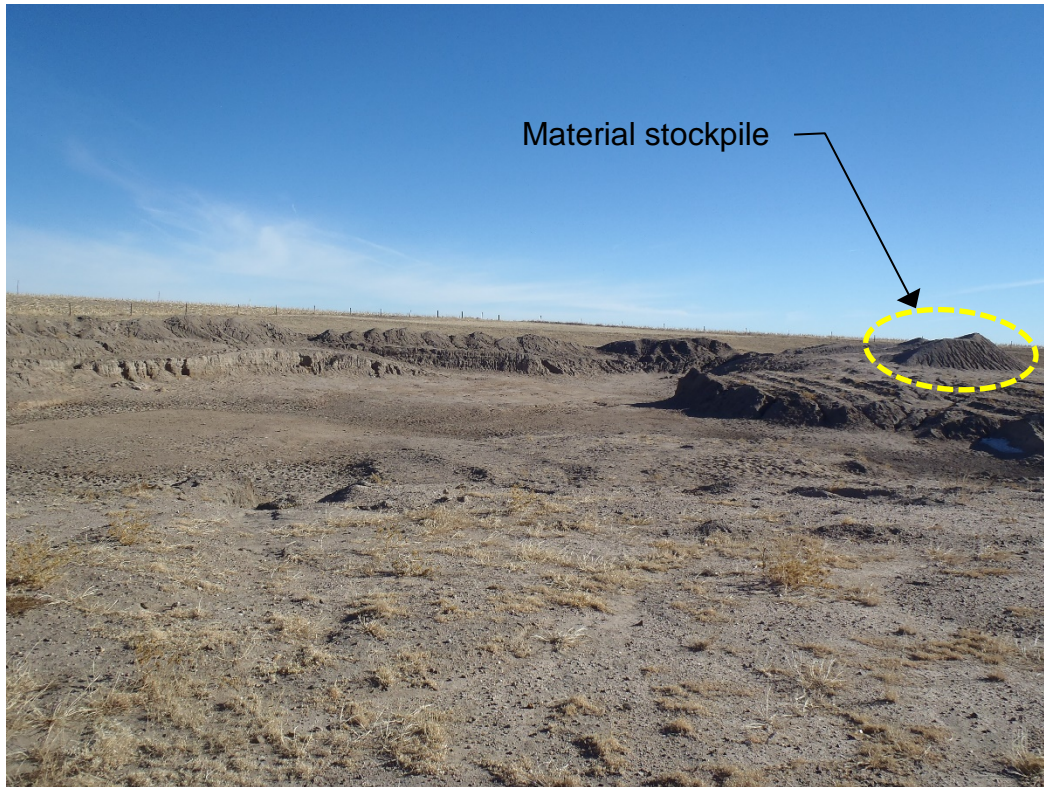
Photo 3. Material stockpile and incomplete grading in pit area (looking ESE).

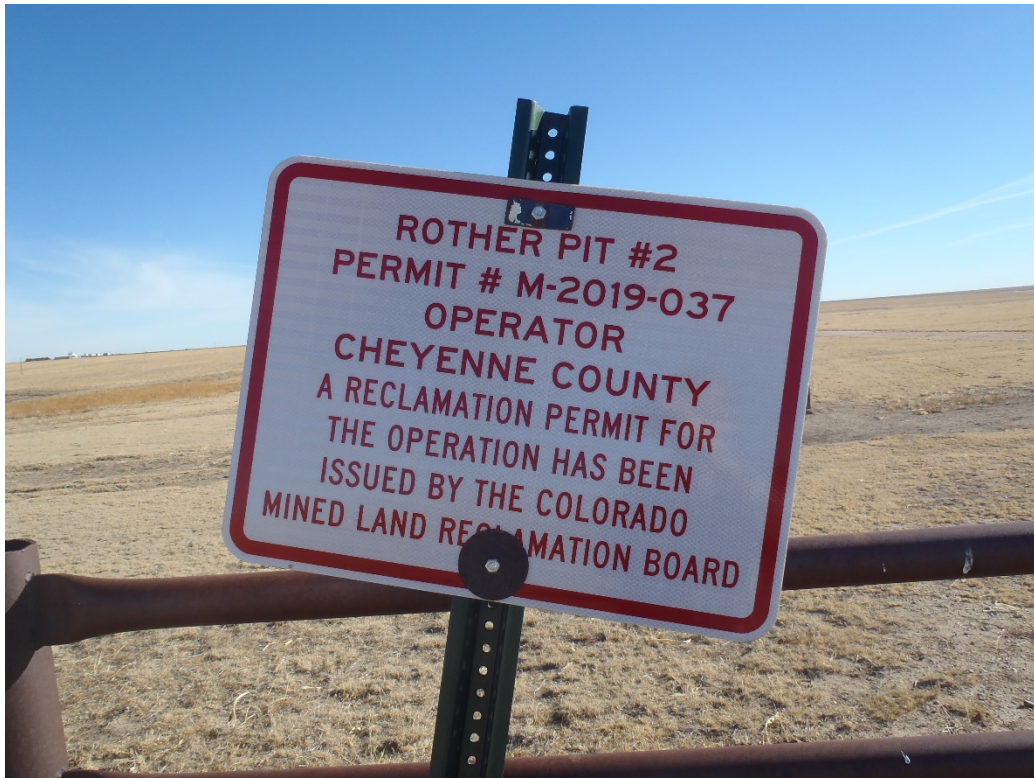
The permit sign was properly posted (see **Photo 4**) and should remain at the site entrance until the DRMS releases the site from reclamation responsibility.

Photo 4. Permit sign at entrance (looking east).

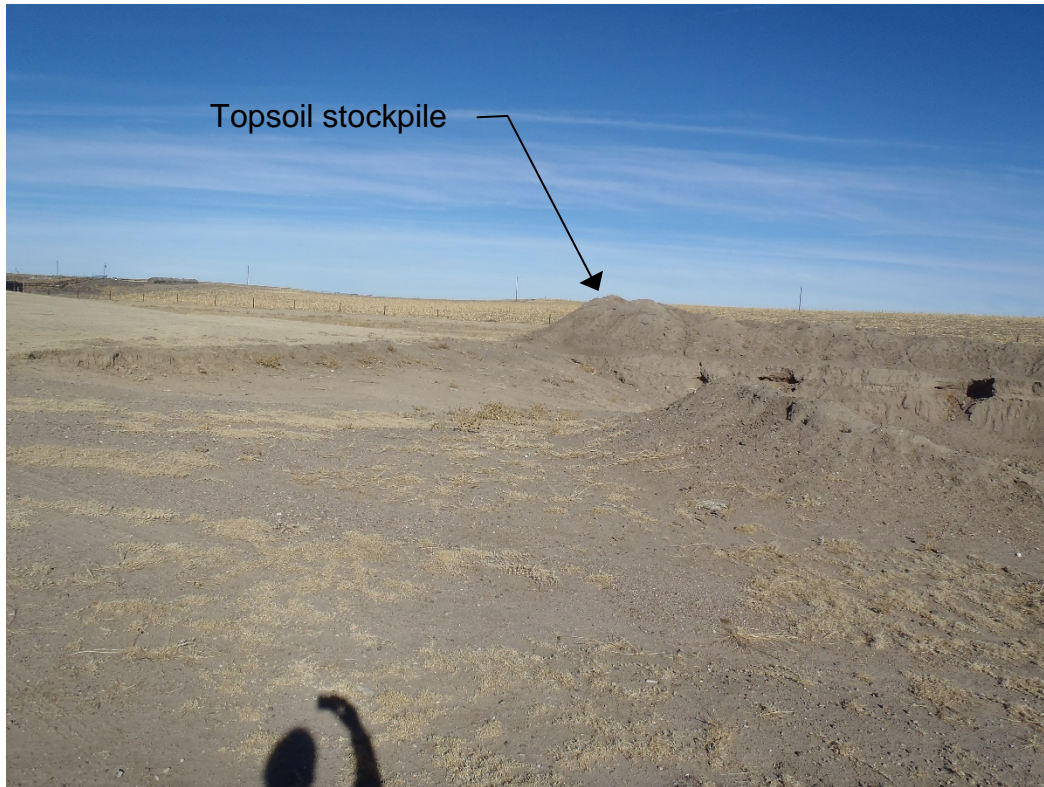
The topsoil stockpile on the north side of the pit (see **Photo 5**) has not been spread, and should not until final slope grading has been completed. A minimum of 12 inches of topsoil (plant growth medium) was proposed in the original Exhibit D, Reclamation Plan and approved by the DRMS for this site.

Photo 5. Topsoil (growth medium) stockpile on north end of pit (looking north).
