January 12, 2021  
Project#01349-0001

Subject: Summary of Instrumentation Monitoring  
4<sup>th</sup> Quarter 2020  
Bowie Coal Waste Disposal Area No. 3  
Paonia, Colorado

**SUBJECT: Summary Report, 4<sup>th</sup> Quarter 2020, Vibrating Wire Piezometers  
October – December 2020, Bowie Mine #2  
Coal Waste Disposal Area (CWDA) #3**

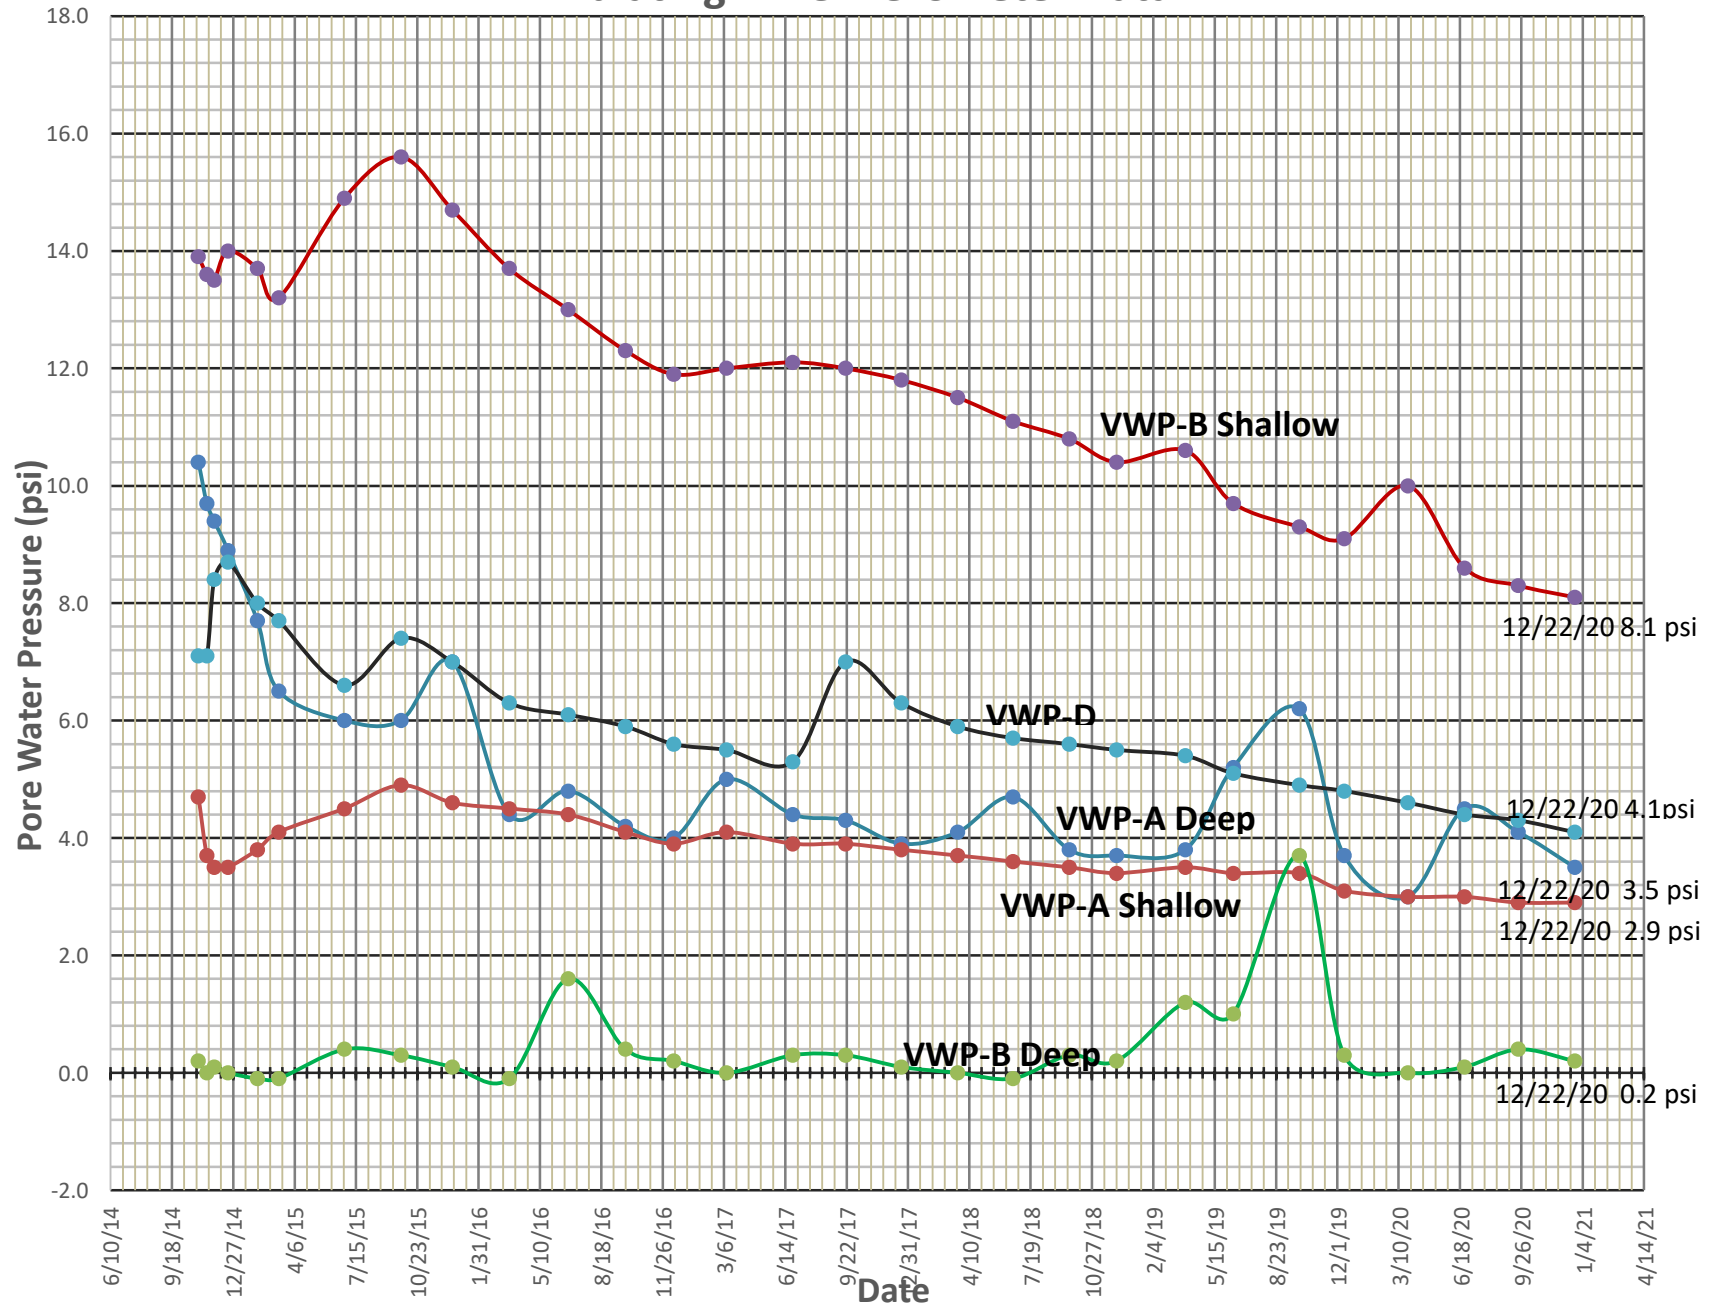
**Figure 1 - Bowie Mine #2 - CWDA #3**  
**Vibrating Wire Piezometer Data**

We present a graph of measured pore pressures on the attached Figure 1 and numerically in Table 1 below. Table 1 is a summary of the initial, last year, last quarter and current readings. In addition, we present the difference between the current pore pressures and those at the time of installation, the previous quarter, and previous year.

As seen on Figure 1 and Table 1, all five VWP's either stayed the same or decreased in pore pressure when compared with the previous quarter and all five VWP's decreased in pore pressure when compared to the 4<sup>th</sup> quarter of last year (a wetter year). Although there is a general trend of decreasing pore pressure over time, three of the piezometers (VWP-A Deep, VWP-B-Deep and VWP-B Shallow) have more recent erratic behavior since early 2019.
