Huddleston-Berry
Engineering & Testing, LLC

Subject: Summary of Instrumentation Monitoring
4th Quarter 2020
Bowie Coal Waste Disposal Area No. 2
Paonia, Colorado

SUBJECT: Summary Report, 4th Quarter 2020, Inclinator and Active Vibrating Wire Piezometer Data October – December 2020, Bowie Mine #2 Coal Waste Disposal Area (CWDA) #2

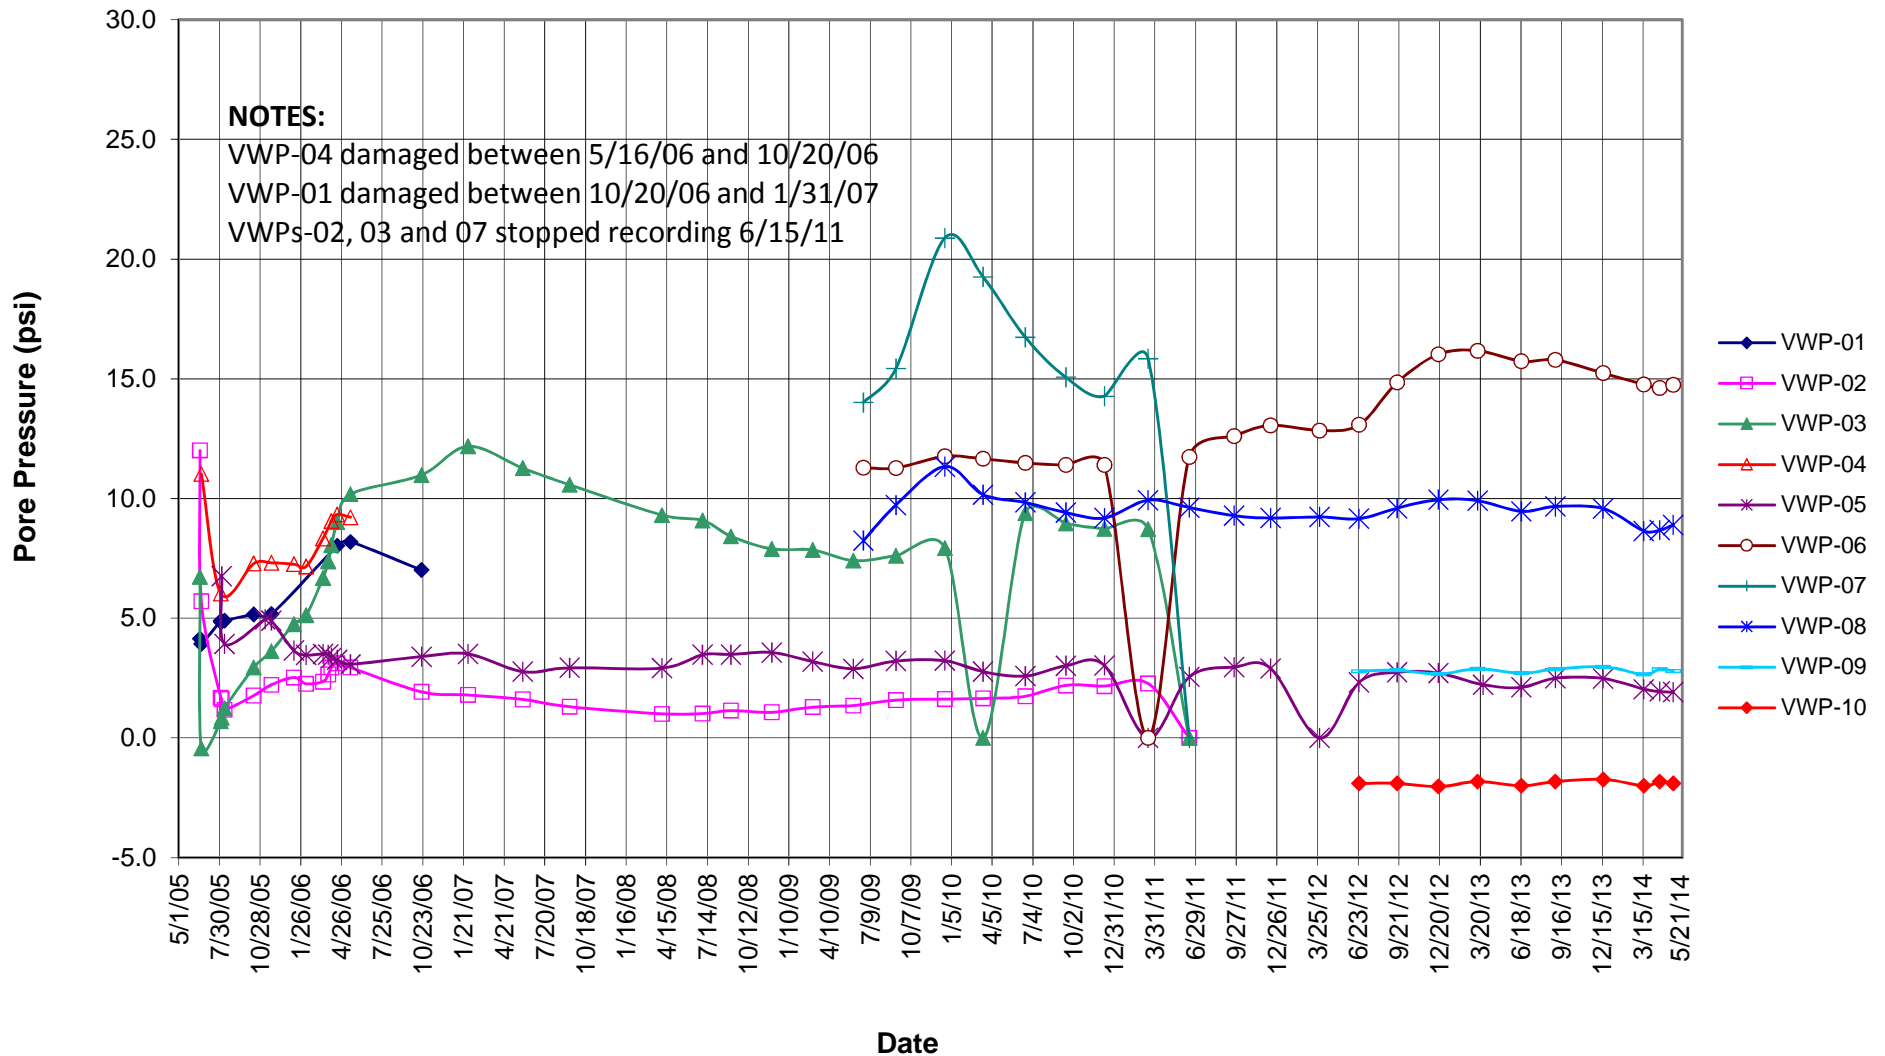
Figure 1 - Bowie Mine #2 - CWDA #2
Active and Damaged Vibrating Wire Piezometer Data

Inception (5/16/05) through 5/21/14

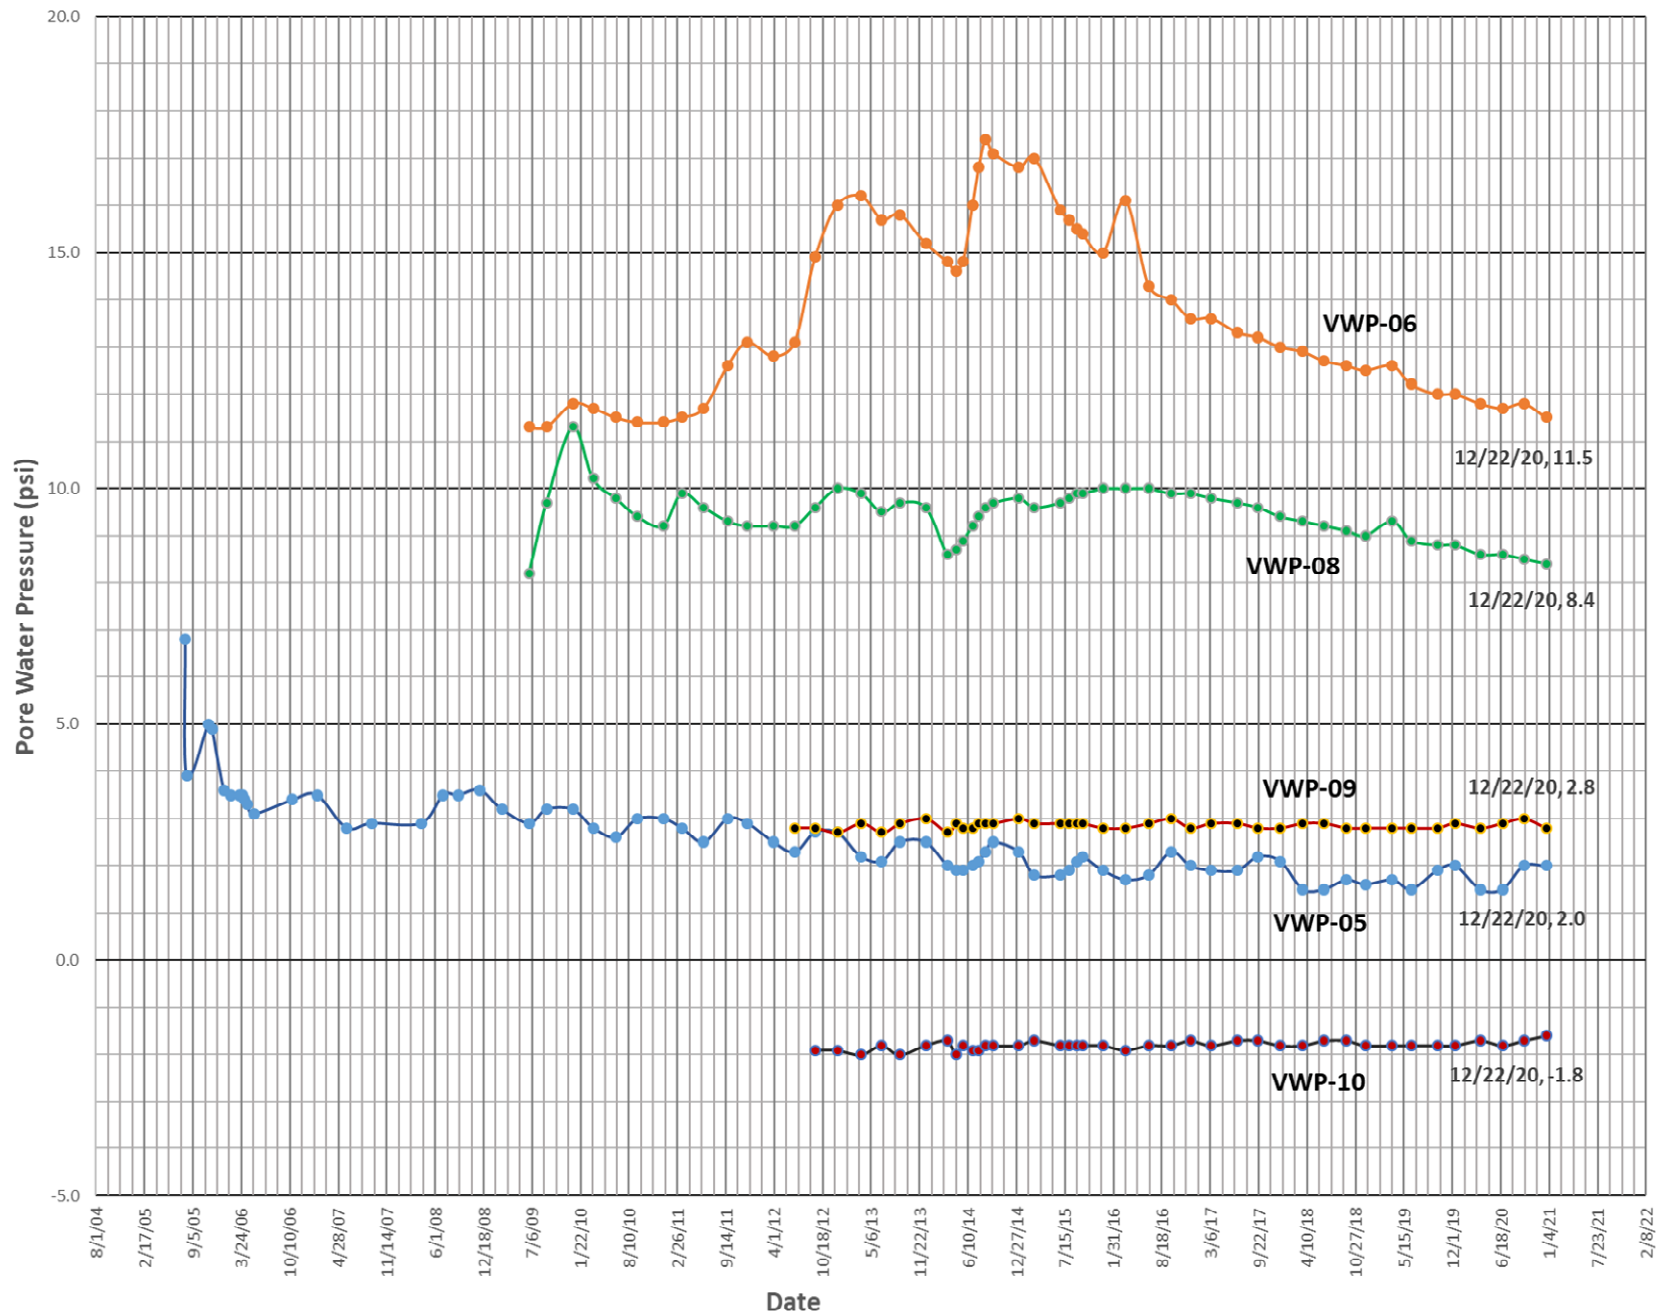
Figure 2 - Bowie Mine #2 - CWDA #2
Active Vibrating Wire Piezometer Data

As seen on Table 1 and Figure 2, the VWP readings and trends are consistent with recent and historic readings. Pore pressure readings either stayed the same or decreased by small amounts (0.1 to 0.3 psi) since the 3rd quarter readings. When compared with a year ago (Q4 2019), pore pressures also either stayed the same or decreased (0.1 to 0.5 psi) for all of the piezometers. Since installation, four of the piezometers experienced net changes of 0.2 psi or less, while VWP-05 had a pore pressure that decreased by 4.8 psi.

As indicated in the referenced *Stability Evaluation* report, the stability of CWDA No. 2 is sensitive to increases in pore pressures in VWP-08. An increase in the pore pressure of 7 psi in VWP-08 would result in a reduction of the Factor of Safety to below 1.5.

The current pore pressure reflects a piezometric surface elevation of approximately 6096 feet which is much less than the critical elevation of 6113 feet. As a result, HBET does not believe that the measured pore pressures in VWP-08 are any indication of instability in CWDA No. 2.

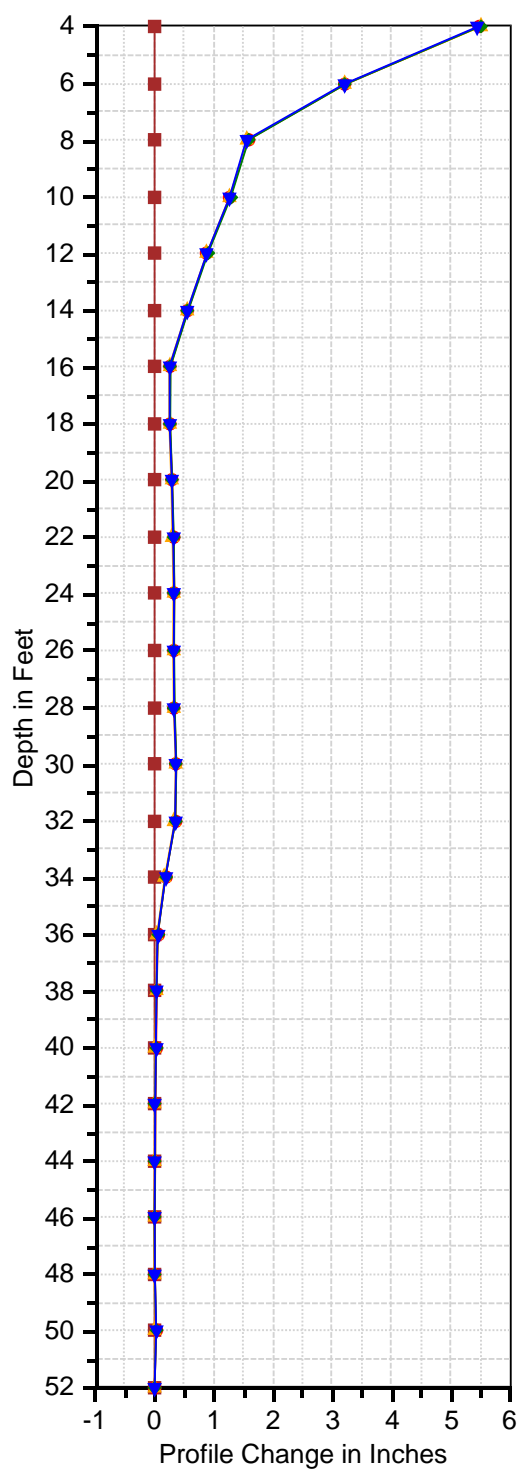
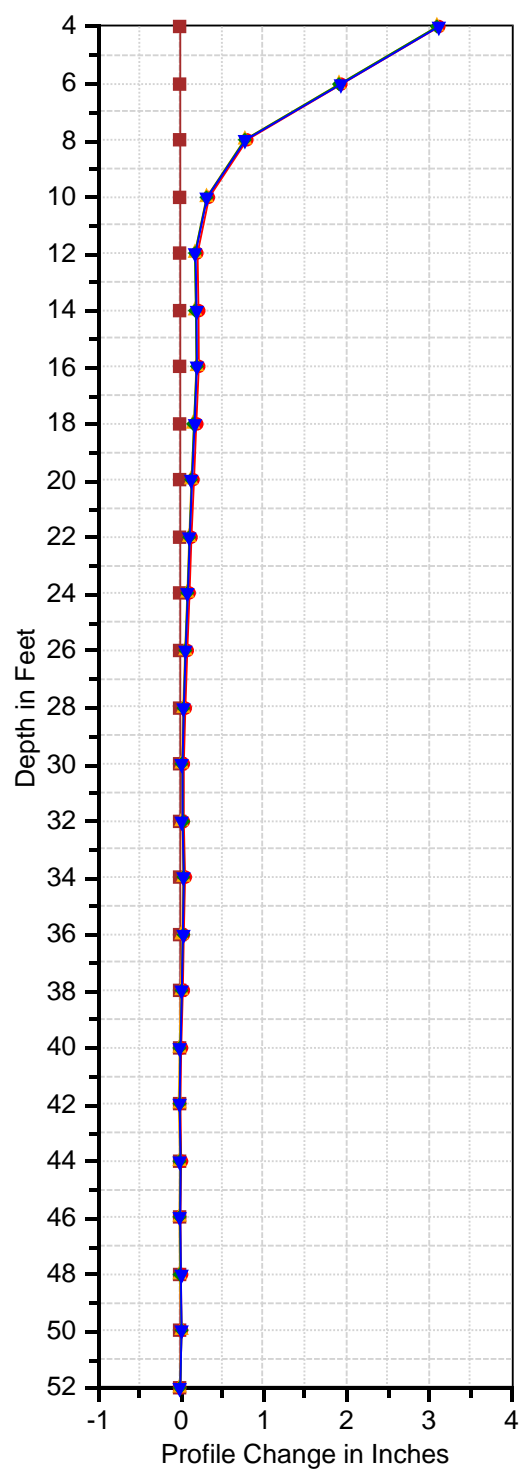
BOWIE BG05_4 A

As described in previous reports, historic displacements indicated on the plots for the approximate upper ten feet of the inclinometers since installation in 2005 are due to placement of cover soil on the face of the waste pile during revegetation operations in late 2006 and early 2007. This man-caused displacement is documented in a report by Buckhorn Geotech dated September 22, 2008 to Bowie Resources called *Revised Stability Evaluations for Coal Mine Waste Disposal Area No. 2, Bowie No. 2 Mine*.

Based on the current inclinometer readings, there hasn't been downslope movement (Axis A) in any of the inclinometers since 2007 and they are generally consistent with previous readings. Some "noise" which is understood to be relatively common in orthogonal direction (Axis B) readings, was observed over the past few years for inclinometer BG05-5B. This can be due to a number of mechanical or installation causes that are unrelated to slope movement. For example, grout voids, poor grout coverage, or soil settlement around the instrument can all contribute to vibrations and pipe movement that impacts inclinometer readings. Software bias adjustments were applied which filtered this noise. All readings were consistent with previous ones and the "displacement" error was within equipment tolerances and not deemed to be due to slope movement.

It should be noted that water was standing in the BGI05-04 inclinometer pipe at a depth of about 12 feet below grade (while it was at 3 feet during our Q4 site visit). Based on our observations there has always been water in this pipe. We also measured water around 12 feet in inclinometer BGI05-07 (while it was at 10 feet during our Q3 readings). There was no water in the BGI05-05 pipe.
