inspection report

PERMIT INFORMATION

Permit Number: C-1981-028 Mine Name: Keenesburg Strip Mine Operator: Coors Energy Company Operator Address: Mr. Ben Moline Coors Energy Company P.O. Box 4030 Golden, CO 80402	County: Weld Operation Type: Surface Permit Status: Permanent Cessation Ownership: Private
	Operator Representative Present: None
Operator Representative Signature: (Field Issuance Only)

INSPECTION INFORMATION

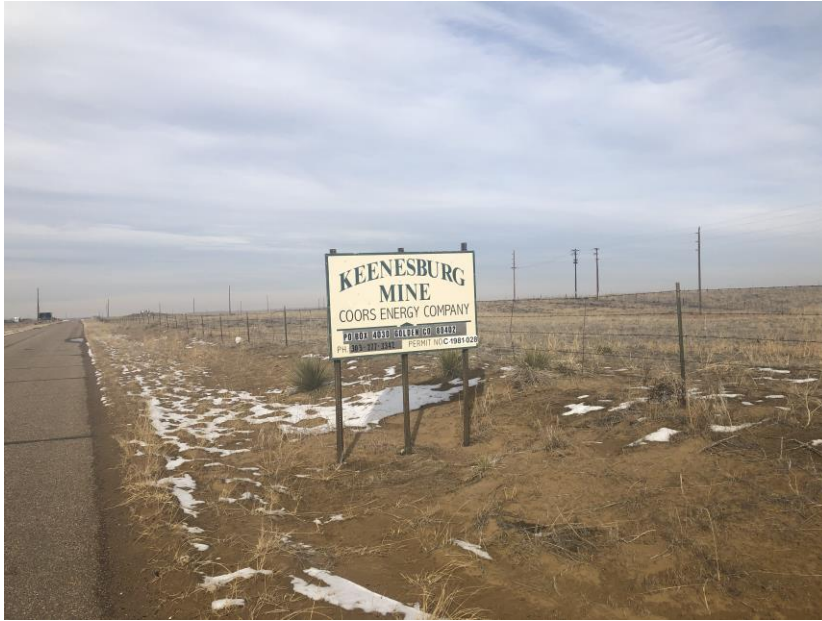
The entrance sign was in place and the Coors Energy address has been updated, but the sign needs to also include contact information for DRMS (including division name, address and telephone number). Alternatively, a new sign could be placed nearby or added to the sign posts that hold the existing sign.

Entrance sign

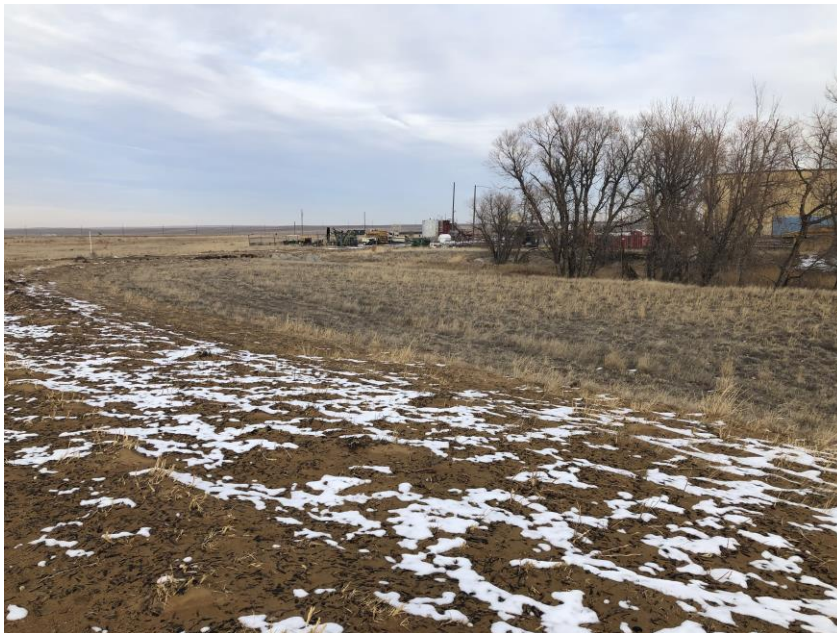
Both Sediment Pond 2 and the Dugout Pond were essentially empty. Neither pond was discharging during the inspection. There were no signs that they had discharged recently. As usual, they both contained large amounts of riparian vegetation. No problems were observed with the two ponds except for two holes in the embankment at Sediment Pond 2 (each approximately 10 inches deep). These should be filled.

Dugout Pond (area of spillway) and reclaimed road in foreground

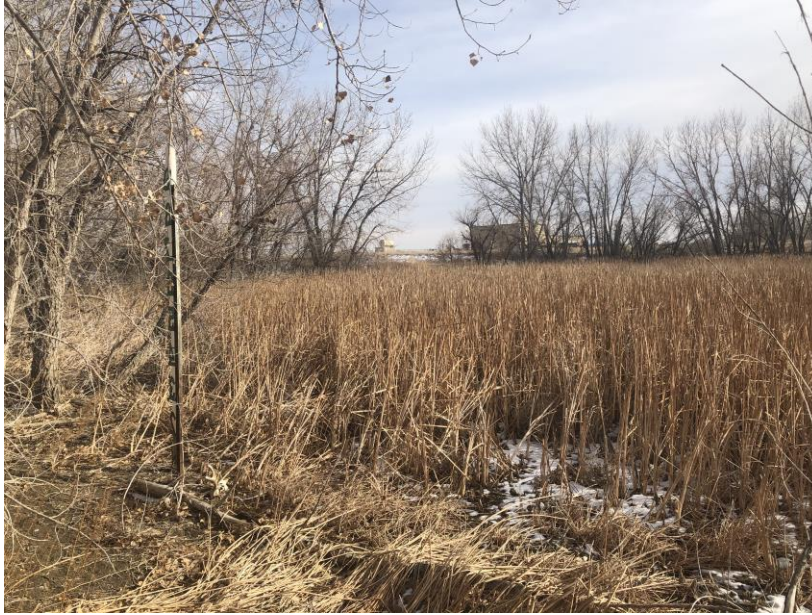
Within empty Sediment Pond 2

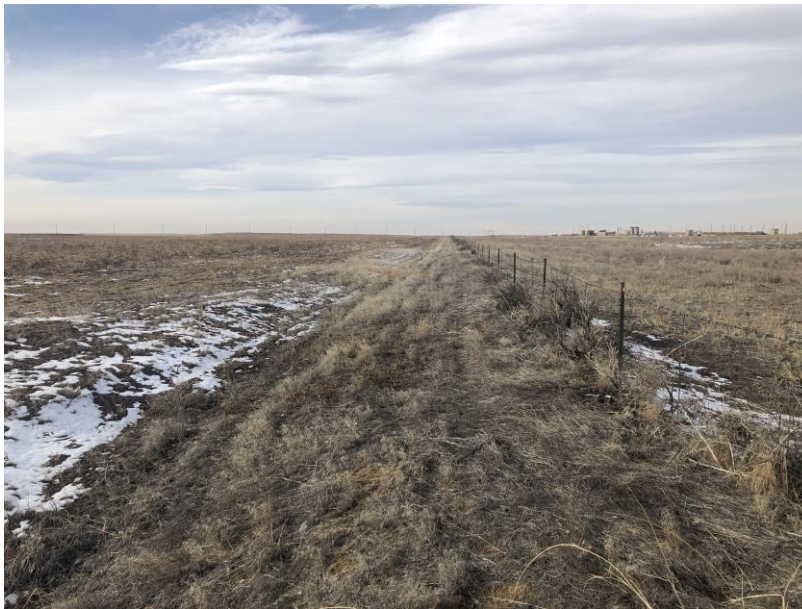
The northern boundary of the site (including the ditch to Sediment Pond 2) was observed, and no signs of pollutant loading from the mine site, or any other problems, were seen. The western boundary was also observed from the reclaimed B Pit; no issues were identified.

North boundary of site, looking northwest

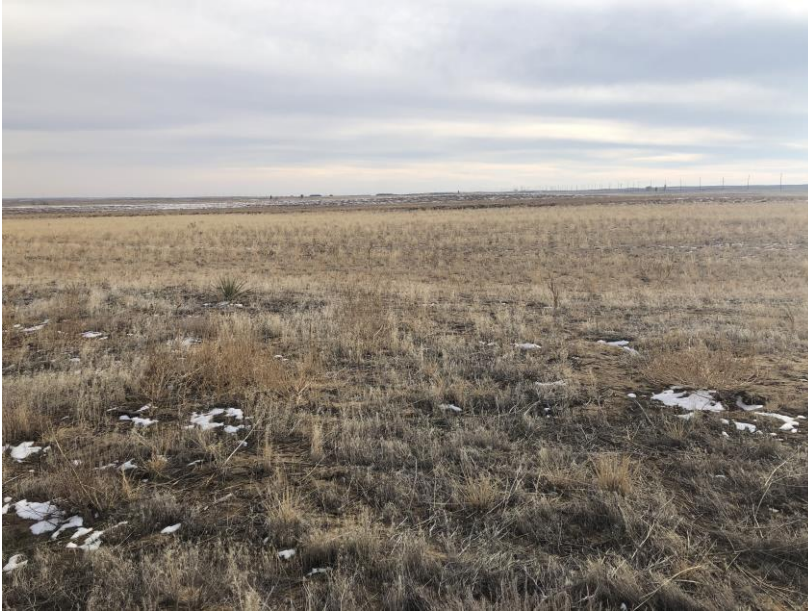
Reclaimed B Pit looking south (north side of area)

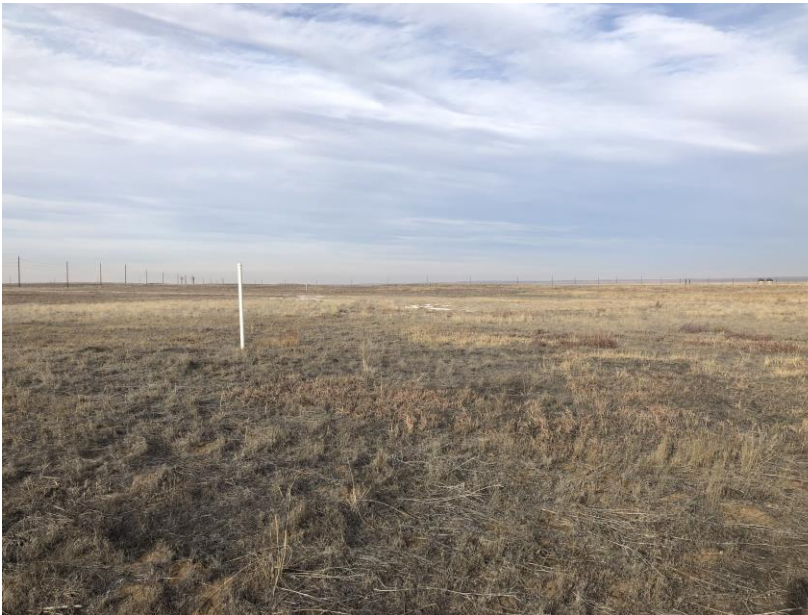
No problems were identified with boundary markers; they were seen in many locations.

Boundary markers on west side of site (looking north)

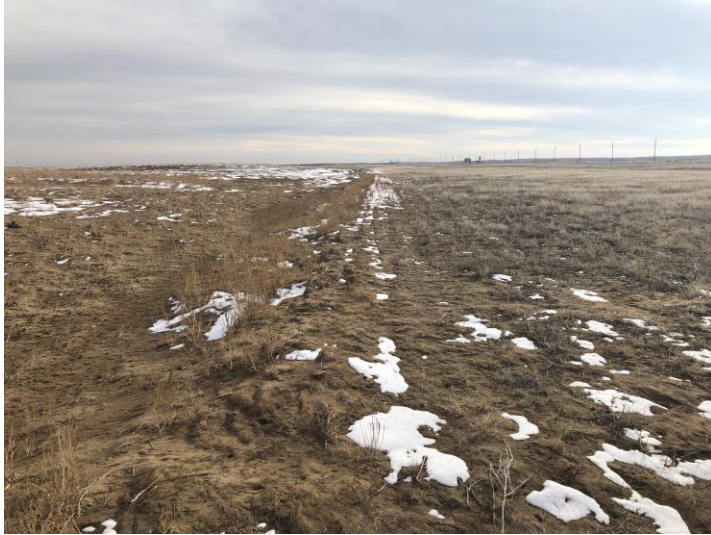
Reclaimed B Pit looking south (west side on left)

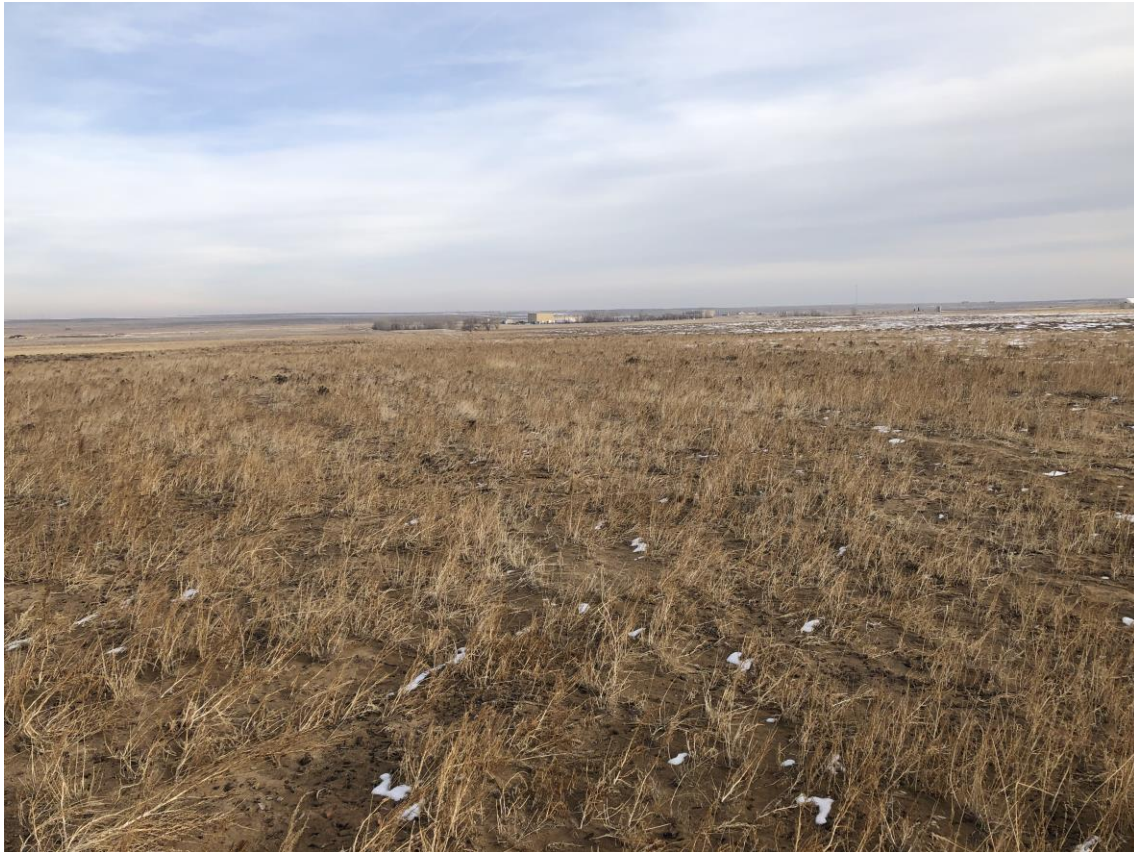
Reclaimed B Pit with facilities and ponds in background
