## Greg Lewicki And Associates, PLLC

**Subj: Adequacy Response to Second Review of a 112c Construction Materials Reclamation Permit Application Package, Kilgore Companies, LLC dba Peak Materials - Peak Ranch Resource, Permit M2020-041**

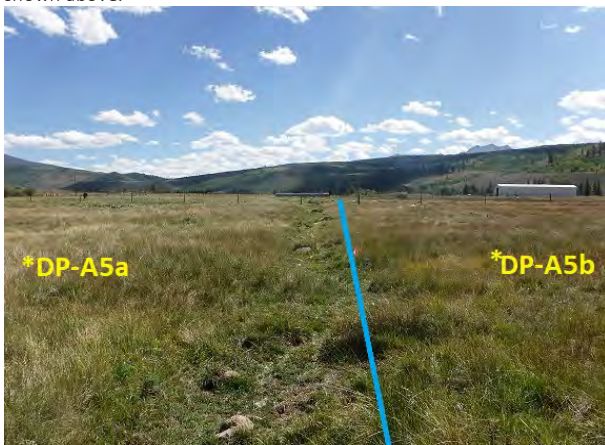
**Photo 3.** Overview south from the northwestern boundary of Aquatic Resource A (western boundary depicted in blue). A discontinuous ditch likely used for flood irrigation forms the boundary in this area. Similar vegetation communities between the upland wetland boundary are evident in this photo. Wetland data point DP-A5a and paired upland DP-A5b shown above.

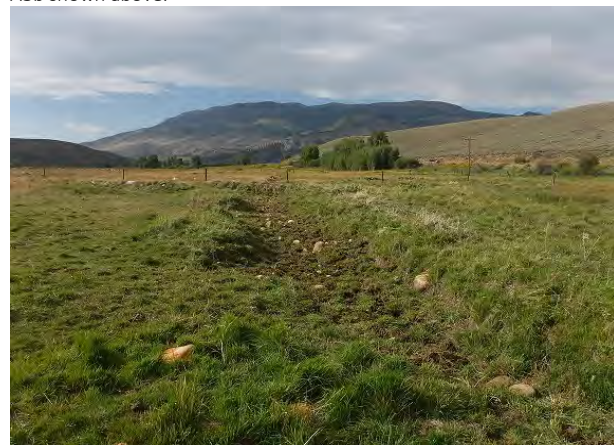
**Photo 4.** Overview north of a typical man-made ditch for flood irrigation and/or a water source for livestock within Aquatic Resource A. This area is still currently in use as a horse pasture which is evident in this photo.

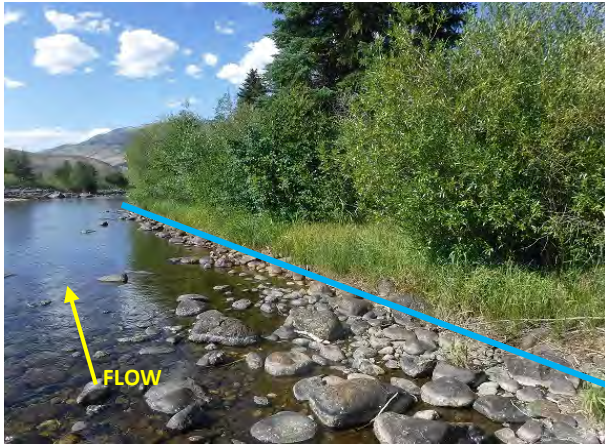
**Photo 7.** View north of the east bank of the Blue River in the northern portion of the survey area (BR1). The blue line depicts approximate OHWM and a PSS riparian fringe dominated by midstory shrubs and an herbaceous understory is evident in the background of this photo.

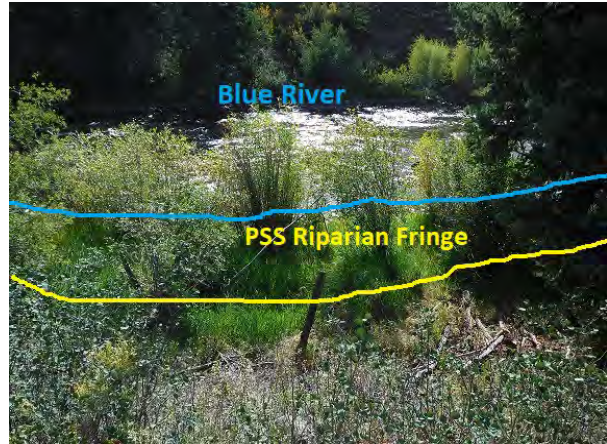
**Photo 8.** View west from the east bank looking down at the Blue River corridor. The OHWM of the Blue River is depicted in blue and the yellow line depicts the extents of the 5-10-foot-wide PSS riparian fringe.

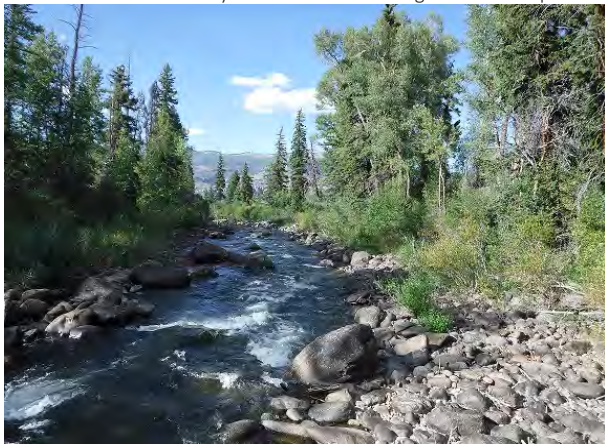
**Photo 9.** View north of the southern portion of the Blue River along the western boundary of the survey area (BR3). This portion of the Blue River is steeper and more entrenched with a narrow (if any) PSS riparian fringe.

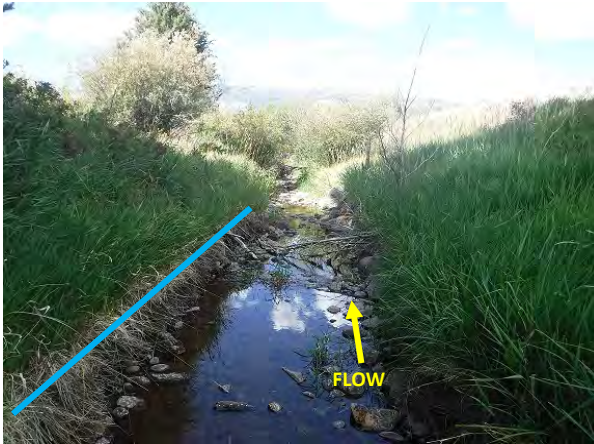
**Photo 11.** View north at Aquatic Resource ID within the survey area. The OHWM at approximately 2 feet above the ditch bottom is depicted above in blue.

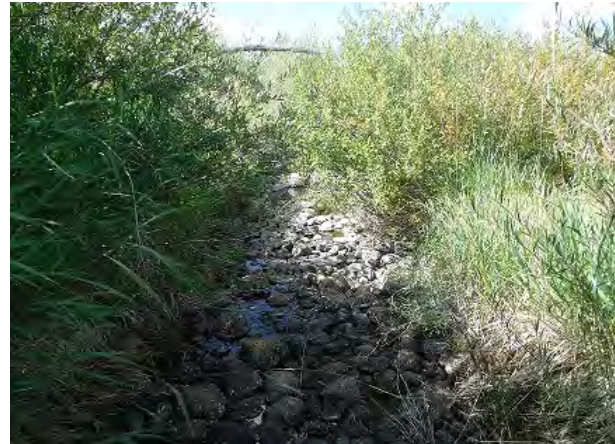
**Photo 12.** View south at Aquatic Resource ID within the survey area. Midstory shrubs and herbaceous vegetation along the ditch banks, and cobble substrate is evident in this photo.

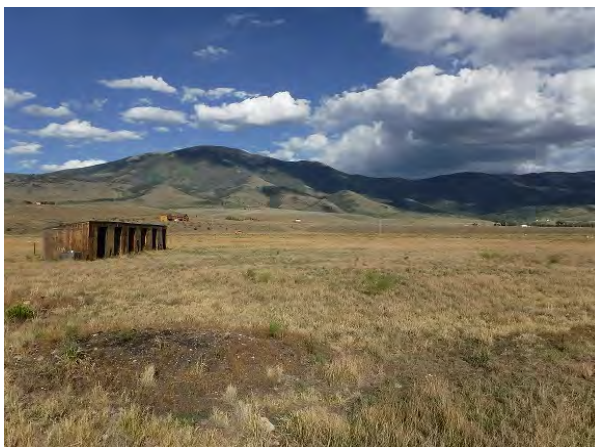
**Photo 13.** View east across the central portion of the survey area comprising the sagebrush steppe vegetation community. This photo represents a degraded form of this community with a decreased shrub component due to heavy grazing.

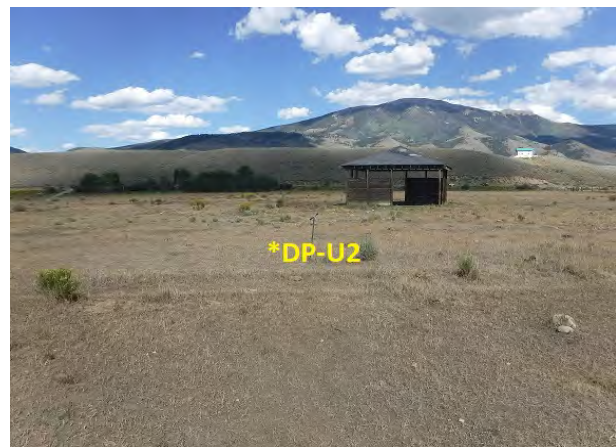
**Photo 14.** View east across the northern portion of the survey area. This area appeared to be the most overgrazed and/or degraded as herbaceous and shrub cover was low. Approximate location of upland data point DP-U2 shown above.

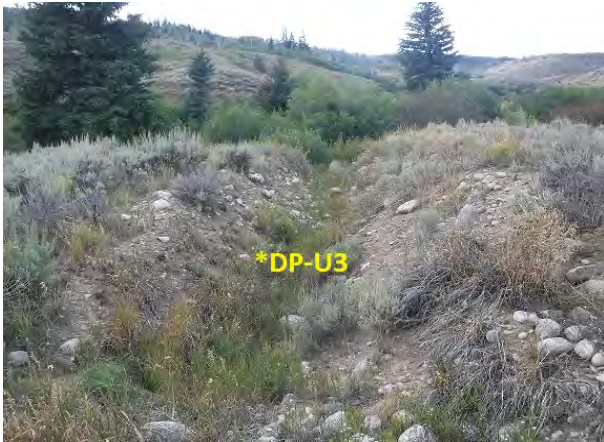
**Photo 15.** View west at the upland ditch in the central portion of the survey area. The ditch was fragmented and discontinuous with no indicators of OHWM and/or regular flow observed. Approximate location of upland data point DP-U3 shown above.

this community in the central western portion of the survey area. The ditch appears to be man-made, excavated in uplands, and used in the past for agricultural purposes. The ditch is fragmented by a farm road without a culvert and no indicators of OHWM or regular flow were observed. See wetland determination data form *DP-U3* in **Appendix B** and *Photo 15* for characteristics of the upland ditch.

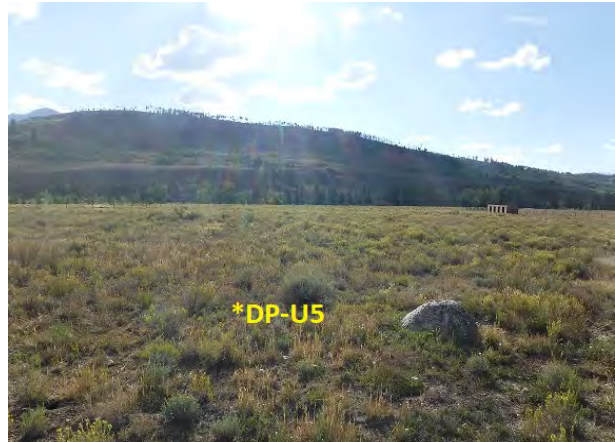
**Photo 16.** View west from the southeast corner of the survey area comprising the sagebrush steppe vegetation community. Low shrubs and exposed rock are evident in this photo. Approximate location of upland data point DP-U5 shown above.

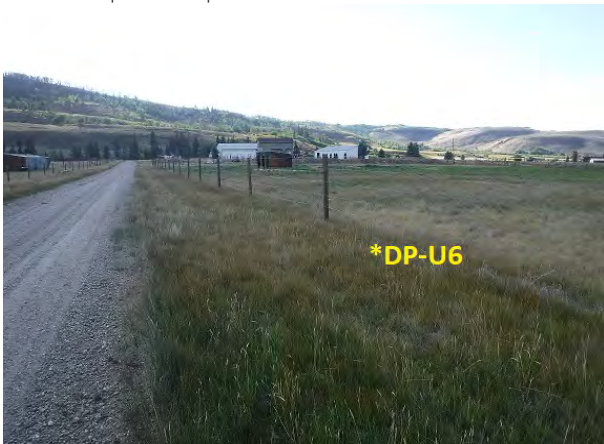
**Photo 17.** View west across the central portion of the survey area. This photo is representative of an upland area dominated with hydrophytes in the wet meadow vegetation community. Approximate location of upland data point DP-U6 shown above.

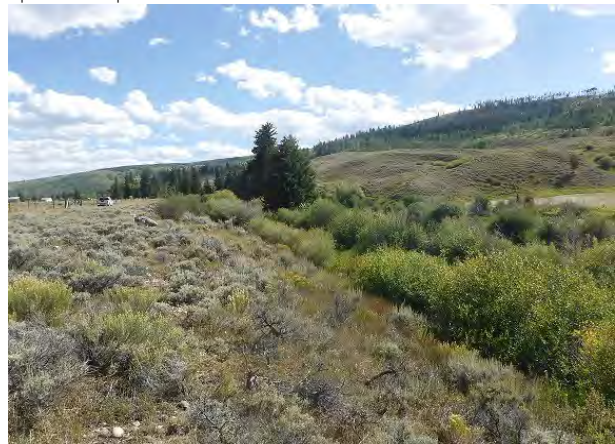
**Photo 18.** View south at the sagebrush steppe vegetation community along the shoulder slope to the Blue River riparian corridor. Overstory canopy spruce trees can be seen in the background.

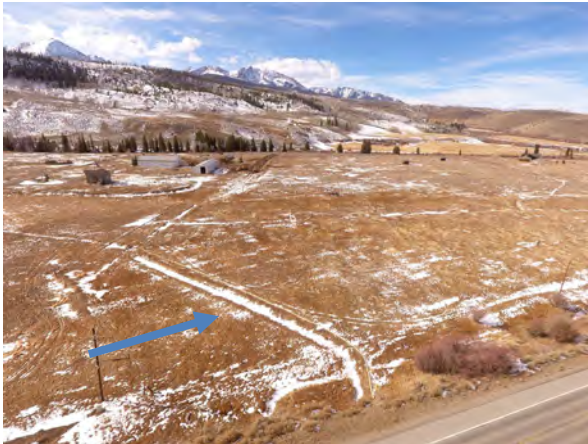
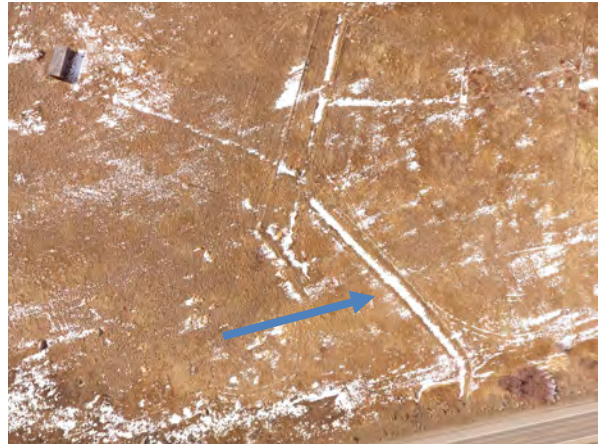
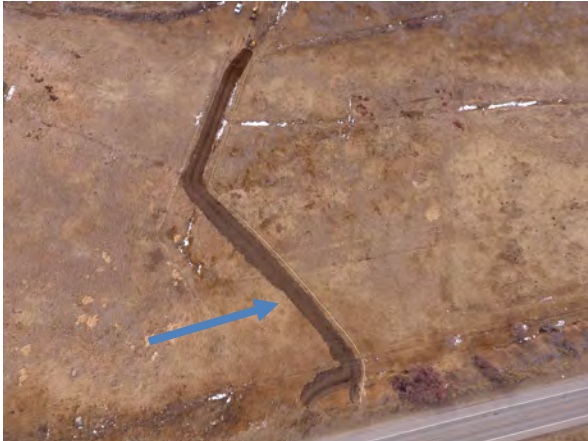
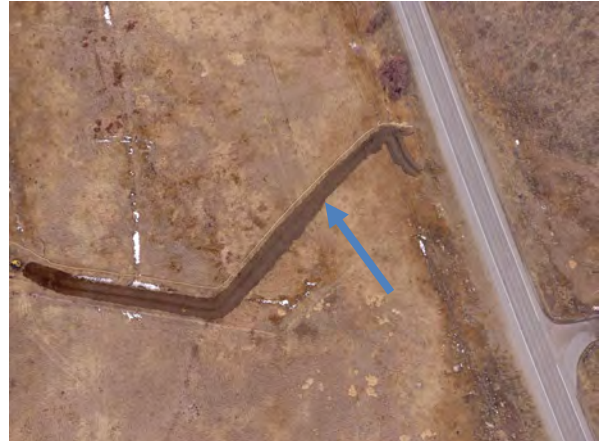
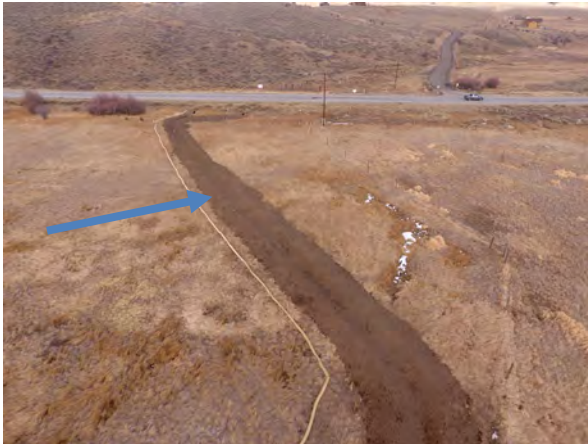
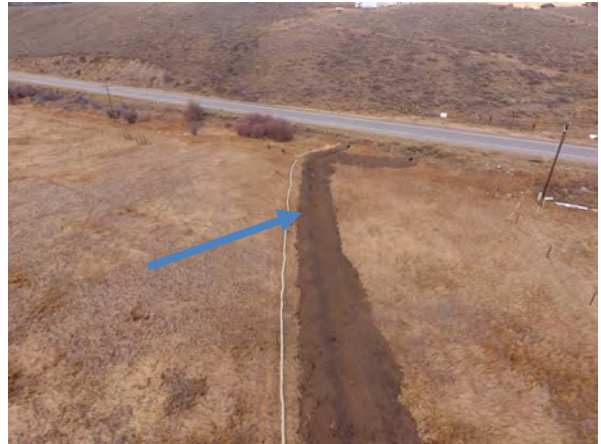
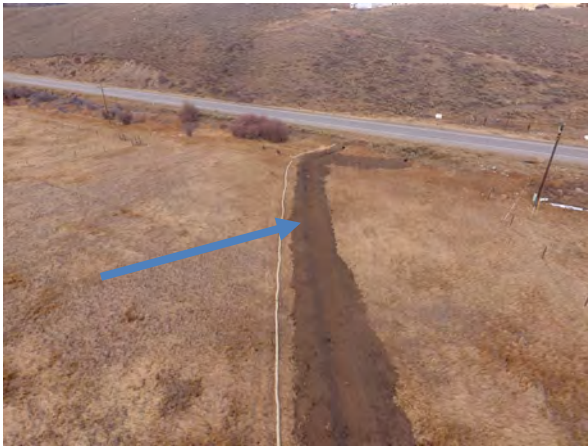
In November 2020, following the 2018 delineation by ERC, the Municipality of Breckenridge upgraded a drainage ditch under Nationwide Permit 3 – Maintenance. This ditch is likely to collect hydrology and may alter the wetland characteristics described in this report. The Aquatic Resources Map (**Appendix A**) shows the location of this ditch as it crosses the survey area. Refer to **Photos 19-25** below for the easement completed by the Municipality of Breckenridge (location of ditch indicated by blue arrow). Photos 19-20 show conditions prior to excavation of the ditch; photos 21-25 show the ditch following trenching and excavation activities.
