**RE: Schumacher II Pit, Permit No. M-2001-018  
Notice of Proposed Decision**

**MINERALS PROGRAM INSPECTION REPORT**  
**PHONE: (303) 866-3567**

<b>MINE NAME:</b> Schumacher II	<b>MINE/PROSPECTING ID#:</b> M-2001-018	<b>MINERAL:</b> Gravel	<b>COUNTY:</b> Logan
<b>INSPECTION TYPE:</b> Surety Release Inspection	<b>INSPECTOR(S):</b> Brock Bowles	<b>INSP. DATE:</b> January 27, 2021	<b>INSP. TIME:</b> 13:00
<b>OPERATOR:</b> Nienhueser Construction & Excavating Co	<b>OPERATOR REPRESENTATIVE:</b> Keith Nienhueser	<b>TYPE OF OPERATION:</b> 110c - Construction Limited Impact	
<b>REASON FOR INSPECTION:</b> Surety Release Requested	<b>BOND CALCULATION TYPE:</b>	<b>BOND AMOUNT:</b> \$6,100.00	
<b>DATE OF COMPLAINT:</b> NA	<b>POST INSP. CONTACTS:</b> None	<b>JOINT INSP. AGENCY:</b> None	
<b>WEATHER:</b> Clear	<b>INSPECTOR'S SIGNATURE:</b>

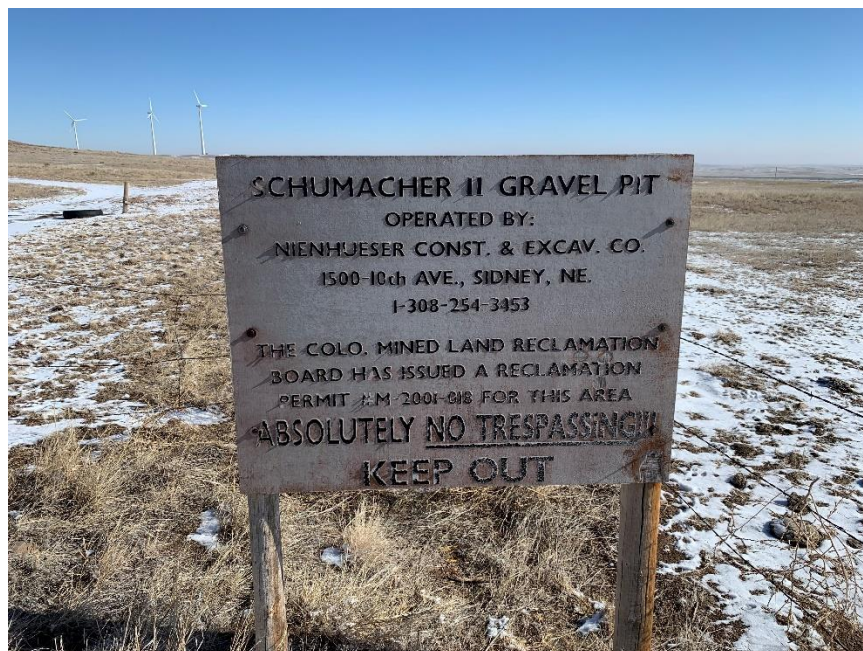
The mine entrance sign was in place facing CR 45 (photo 1). The pit slopes were graded to approximately 3h:1v and appear to be stable as there were no signs of erosion.

Photo 1 - Mine entrance sign facing CR-45

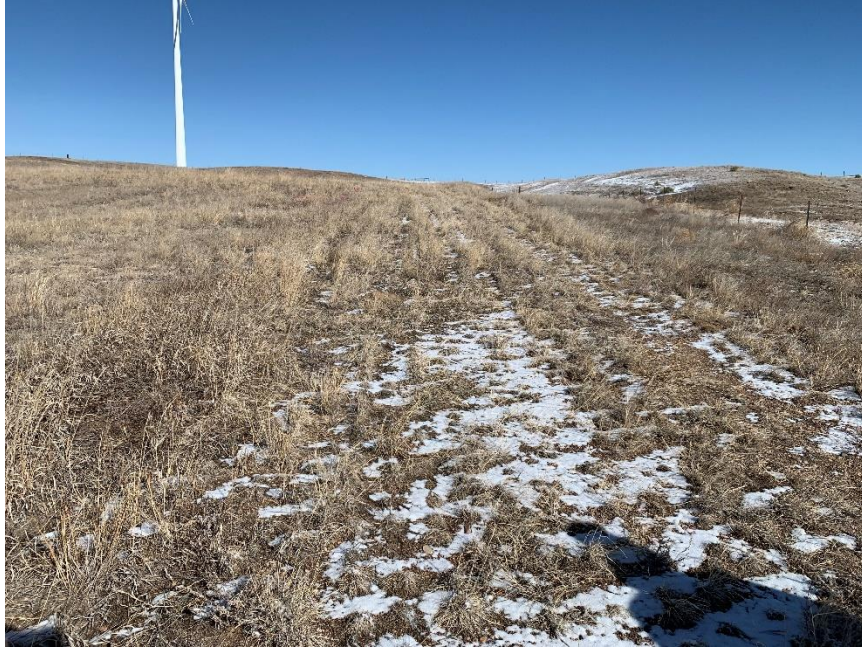
The access road and in pit road (photo 2) appeared to be stable and there were no signs of erosion. The vegetation on the road areas were planted in June 2017 according to Mr. Nienhueser. The vegetation looks good and is well established.

Photo 2 – In pit road facing northeast

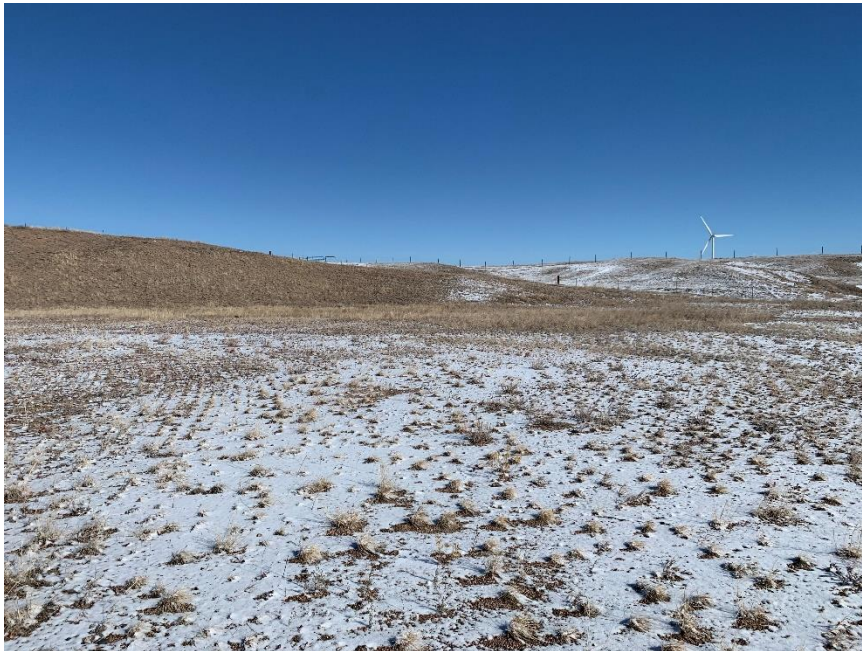
The pit area was fenced and the gate was closed upon arrival. The pit area was also seeded in June 2017. The vegetation has improved greatly since the last inspection. It is well established and the cover is similar to that of the surrounding areas (Rule 3.1.10(1)). The bare spots noted in the last report were still present but have filled in (photos 3 & 4). Many seed heads on grasses and forbs were noted indicating the plants are mature and self-regenerating. The patches of musk thistle were treated and no thistle or any other noxious weeds were noted.

Photo 3 – Pit floor vegetation has filled in compared to previous inspection, facing northeast

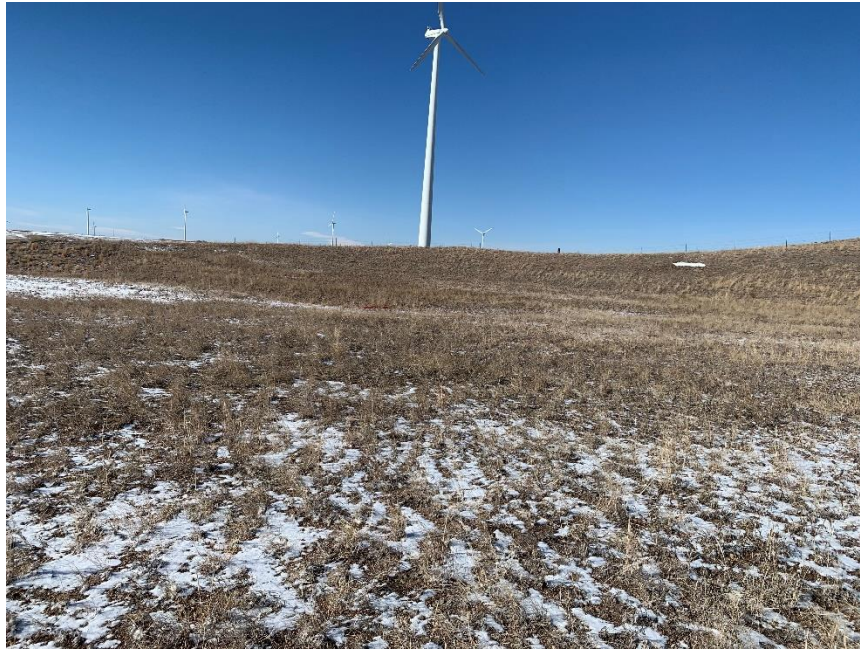
Photo 4 – Pit floor vegetation filled in, facing north
