NOTICE EXPIRED – RECLAMATION REQUIREMENTS INCOMPLETE

The Western Union Corporation Notice, COC-074166 to conduct uranium exploration drilling located in Fremont County, T. 17 S., R. 73 W., section 27, expired on October 10, 2020. A final inspection was conducted on August 25, 2020 (Enclosure 1) and BLM determined all reclamation requirements for bore hole abandonment (bore hole and drill pad number Hndd010) had been met; however, Class A noxious weeds (i.e., thistles) and erosion along the reclaimed access road were present. Per 43 CFR 3809.335(b), all reclamation obligations continue beyond the expiration of the Notice, until reclamation has been satisfied.

Minerals Exploration/Sampling/Testing Inspection
U.S. Department of the Interior
Bureau of Land Management
Royal Gorge Field Office

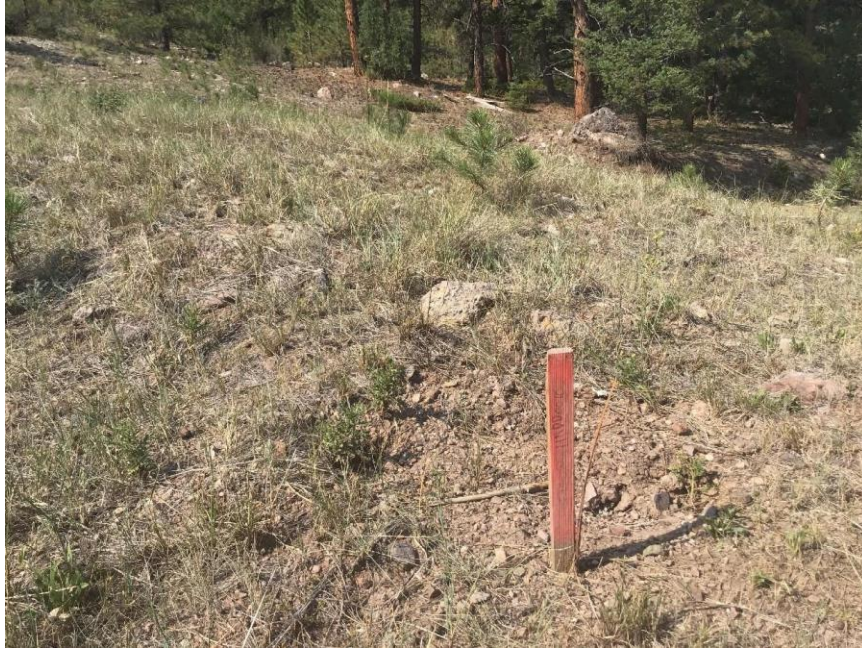
Image 1: (Image taken by J. Elkington, 08/25/20)

Comment: Signage on drill pad/site number (Hndd010). The site is reclaimed and has a capped borehole. A piezometer was previously present at this location.

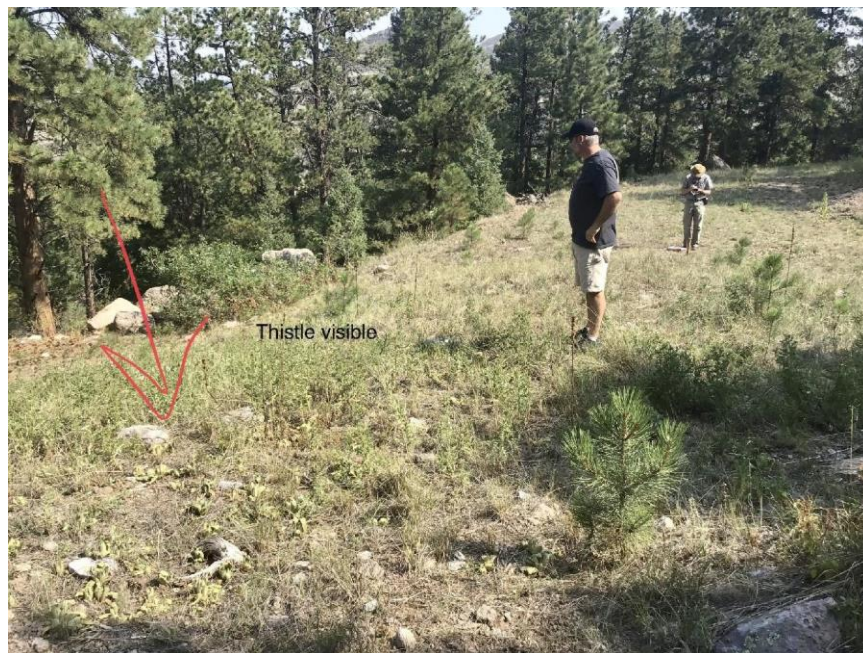
Image 2: (Image taken by J. Elkington, 08/25/20)

Comment: Visible thistle growth on drill pad/site number (Hndd010). Operator will spray for weed management next spring (2021). Viewed to the east.

1. The operator will hire a certified weed sprayer to spray for any Class A or B noxious weeds in spring 2021. BLM will require a copy of the noxious weed report.
2. The operator will construct a bar ditch to divert storm/meltwater runoff toward the existing drainage channel to help control short-term erosion and increase vegetation regrowth along the reclaimed access road.

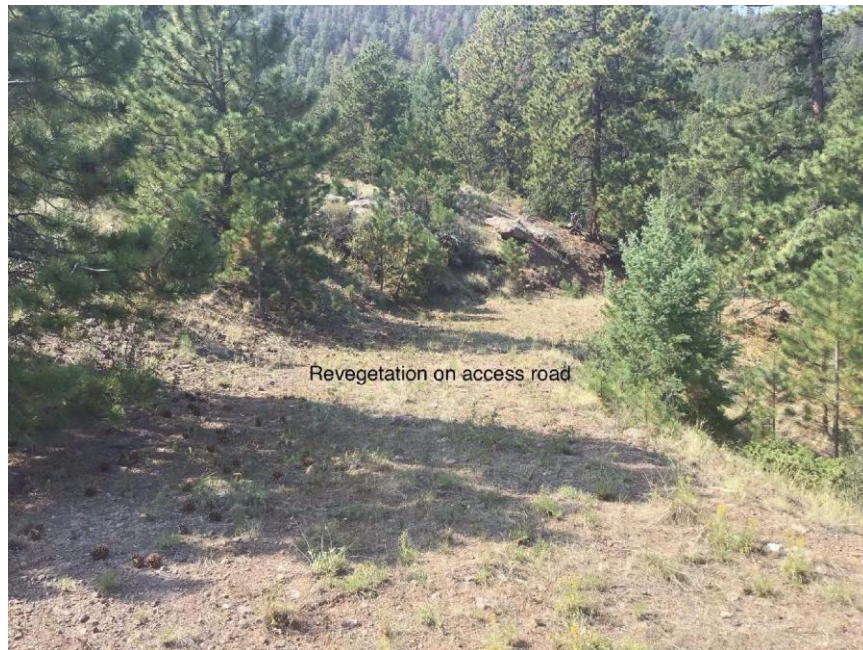
Image 3: (Image taken by J. Elkington, 08/25/20)

Comment: Adequate revegetation on access road near drill pad/site number (Hndd010). Growth of grasses, yarrow, and voluntary ponderosa pine. Viewed to the west.

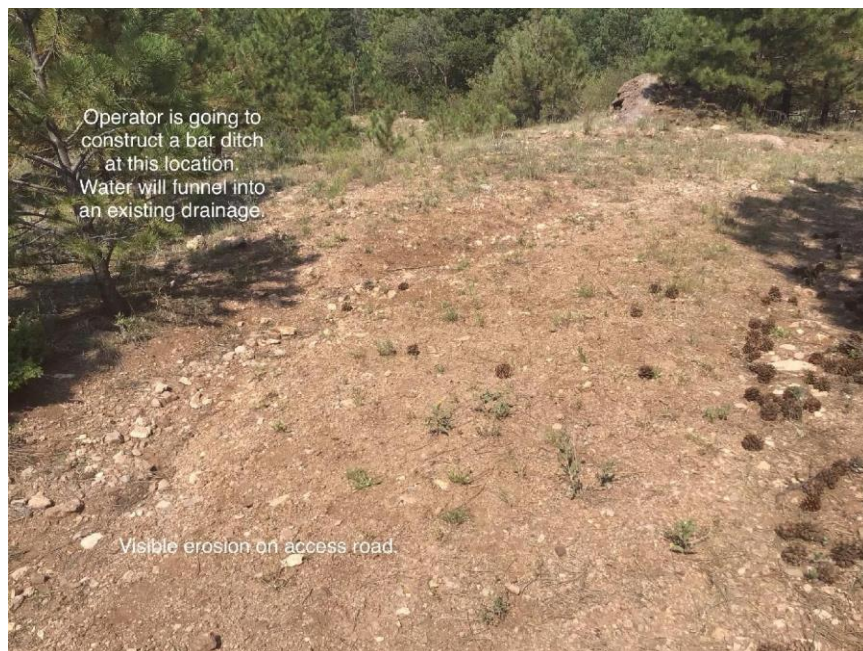
Image 4: (Image taken by J. Elkington, 08/25/20)

Comment: Some erosion is present along the access road near drill pad/site number (Hndd010). Operator will construct a bar ditch to funnel the water off the access road and into an existing drainage. Viewed to the northwest.

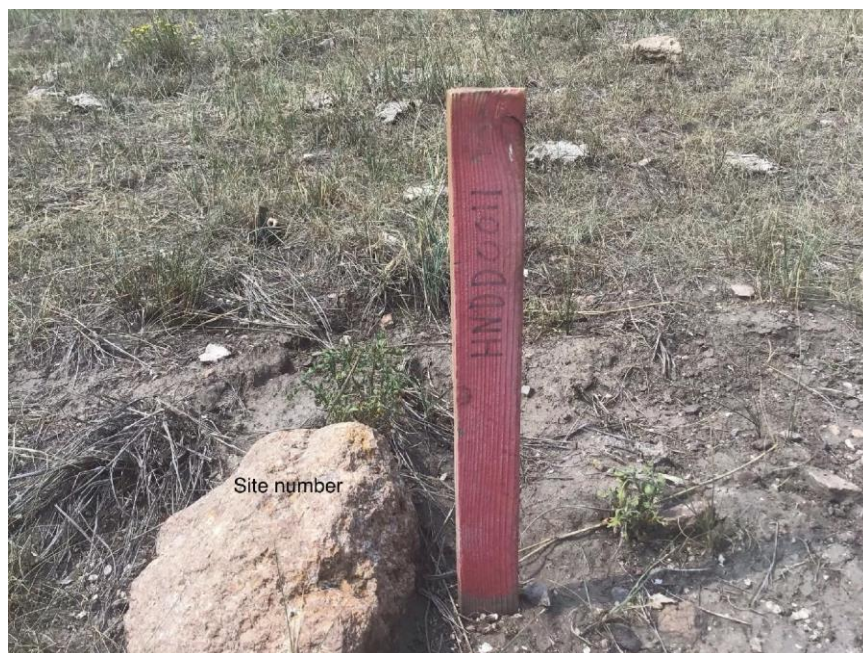
Image 5: (Image taken by J. Elkington, 08/25/20)

Comment: Drill pad/site number (Hndd011) at different location, not on BLM surface. The site is reclaimed and has a capped borehole. A piezometer was previously present at this location.

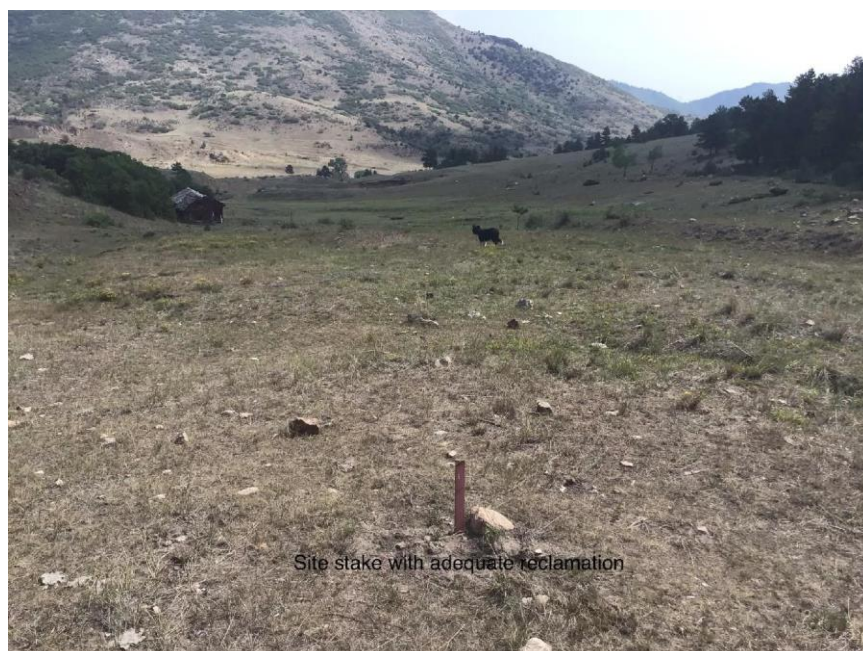
Image 6: (Image taken by J. Elkington, 08/25/20)

Comment: Drill pad site stake (Hndd011) with acceptable reclamation with sufficient growth of grasses. Animal grazing on site. This site will mostly likely be released of bonding in the next year. Viewed to the east.

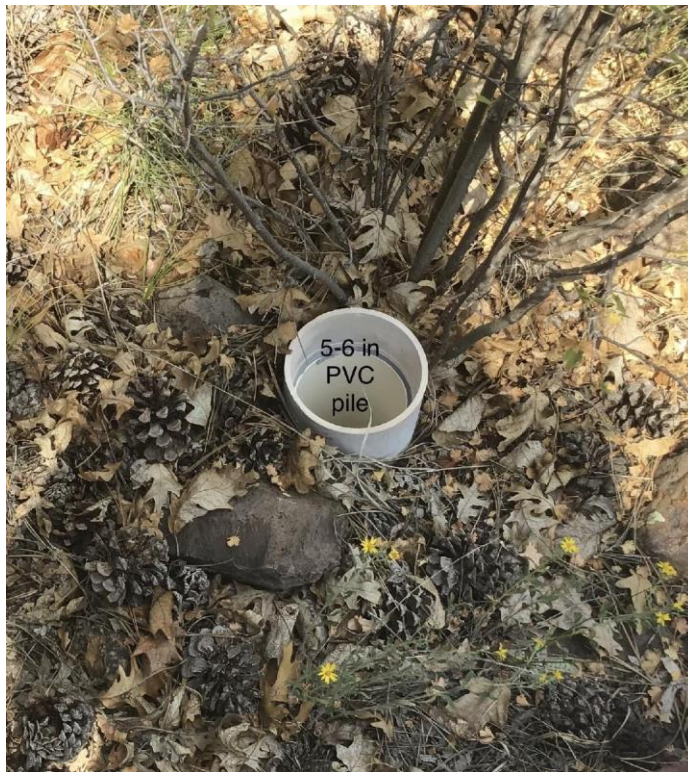
Image 7: (Image taken by J. Elkington, 08/25/20)

Comment: Unknown drill hole with no drill PVC cap near drill pad/site number (Hndd009). Operator will need to put a PVC cap on this drill hole.

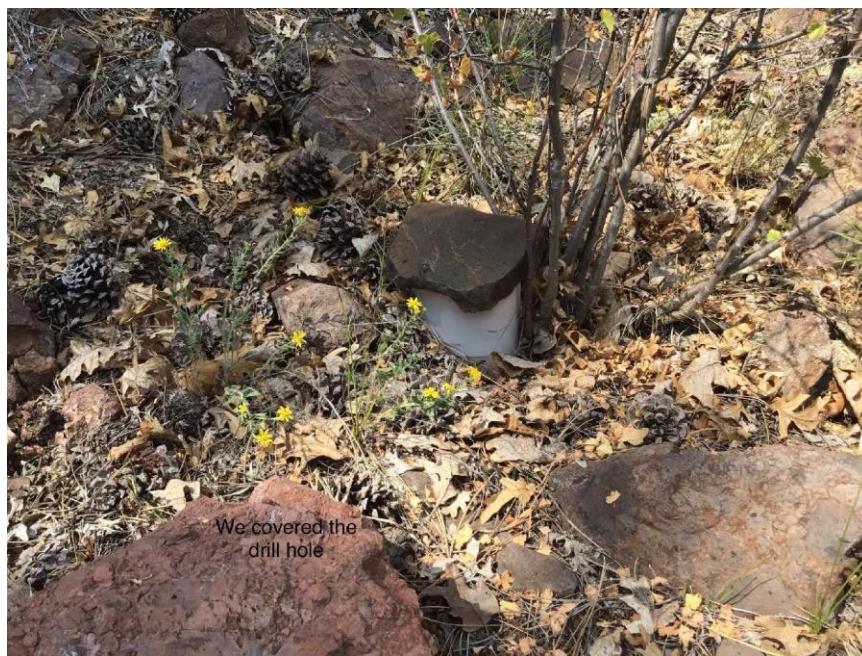
Image 8: (Image taken by J. Elkington, 08/25/20)

Comment: We covered the unknown drill hole near drill pad/site number (Hndd009) by putting a rock over the drill hole. Operator will need a PVC cap on this drill hole to limit cross-contamination with the aquifer.

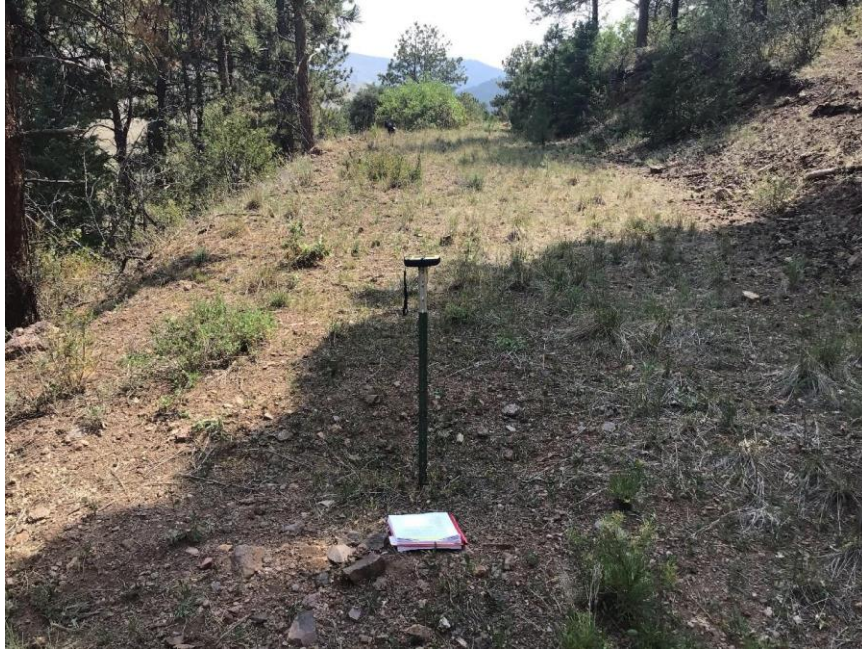
Image 9: (Image taken by J. Elkington, 08/25/20)

Comment: Most likely drillpad/site number (Hndd009) with good revegetation on access road. Could see broken off stake post underneath the T-post. Viewed to the southeast.
