MINERALS PROGRAM INSPECTION REPORT
PHONE: (303) 866-3567

MINE NAME: Hansen Uranium Project	MINE/PROSPECTING ID#: P-2009-025	MINERAL: Uranium	COUNTY: Fremont
INSPECTION TYPE: Monitoring	INSPECTOR(S): Timothy Cazier	INSP. DATE: August 25, 2020	INSP. TIME: 10:00
OPERATOR: Black Range Minerals Colorado, LLC	OPERATOR REPRESENTATIVE: Mike Rutter	TYPE OF OPERATION: MP - Mineral Prospecting	
REASON FOR INSPECTION: Normal I&E Program	BOND CALCULATION TYPE: Complete Bond	BOND AMOUNT: \$154,936.58	
DATE OF COMPLAINT: NA	POST INSP. CONTACTS: None	JOINT INSP. AGENCY: U.S.BLM	
WEATHER: Clear	INSPECTOR'S SIGNATURE:

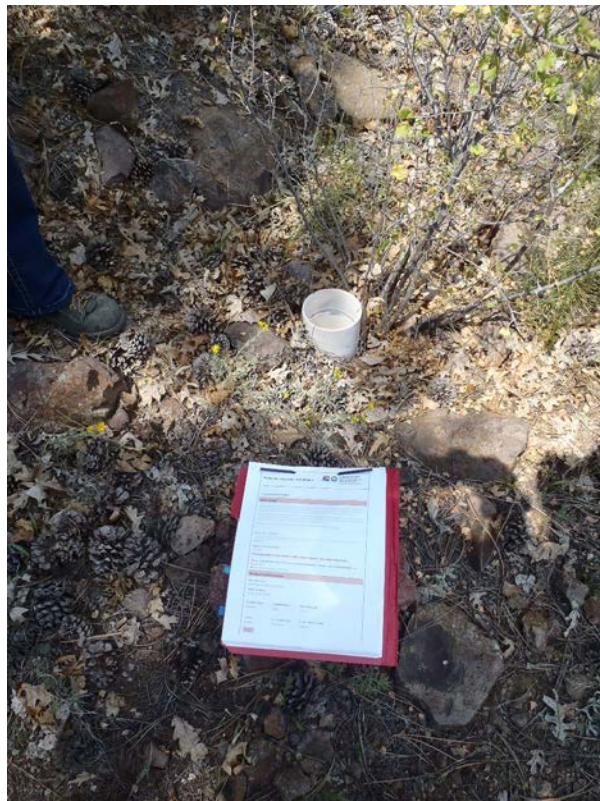
Photo 1. PVC casing observed approximately 160 north of HNDD0009.

Hydrologic Balance: The DRMS has received final abandonment reports for all eleven HNND boreholes/wells drilled in 2011. No abandonment reports have been received for the five MW-27 series (290 through 294) holes drilled in 2014. **Attachment A** provides a summary of the reclamation status for each of these 16 wells. A PVC casing extending a few inches above the ground was observed approximately 160 north of HNDD0009 (see **Photo 1**, Lat. 38° 32.376'N; Long. 105° 32.166'W - based on data collected with a hand held Trimble Juno 3B GPS unit). A review of DRMS records indicates no known boring in this location. As the construction differs from other project borings, the DRMS does not consider this hole to be part of the NOI. Mr. Rutter agreed to put a PVC cap on this casing.

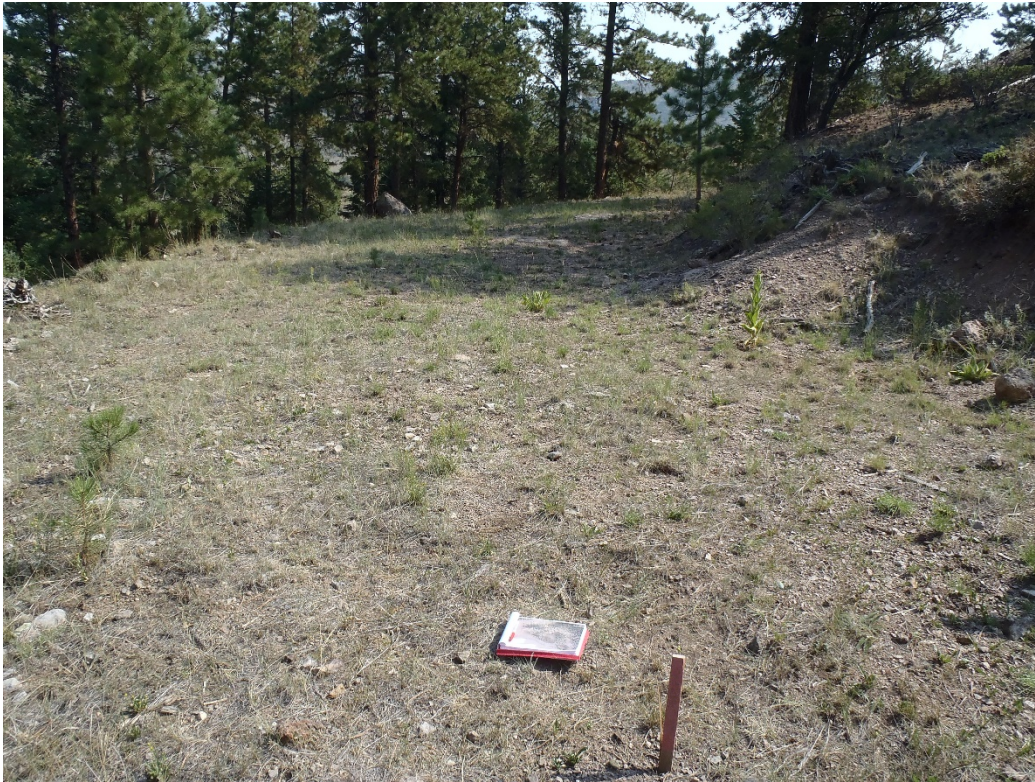
Roads: With the exception of best management practices (BMPs) needed just north of the where the drill road to HNDD0010 crests the hill to prevent future erosion, drill roads appeared to be adequately reclaimed (see **Photos 2 and 3**) and did not appear to be a source of sediment. DRMS recommended installing a water bar/bar ditch north of the HNDD0010 drill road crest to prevent runoff from following the drill road down to the final switchback to the drill site. Mr. Rutter and Ms. Carter concurred with this approach.

Photo 2. Reclaimed drill site and road – HNDD0010 (looking NE).

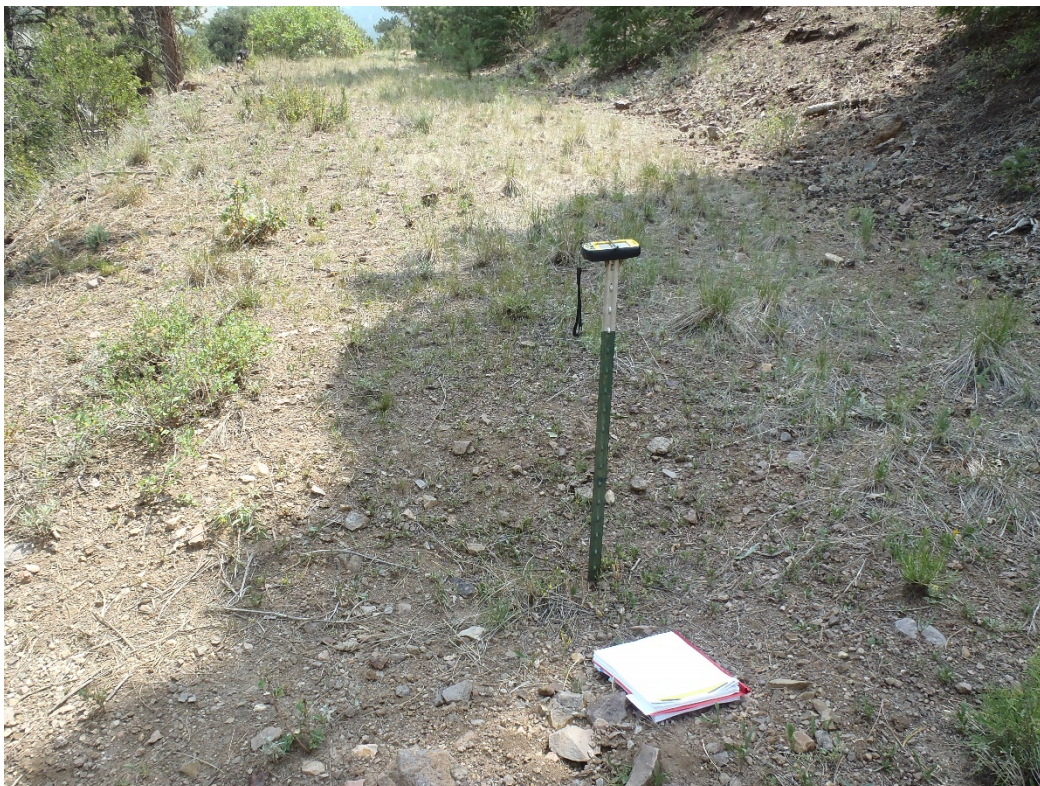
Photo 3. Reclaimed drill site and road – HNDD0009 (looking south).

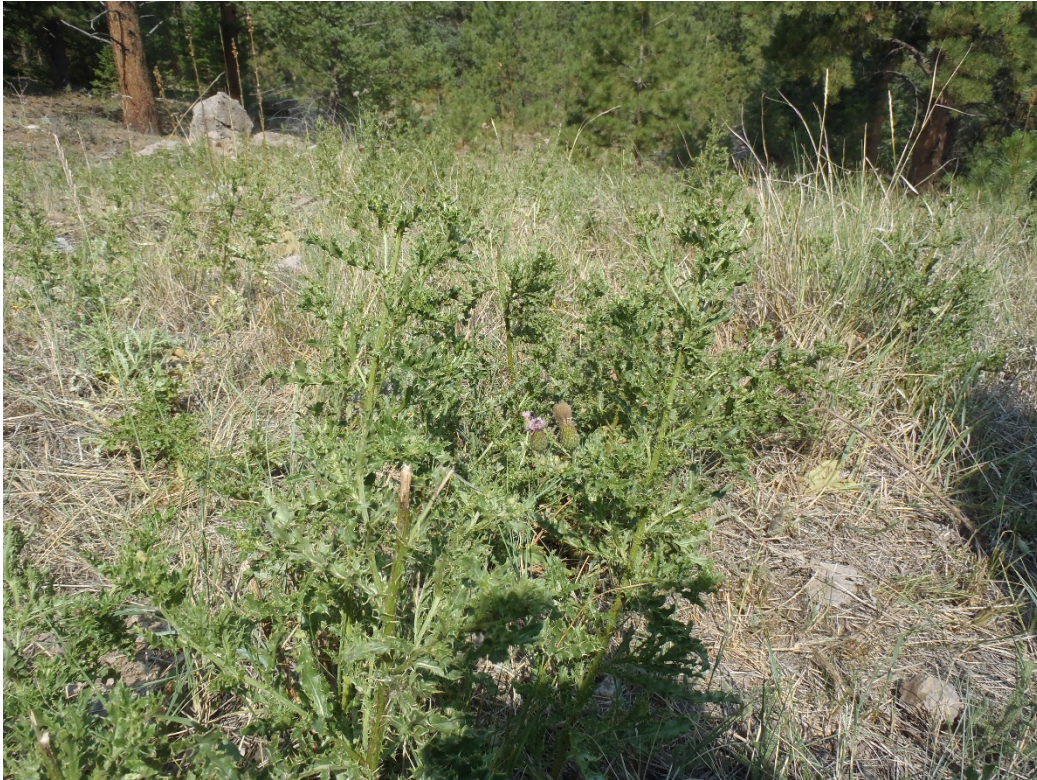
1. The aforementioned water bar install on the HNDD0010 drill road,
2. A small amount of Canada thistle observed near the HNDD0010 drill site (see **Photo 4**) needs to be treated,

Photo 4. Canada thistle near HNDD0010 (looking NW).

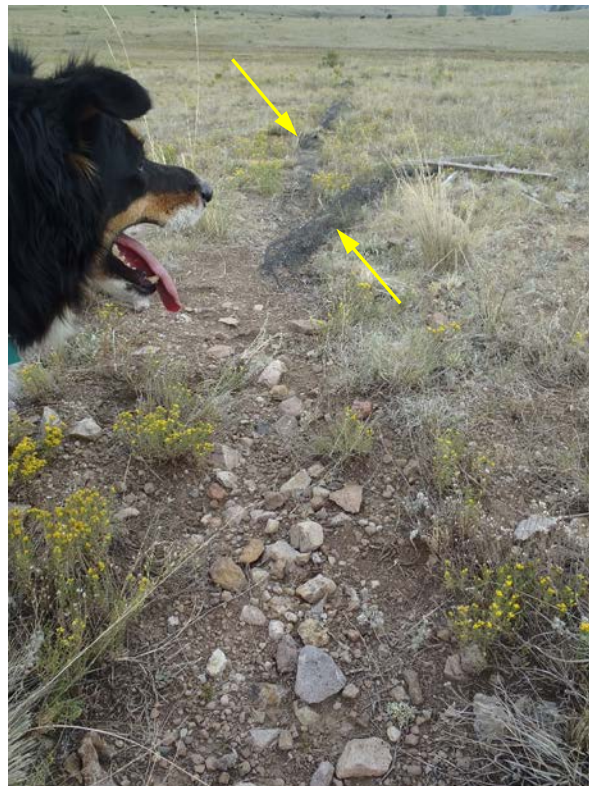
3. Straw wattles (see **Photo 5**) and rebar stakes were observed on the perimeter of the HNDD0006 drill site that need to be removed.

Photo 5. Straw wattles remaining at HNDD0006.

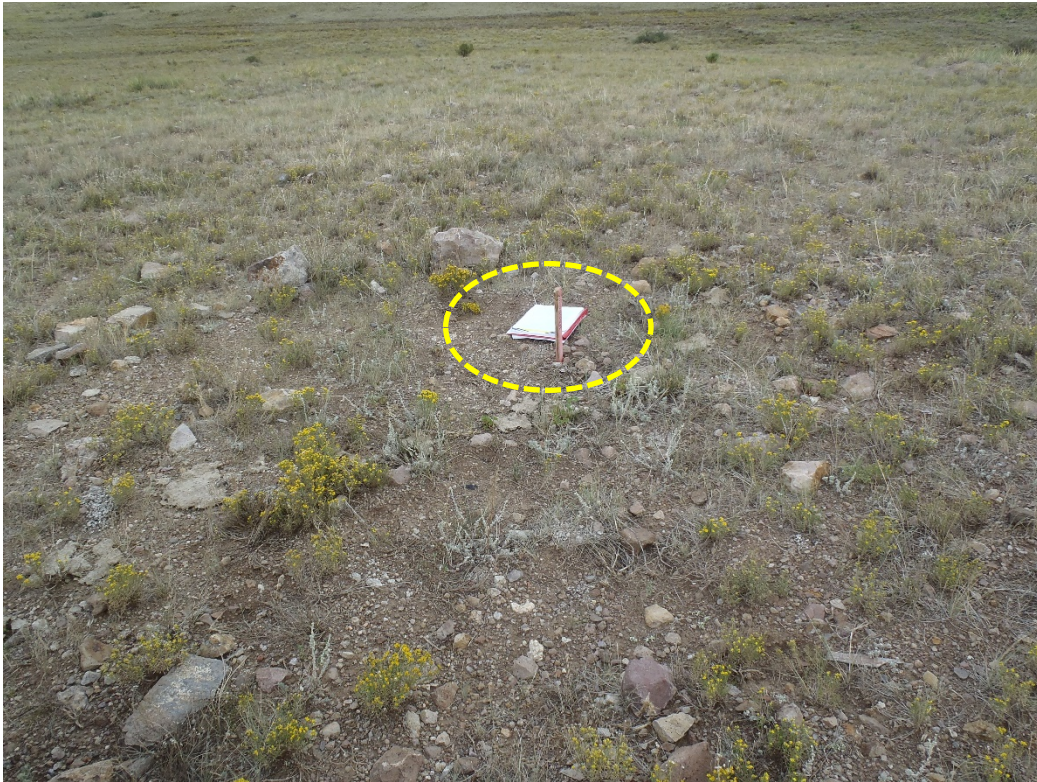
Revegetation: Vegetation appears to be well established at all drill sites (see **Photos 6 and 7**). The only noxious weeds observed were the small number of Canada thistles near HNDD0010.

Photo 6. Revegetated HNDD0006 drill site (looking SE, hole marker circled).

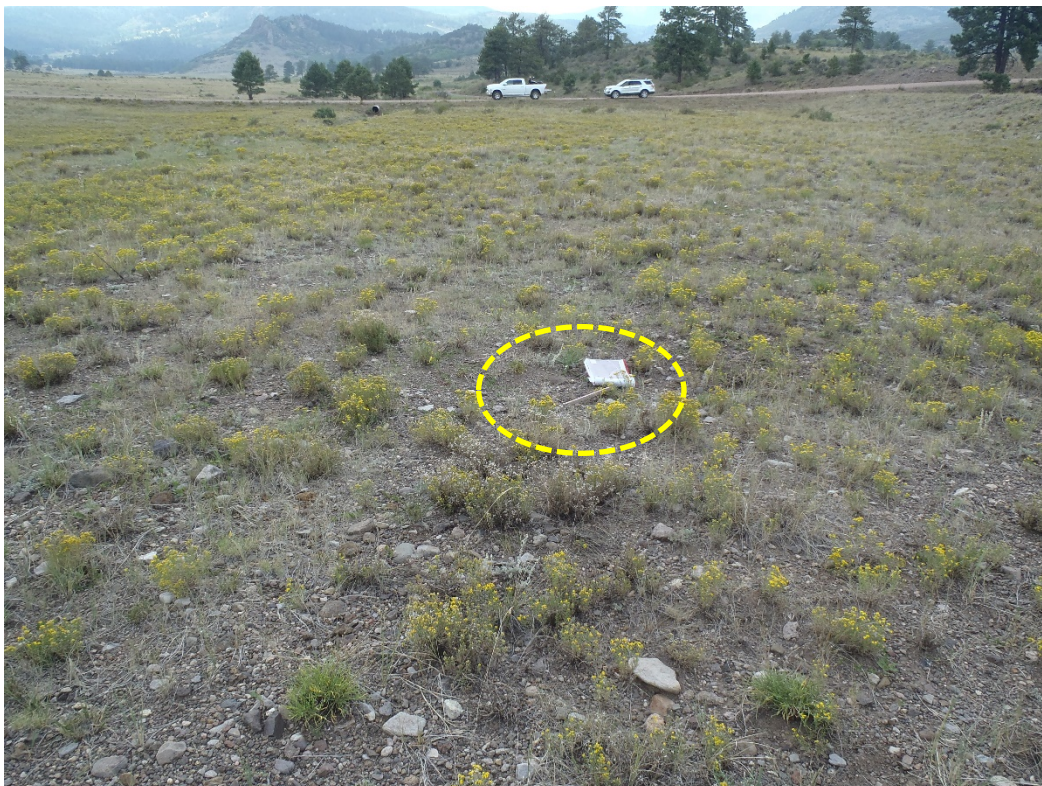
Photo 7. Revegetated HNDD0007 drill site (looking north, hole marker circled).
