April 8, 2021

Job Number: 99-3983

Subject: Quarterly Observation Report, Refuse
Pile, Foidel Creek Mine, Routt County, Colorado.

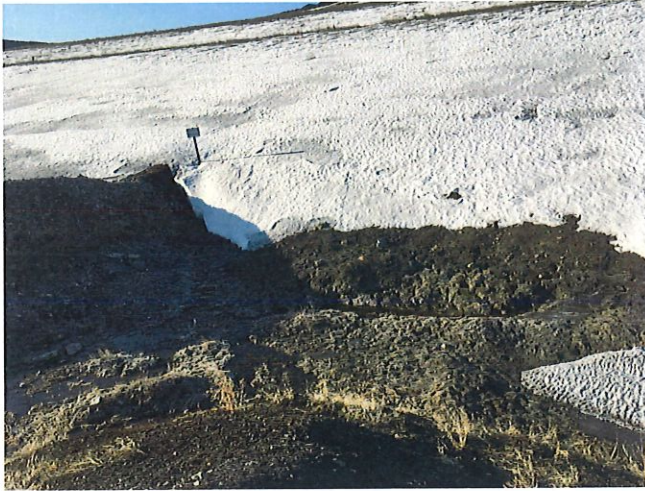
A seepage area at the toe of the northeast end of the refuse pile expansion area, approximately 30 feet northwest of the outlet of the underdrain, developed in fall 2014. At the time of our observations, the seepage was surfacing at the toe of the slope and flowing into the drainage from the undrain outlet then into the existing pond east of the Refuse Pile Expansion Area. The discharge was clear, with no evidence of sediment. No signs of washout, slumps or slope instability were observed at this time. The seepage area

will be monitored during future inspections and noted in our inspection reports. Photographs of the seepage area taken at the time of our inspection on March 31, 2021 are attached.

March 31, 2021-Drain Outlet and Seepage Area
