**Huddleston-Berry**  
Engineering & Testing, LLC

Subject: Summary of Instrumentation Monitoring  
1<sup>st</sup> Quarter 2021  
Bowie Coal Waste Disposal Area No. 2  
Paonia, Colorado

**SUBJECT: Summary Report, 1<sup>st</sup> Quarter 2021, Inclinometer and Active Vibrating Wire Piezometer Data January – March 2021, Bowie Mine #2 Coal Waste Disposal Area (CWDA) #2**

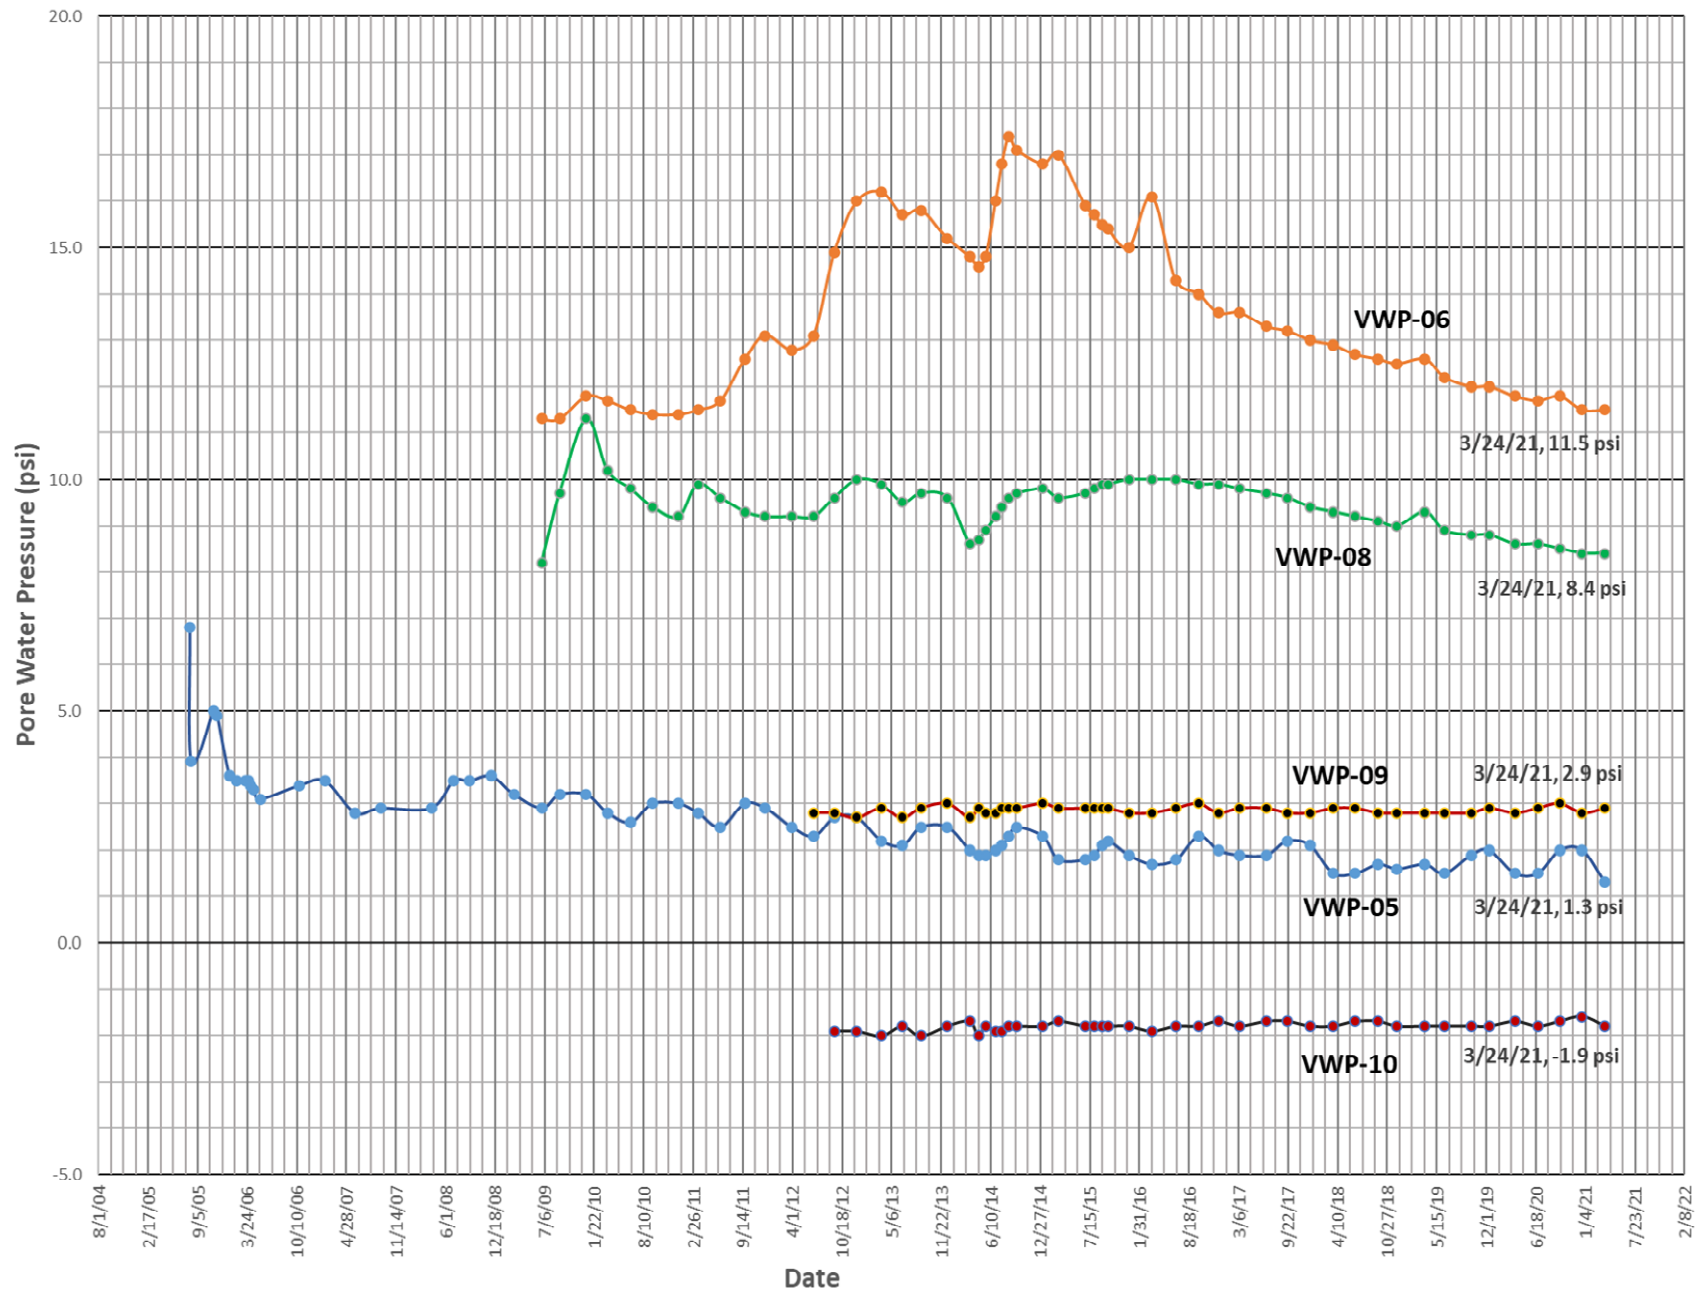
**Figure 2 - Bowie Mine #2 - CWDA #2**  
**Active Vibrating Wire Piezometer Data**

As seen on Table 1 and Figure 2, the VWP readings and trends are consistent with recent and historic readings. Pore pressure readings changed by small amounts (+0.1 to -0.3 psi) since the readings one year ago (Q1 2020). When compared with a last quarter (Q4 2020), pore pressures changed very little (0.0 to +/-0.1 psi) for four of the VWP's, while one (VWP-05) decreased by 0.7 psi. This anomalous VWP has exhibited a seasonal cycle since installation that shows low pore pressures for Q1 and Q2 and higher pressures for Q3 and Q4, with a net loss of 5.5 psi over the lifetime of that VWP. The other four VWP's have experienced net changes of 0.2 psi or less since installation.

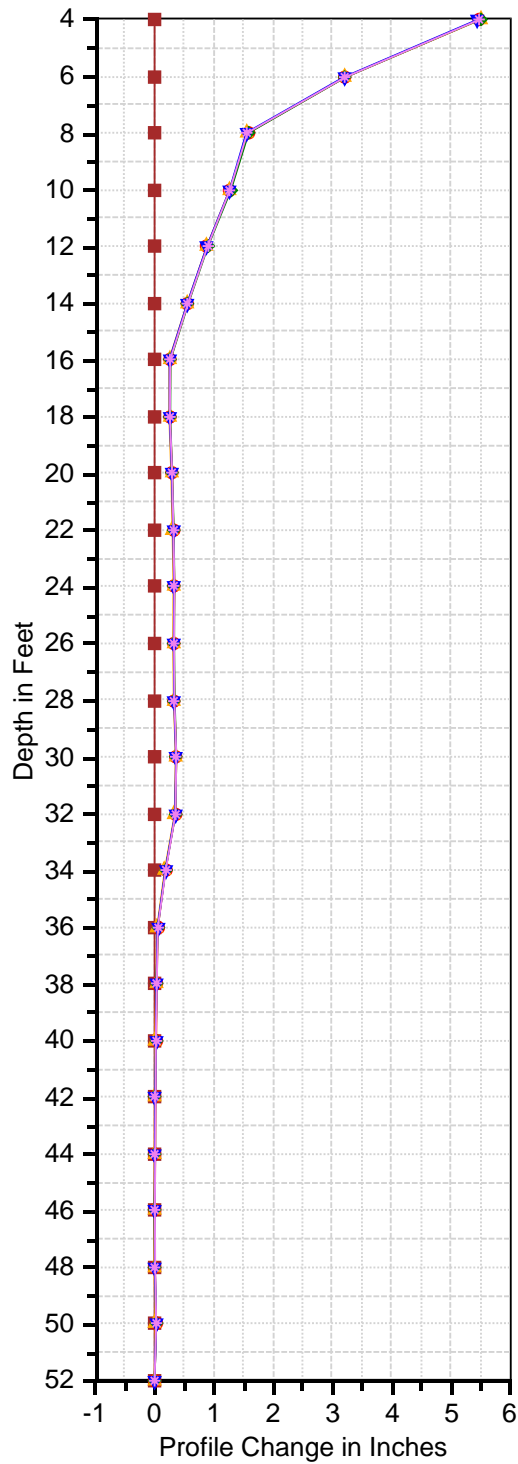
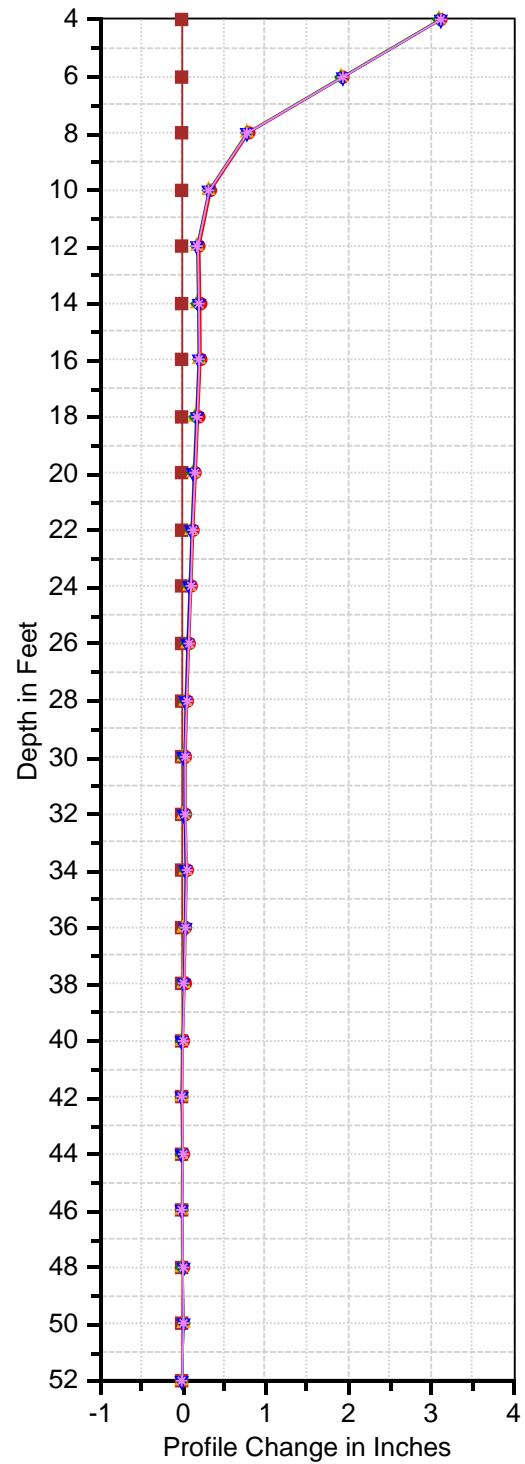
BOWIE BG05\_4 A

As described in previous reports, historic displacements indicated on the plots for the approximate upper ten feet of the inclinometers since installation in 2005 are due to placement of cover soil on the face of the waste pile during revegetation operations in late 2006 and early 2007. This man-caused displacement is documented in a report by Buckhorn Geotech dated September 22, 2008 to Bowie Resources called *Revised Stability Evaluations for Coal Mine Waste Disposal Area No. 2, Bowie No. 2 Mine*.

Based on the current inclinometer readings, there hasn't been downslope movement (Axis A) in any of the inclinometers since 2007 and they are generally consistent with previous readings. Some "noise" which is understood to be relatively common in orthogonal direction (Axis B) readings, was observed over the past few years for inclinometer BG05-5B. This can be due to a number of mechanical or installation causes that are unrelated to slope movement. For example, grout voids, poor grout coverage, or soil settlement around the instrument can all contribute to vibrations and pipe movement that impacts inclinometer readings. Software bias adjustments were applied which filtered this noise. All readings were consistent with previous ones and the "displacement" error was within equipment tolerances and not deemed to be due to slope movement.

It should be noted that water was standing in the BGI05-04 inclinometer pipe at a depth of about 6 feet below grade (while it was at 12 feet during our Q4 2020 site visit). Based on our observations there has always been water in this pipe. We also measured water around 5 feet in inclinometer BGI05-07 (while it was at 12 feet during our Q4 2020 readings). There was no water in the BGI05-05 pipe.
