MINERALS PROGRAM INSPECTION REPORT
PHONE: (303) 866-3567

MINE NAME: Bootleg Quarry	MINE/PROSPECTING ID#: M-2015-022	MINERAL: Sand and overburden	COUNTY: Adams
INSPECTION TYPE: Monitoring	INSPECTOR(S): Patrick Lennberg	INSP. DATE: May 5, 2021	INSP. TIME: 11:00
OPERATOR: Lazy H Inc	OPERATOR REPRESENTATIVE: None	TYPE OF OPERATION: 111 - Construction by Government Agency	
REASON FOR INSPECTION: Normal I&E Program		BOND CALCULATION TYPE: Partial Bond	BOND AMOUNT: \$34,000.00
DATE OF COMPLAINT: NA		POST INSP. CONTACTS: None	JOINT INSP. AGENCY: None
WEATHER: Clear	INSPECTOR'S SIGNATURE:

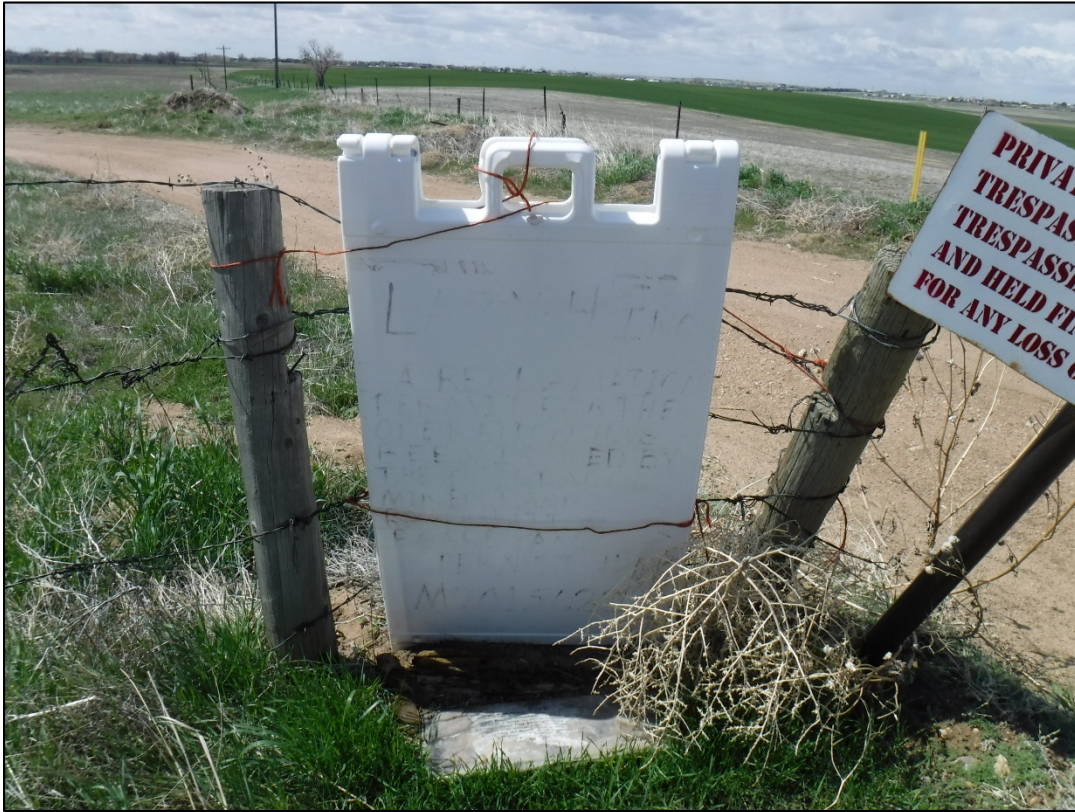
PROBLEM/POSSIBLE VIOLATION: The mine identification sign was not posted at the entrance of the mine site. This is a problem for failure to post a mine identification sign as required by Section 3.1.12(1) of the rule. The Operator shall, at the entrance of the mine site post a sign, which shall be clearly visible from the access road, with a minimum size equaling one hundred and eighty-seven (187) square inches, such as eleven (11) inches in height and seventeen (17) inches in width, with appropriate font size, with the following: the name of the Operator, a statement that a reclamation permit for the operation has been issued by the Colorado Mined Land Reclamation Board; and the permit number.

The entrance to the Bootleg Quarry is approximately 1 mile south of the intersection of East 168th avenue and Hudson Mile Road east of Lochbuie, CO in Adams County. The quarry is a 111c permitted site for 13.5 acres. The primary commodity mined is sand. A mine sign was not observed as required by Rule 3.1.12 and is being cited as a problem in this report. The affected area of the site is surrounded by a barbed-wire fence.

Photo 1: Mine sign at entrance to mine site

CORRECTIVE ACTIONS: The operator shall, at the entrance of the mine site, post a sign which shall be clearly visible from the access road with the following: the name of the operator, a statement that a reclamation permit for the operation has been issued by the Colorado Mined Land Reclamation Board; and the permit number. The operator shall submit photo documentation that a proper sign has been posted by the corrective action date.

CORRECTIVE ACTION DUE DATE: 6/05/21

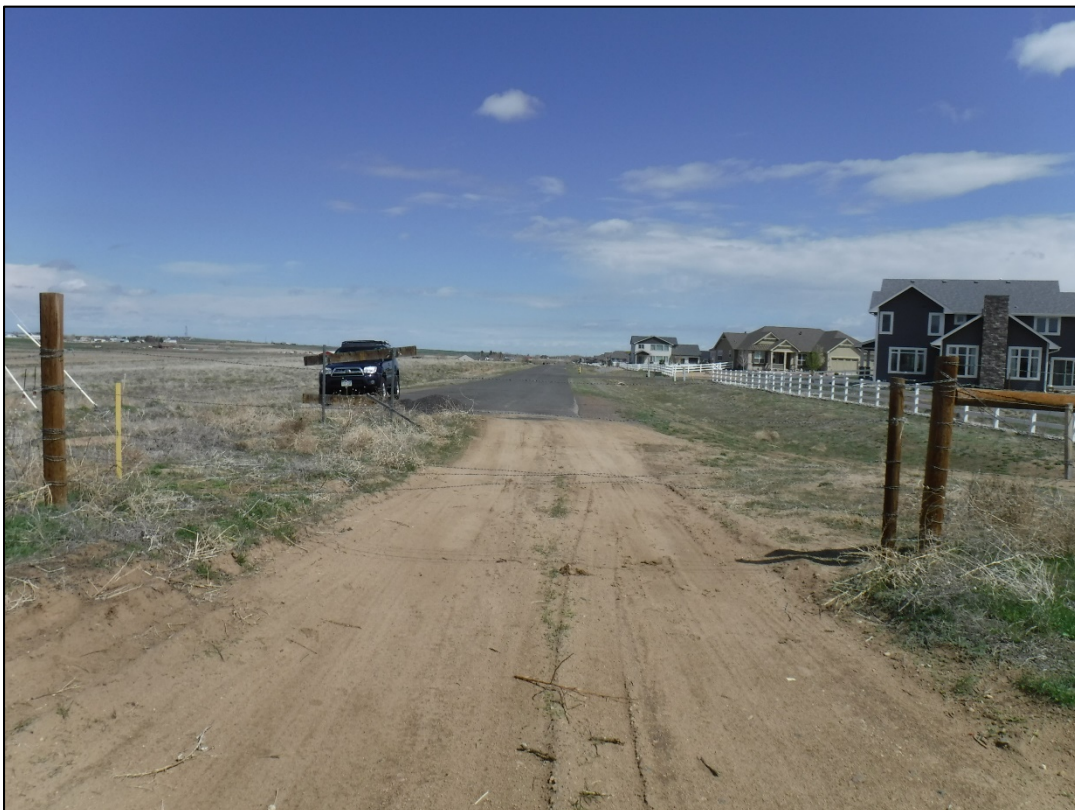
Photo 2: Mine entrance looking north along Hudson Mile Rd

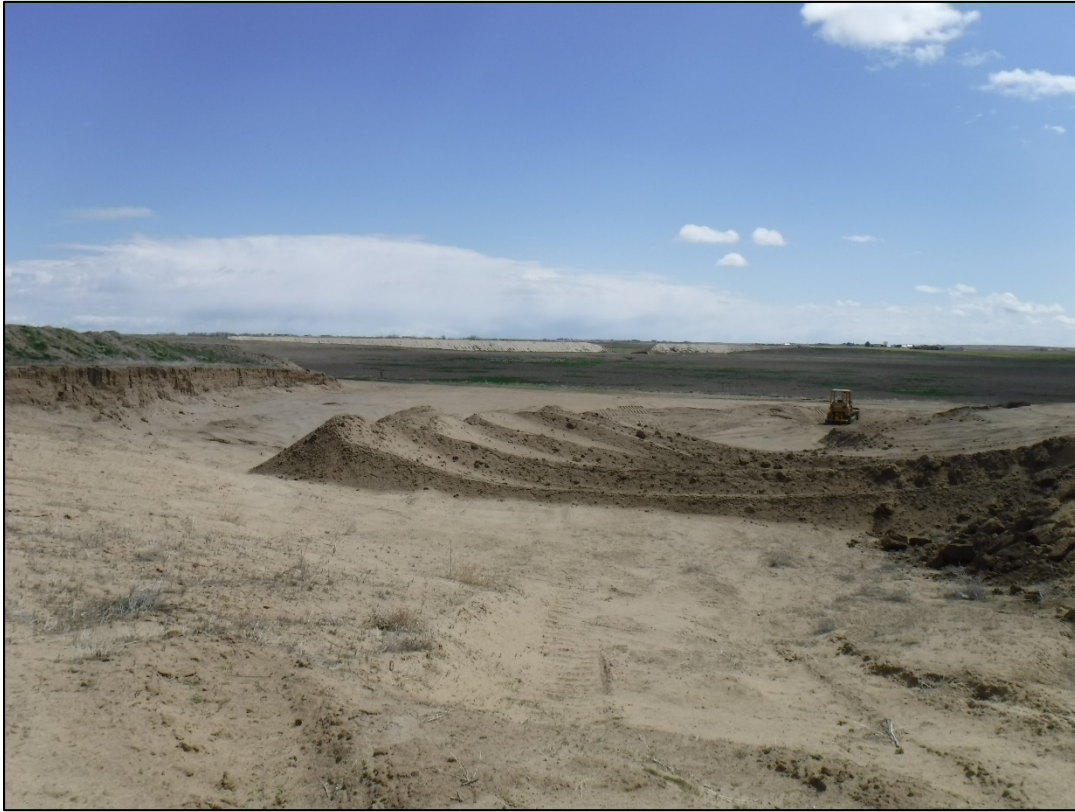
The site was not active at the time of the inspection. However, there was a 955 track loader staged at the mine. It appears that mining along the southern highwall has recently occurred at the site. It appears current mining is being conducted to leave 3H:1V slopes. The affected area of the site is approximately 3 acres. Of the three acres about 1.5 acres is of excavated area while the other 1.5 acres consists of topsoil stockpiles. The excavation daylights to the east while the western side of the pit has been graded to a 4H:1V or shallower slope. The north side highwall of the pit area is vertical with heights approaching 10 to 15 feet. The pit floor was dry and there was no evidence that ponding was occurring at the site.

Photo 3: Looking east across mine area and recent disturbance along the southern mine area

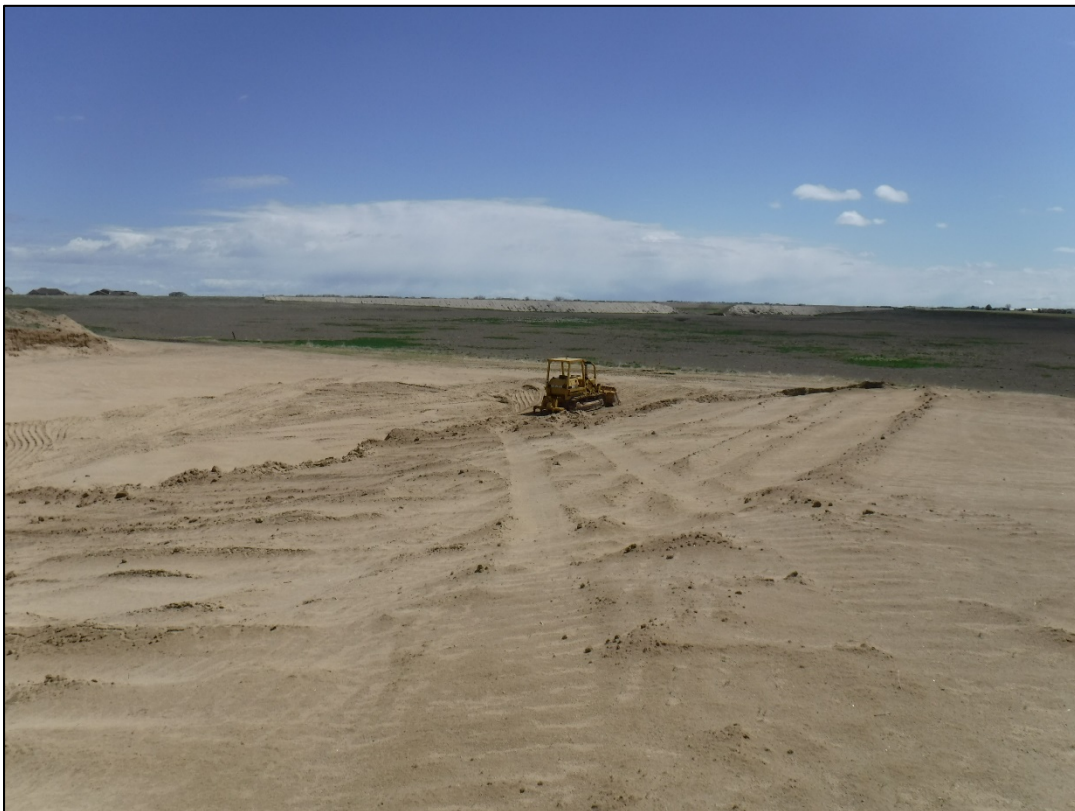
Photo 4: Mining being completed to leave an approximate 3H:1V slope

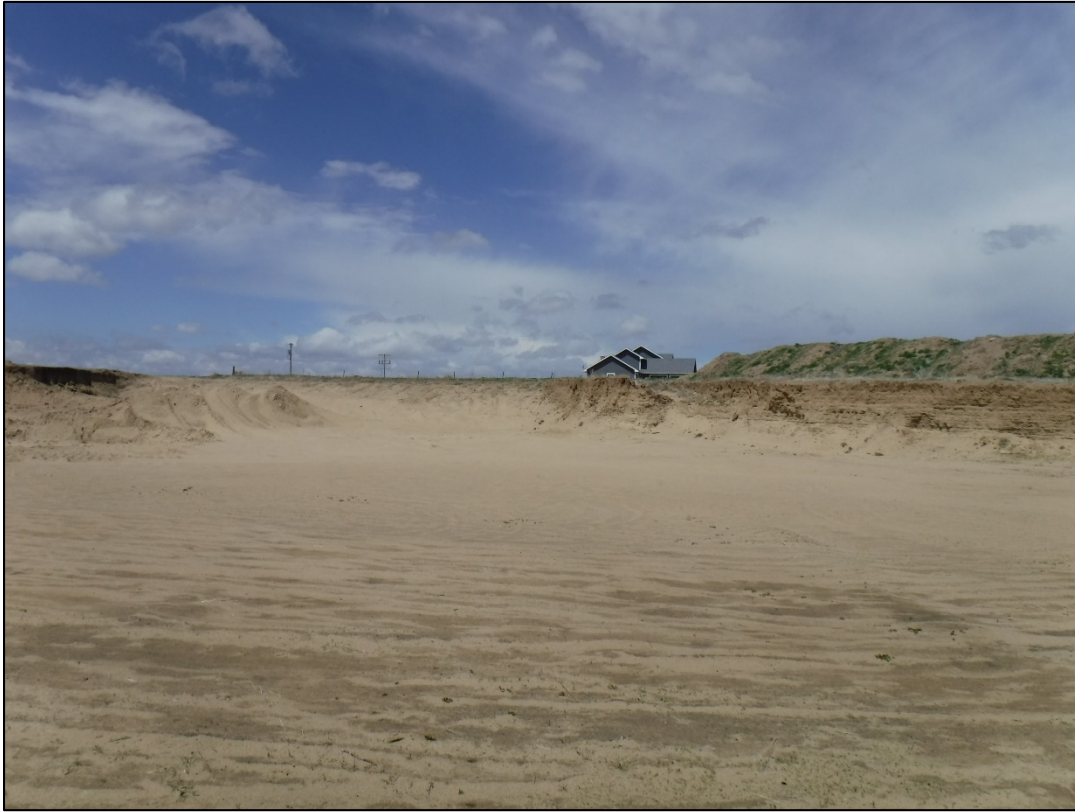
Topsoil stockpiles appeared to be stable. Annual weeds, cheat grass and thistles, were encroaching upon the site. However the site is not acting as a source to the surrounding area.

Photo 5: Looking west across mine area, topsoil stockpile to right of picture has green vegetation growing

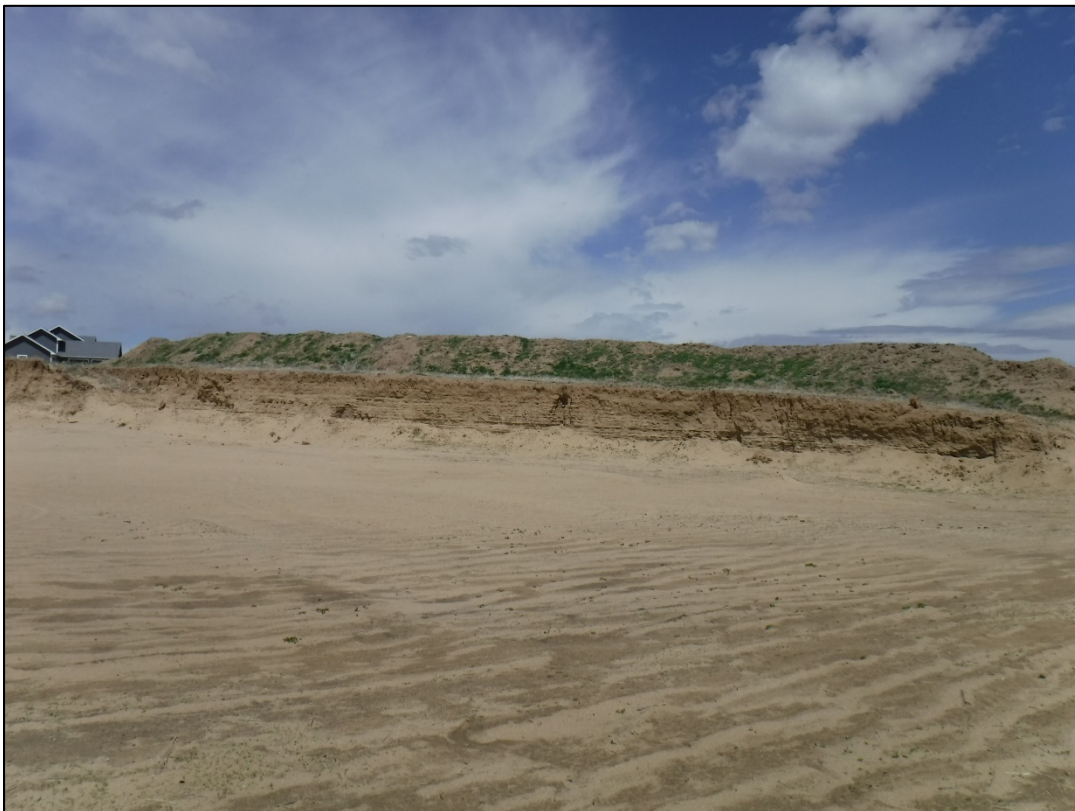
Photo 6: Looking north towards the northern highwall
