RE: Cross Gold Mine, Permit No. M-1977-410, Technical Revision No. 9 (TR-09)
Request for Technical Review

Technical Revision No. 9

DATE:	3 May, 2021	PROJECT:	Cross Mine
ATTENTION:	Richard Mittasch	COMPANY:	Grand Island Resources, LLC
PREPARED BY:	Dave Hallman, PE, PG	REVIEWED BY:	RM
SUBJECT: Idaho Tunnel Portal – Slope Stability Analysis

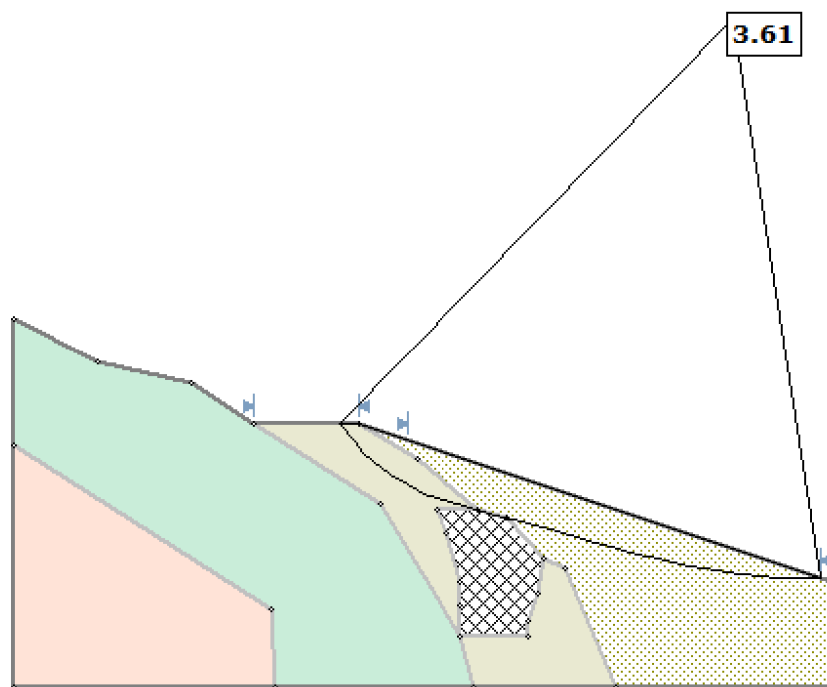
Figure 2 – Stability Analysis Summary

The minimum FoS for a failure surface which intersects the County Road was found to be 3.6. Figure 2 presents a summary of these stability analysis results and includes the critical failure surface. These analyses demonstrate that the lower FoS failure surfaces pass entirely through the colluvium and waste rock fill materials due to the slope geometry. The cellular concrete beneath the slope prevents deep seated instability.

(MLRB), effective May 16, 2018, the Division requires the Operator to comply with a minimum factor of safety (FOS) of 1.5 for critical structures (roads) in static conditions since the Operator utilized limited engineering data in the current analysis. With a calculated minimum FoS of 3.6 using conservative input parameters the results of the analyses are sufficient to demonstrate that the slope meets the Division criteria for long-term static loading conditions.

This study updates previous analyses based on additional data such as the as-built slope geometry. Due to the difficulty of trying to accurately characterize the highly variable geologic conditions within the slope due to weathering of the gneiss bedrock, rather conservative material properties were adopted. For the final 3H:1V slope configuration the critical least factor of safety failure surfaces lie entirely within the waste rock fill and the strength of the underlying soil and regolith make little difference in the analyses.

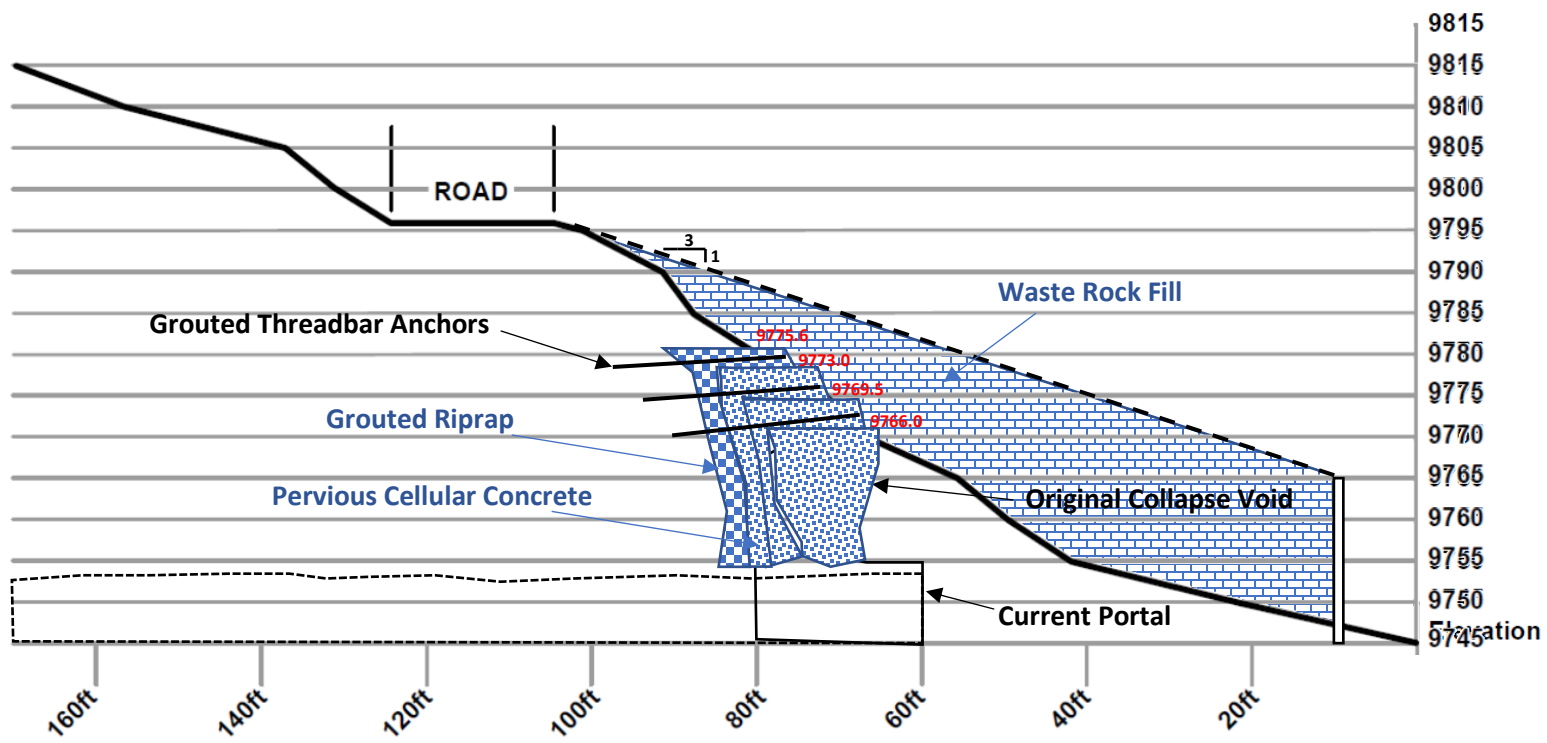
Figure 1 presents a schematic cross section of the tunnel and slope which depicts these conditions.

An idealized representative two-dimensional cross-section was considered for analysis. This section consisted of the profile along the axis of the tunnel included on Figure 1, consisting of a 28-ft high excavation at an angle of 75-degrees then natural ground sloping at approximately 40 ft to the edge of

the 20-ft wide County Road. Starting below the road the slope will be backfilled to 3H:1V using compacted rock fill. A pair of Connex shipping containers and steel supports will be used to maintain the tunnel opening through the waste rock. A reinforced concrete retaining structure will be used to create a vertical face around the portal opening. The surface of the waste rock will be covered with growth media and revegetated. The previous nature of the cellular concrete, waste rock backfill and presence of the tunnel will allow groundwater to freely drain from the slope in order to ensure long-term stability.
