## C1981022, Elk Creek Mine, May Inspection Report/SL-5

SL-5 Bond Release Inspection

MINE: Elk Creek

PERMIT NO: C-022-81

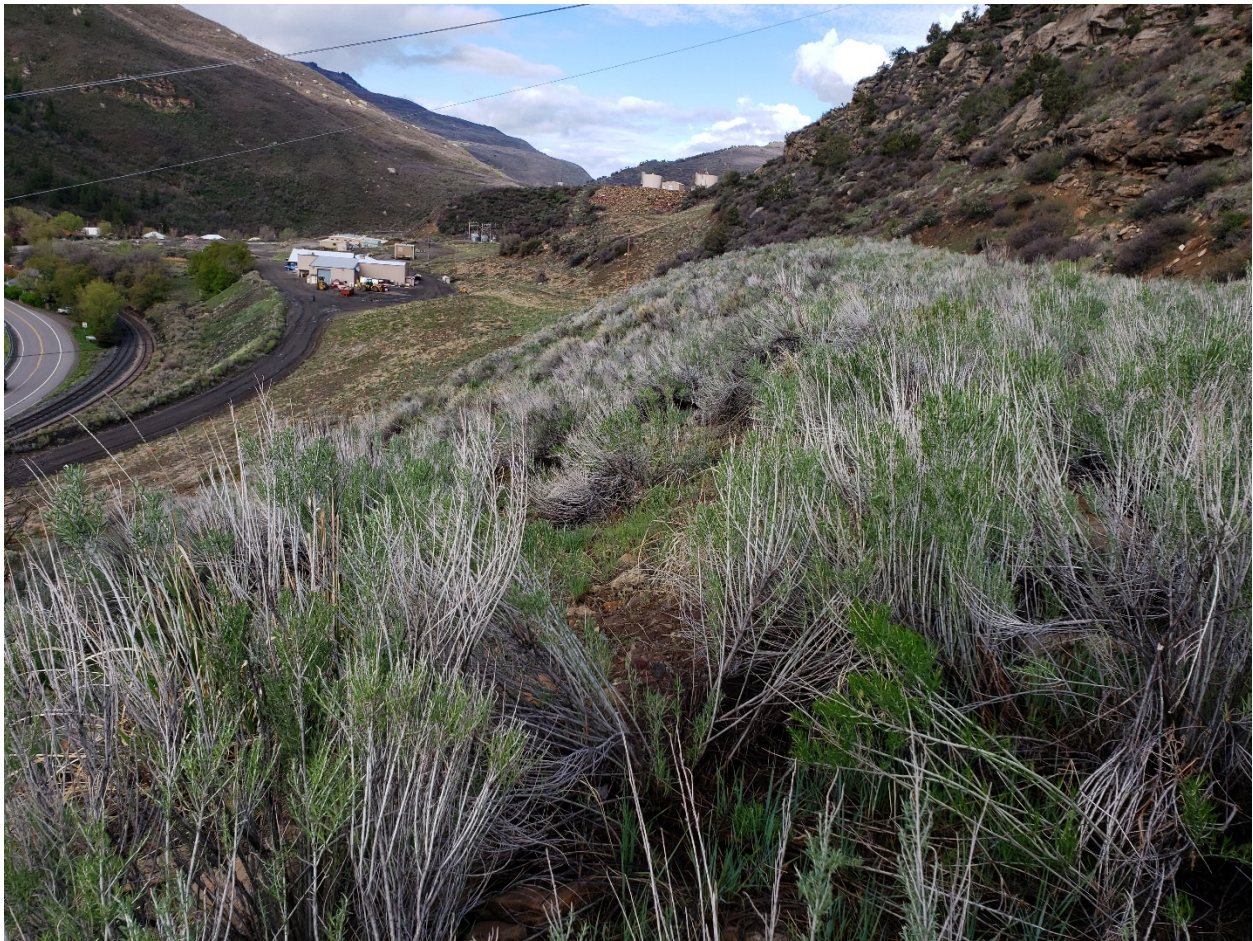
Figure 1 - Example vegetation (foreground) at the East Yard Refuse Pile. Overall this site was well vegetated, stable, and no issues were noted at the time of inspection.

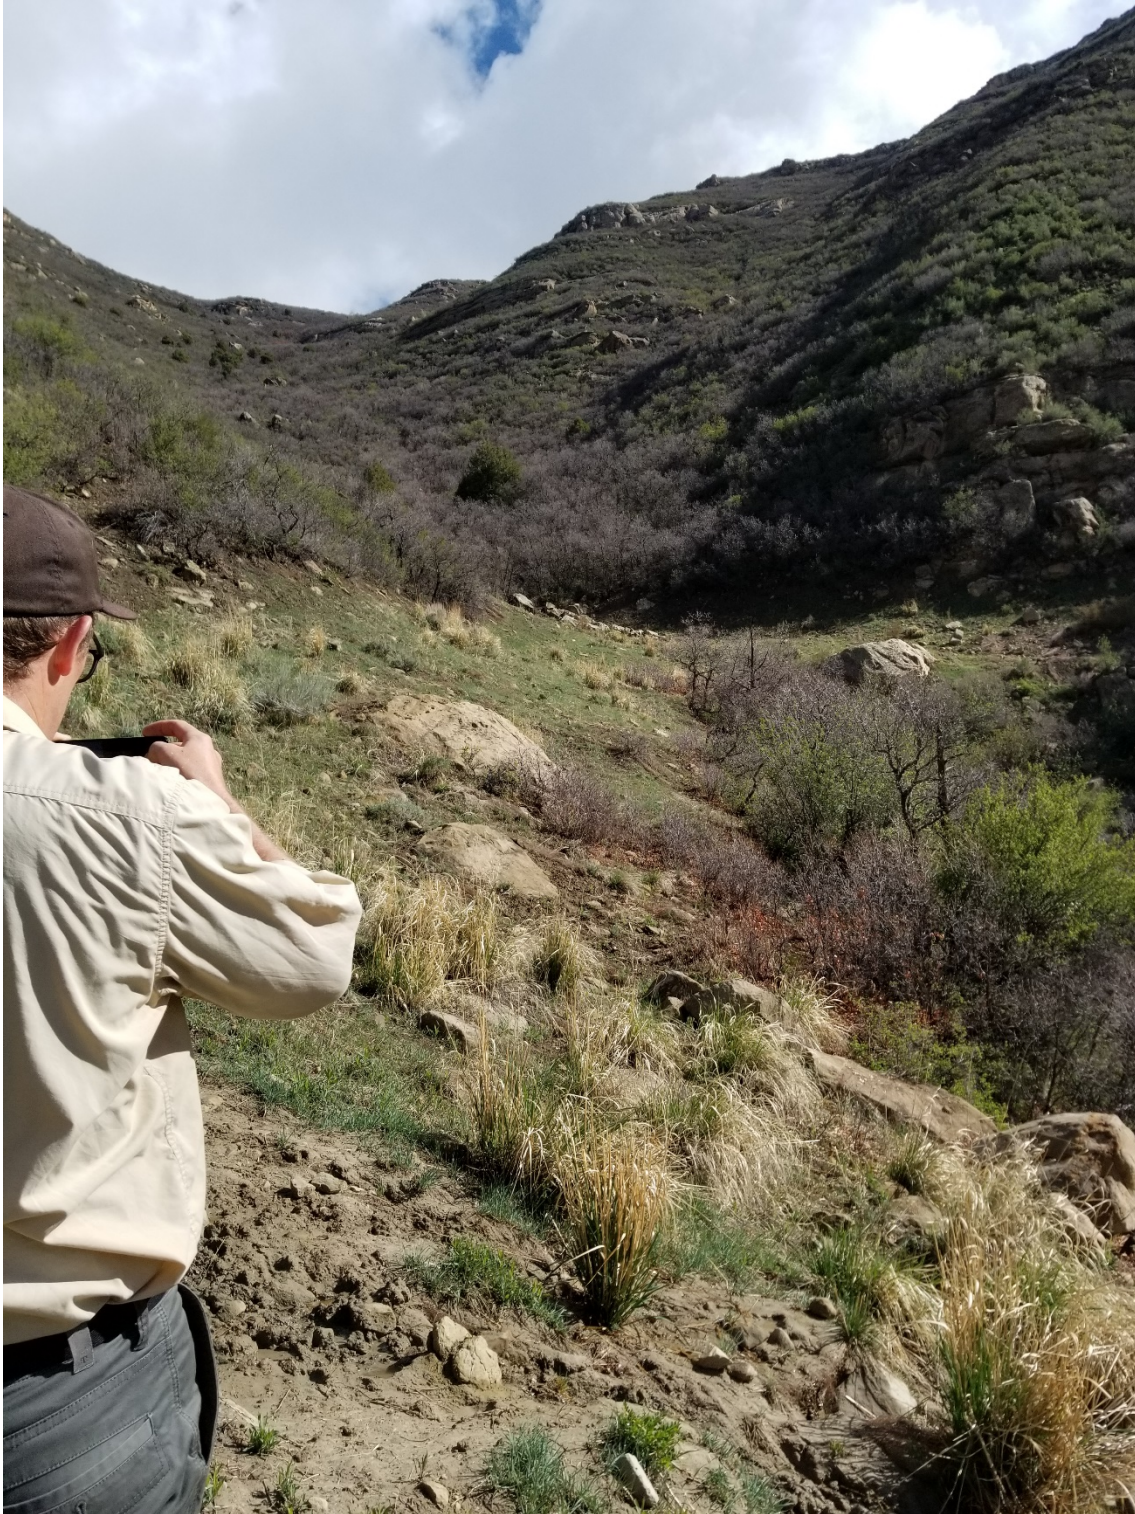
Figure 2 - The top of A Gulch reclamation. We walked its entire length and found it to be well vegetated and stable. A population of whitetop (a noxious weed) requires treatment.

- Treating the population(s) of white top in A Gulch;
- Treating the houndstongue at LW3-01 and LW4-03;
- Sowing an appropriate seed mix on the bare spots at LW9-02; and
- Treating the patches of houndstongue and musk thistle along the road to LW10-04 (Figure 3).

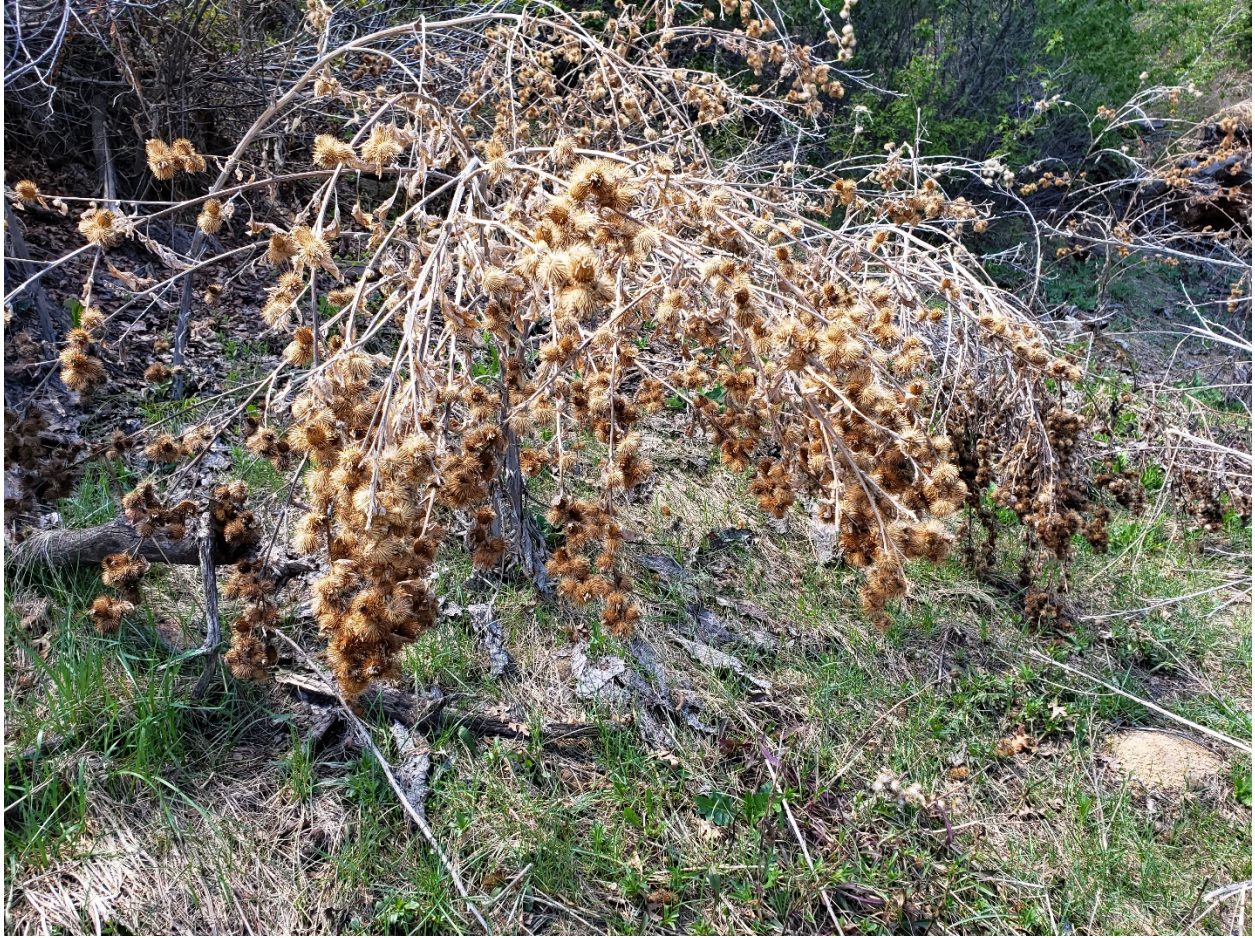
Figure 3 - A robust musk thistle population requires treatment along the road to LW10-04 (DRMS has the location). This is last year's growth; note the large amount of seed heads.
