MINERALS PROGRAM INSPECTION REPORT
PHONE: (303) 866-3567

| MINE NAME: Cortez Pit | MINE/PROSPECTING ID#: M-1976-059 | MINERAL: Sandstone | COUNTY: Montezuma |

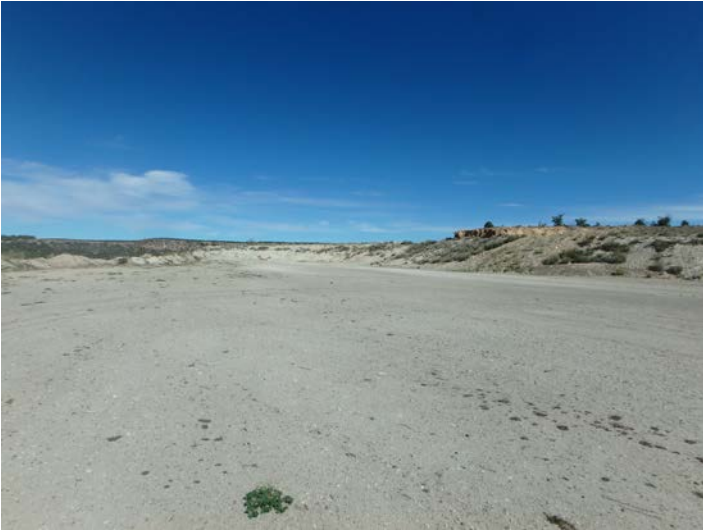
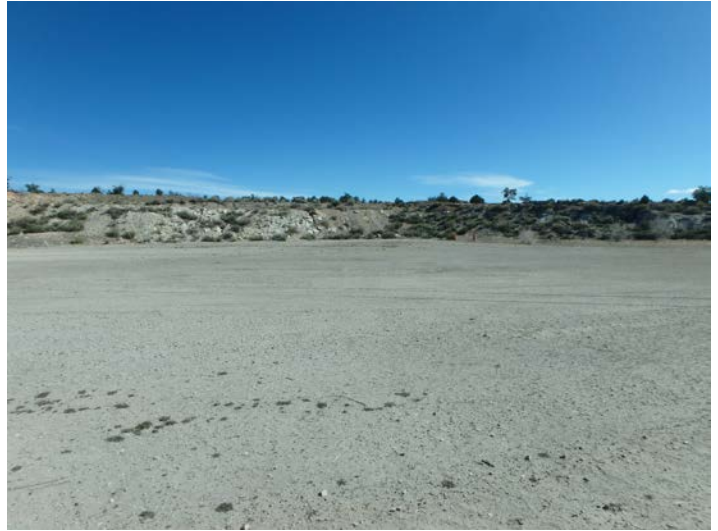
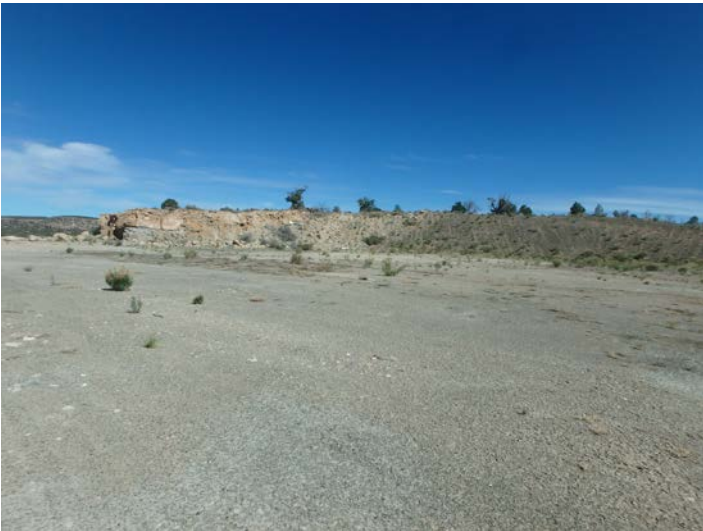
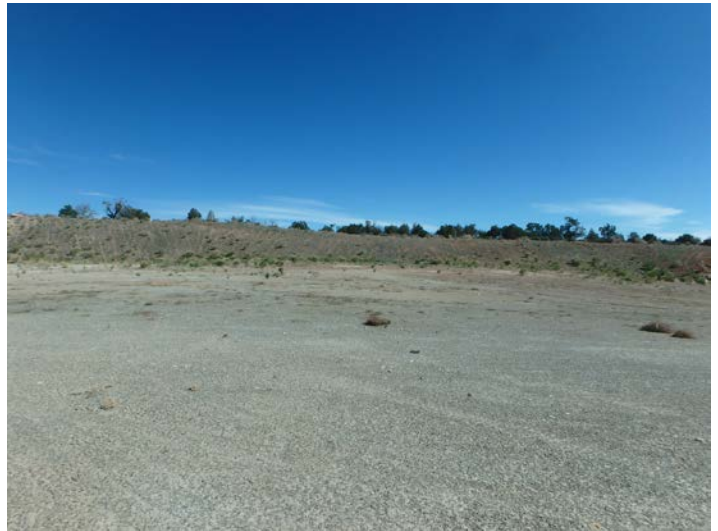
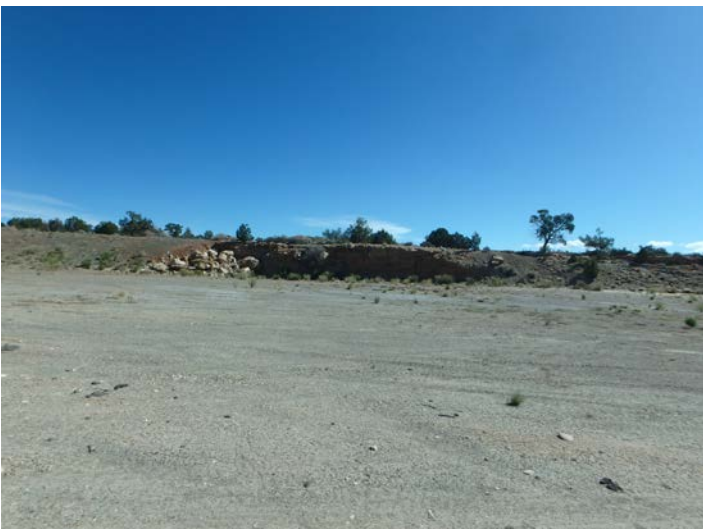
PHOTOGRAPHS

The site is in the final stages of reclamation, with limited re-vegetation of pit slopes remaining to be completed. The slopes that required grading have been mostly left at 2H:1V. Native vegetation is establishing itself on the slopes. No erosional or stability problems were noted.
