# MINERALS PROGRAM INSPECTION REPORT PHONE: (303) 866-3567

MINE NAME:		MINE/PROSPECTING ID#:	MINERAL:	COUNTY:
Walsenburg Gravel Pit		M-2000-092	Sand and gravel	Huerfano
INSPECTION TYPE:		INSPECTOR(S):	INSP. DATE:	INSP. TIME:
Monitoring		Patrick Lennberg	May 26, 2021	10:45
OPERATOR:		OPERATOR REPRESENTATIVE:	TYPE OF OPERATION:	
City of Walsenburg		Brian Lalander, Dustin Stambaugh	110c - Construction Limited Impact	
DE LOON FOR INCREGRACION		DON'D GAY GAY ARYON FRANCE	DOME ALCOHOLD	
REASON FOR INSPECTION:		BOND CALCULATION TYPE:	<b>BOND AMOUNT:</b>	
Normal I&E Program		None	\$0.00	
DATE OF COMPLAINT:		POST INSP. CONTACTS:	JOINT INSP. AGENCY:	
NA		None	None	
WEATHER:	INSPECTOR'S SIGNATURE:		SIGNATURE DATE:	
Cloudy	Par	trich 18	June 2, 2021

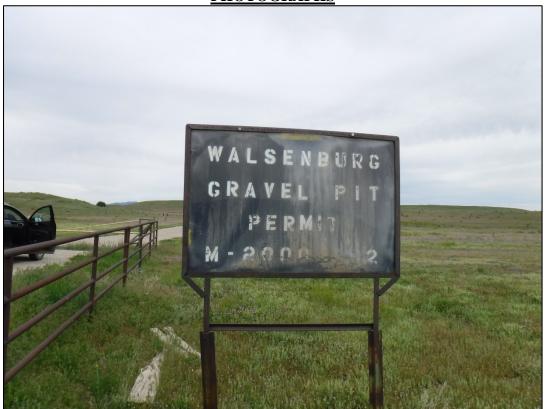
Photo 1: Mine sign at entrance off of Highway 10

The Walsenburg Gravel Pit is located in Huerfano County approximately 3 miles northeast of Walsenburg off of Highway 10. The mine is a 110 construction materials permit for 9.9 acres on property owned by the City of Walsenburg. The primary commodity that was mined at the site was gravel. The approved post-mining land use is rangeland and the land surrounding the pit is rangeland. A mine sign was posted at the mine entrance pursuant to Rule 3.1.12, although the mine sign is faded and almost illegible.

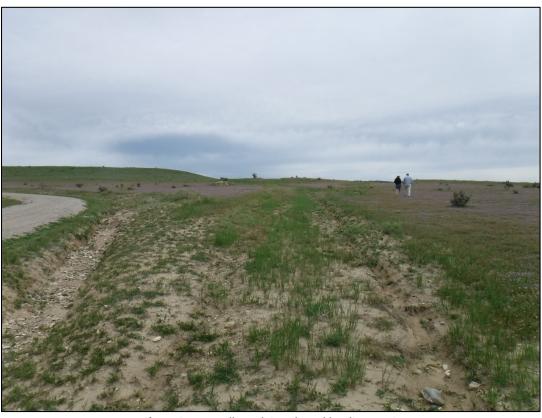
Photo 2: Naturally reclaimed road leading to pit

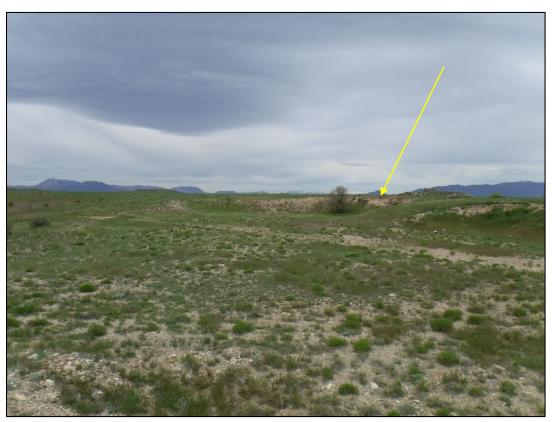
**Photo 3:** Looking west across the pit area from the east side, yellow arrow indicates highwall are needing grading, the tamarisk tree will also require removal

The city no longer wants to mine the pit and obtains all their gravel material from the county. The city would like to finish reclamation and terminate the permit. Successful reclamation at the site would consist of grading out one section of highwall to a 3H:1V slope of shallower using the remaining stockpiled material onsite. Care should be taken to minimize disturbance to the established vegetation. Once this slope has been graded the operator should seek permit release by completing the attached release form. Additionally, during regarding activities the tamarisk tree should be removed and the area graded to prevent ponding which could lead to additional tamarisk growth.

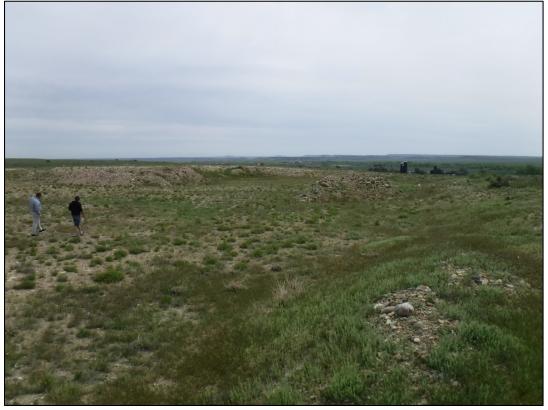
Photo 4: Looking east at naturally reclaimed areas of pit and minor stockpiles of material

The pit was not active at the time of the inspection and it does not appear that there has been any activity at the pit for several years. The pit is being naturally reclaimed with volunteer vegetation and some annual weeds.

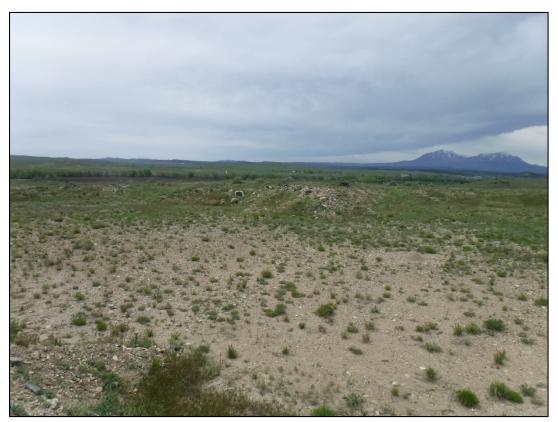
Photo 5: Looking south across the pit area

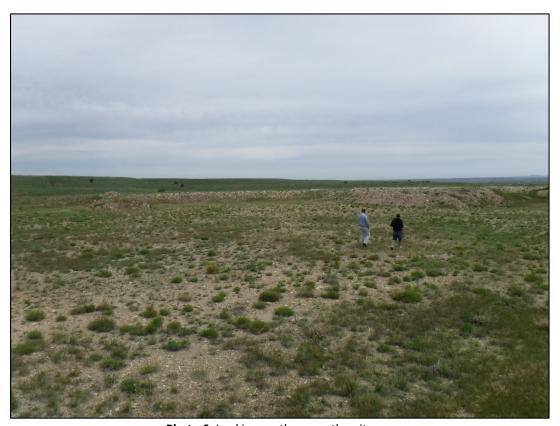
Photo 6: Looking north across the pit area

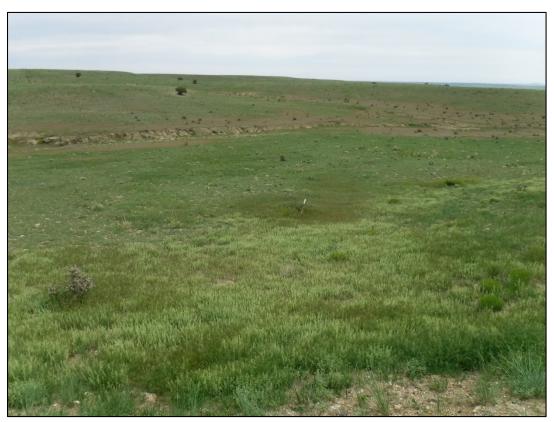
Photo 7: Typical permit boundary marker and vegetation conditions outside disturbed area

The Division was able to view some of permit boundary markers. All current mining appears to be within the permit boundaries.

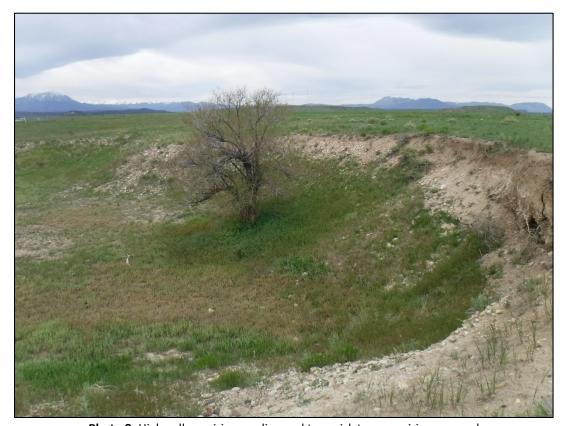
**Photo 8:** Highwall requiring grading and tamarisk tree requiring removal
