Inspection report for Keenesburg Mine

PERMIT INFORMATION

Permit Number: C-1981-028 Mine Name: Keenesburg Strip Mine Operator: Coors Energy Company Operator Address: Mr. Ben Moline PO Box 4030 Golden, CO 80402 **County:** Weld **Operation Type:** Surface **Permit Status:** Permanent Cessation **Ownership:** Private

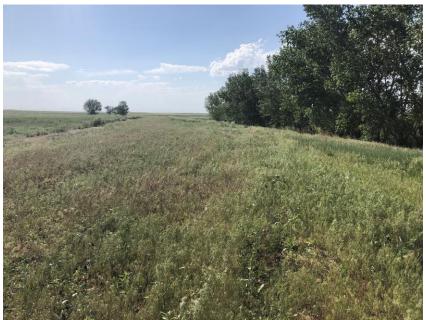
Cheat grass is the predominant species in some of the newly reclaimed areas, such as the reclaimed road adjacent to Sediment Pond 2. In other newly reclaimed areas (e.g., the reclaimed road west of the Dugout Pond), there is very little vegetation or young vegetation has been buried by wind-driven sand.

Cheat grass on reclaimed road south of Sediment Pond 2

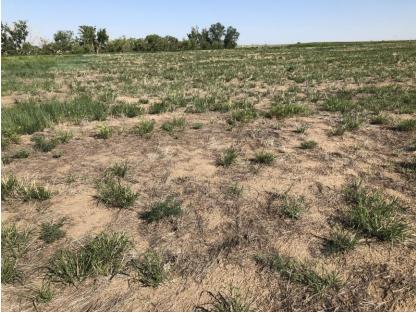
At Area 25, bare areas and dead vegetation was observed. The vegetation may be cheat grass that was intentionally killed by CEC or a consultant as a part of weed maintenance. This will be a subject of conversation between the Division and CEC.

Bare area and dead vegetation in Area 25

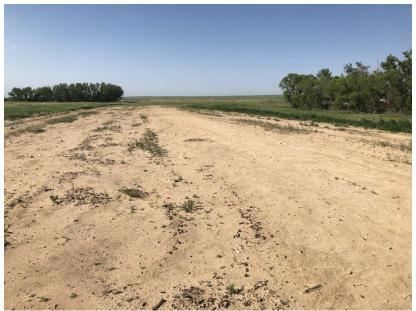
Reclaimed road west of the Dugout Pond

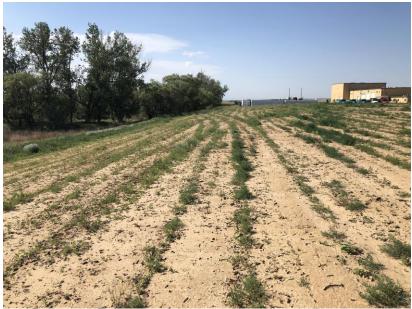
Looking north toward the Dugout Pond, with reclaimed topsand pile in foreground
