**MINERALS PROGRAM INSPECTION REPORT**  
**PHONE: (303) 866-3567**

<b>MINE NAME:</b> Salida Pit	<b>MINE/PROSPECTING ID#:</b> M-1985-091	<b>MINERAL:</b> Sand and gravel	<b>COUNTY:</b> Chaffee
<b>INSPECTION TYPE:</b> Monitoring	<b>INSPECTOR(S):</b> Dustin Czapla	<b>INSP. DATE:</b> May 25, 2021	<b>INSP. TIME:</b> 07:30
<b>OPERATOR:</b> Chaffee County	<b>OPERATOR REPRESENTATIVE:</b>	<b>TYPE OF OPERATION:</b> 112c - Construction Regular Operation	
<b>REASON FOR INSPECTION:</b> Normal I&E Program	<b>BOND CALCULATION TYPE:</b> None	<b>BOND AMOUNT:</b> No Bond Held	
<b>DATE OF COMPLAINT:</b> NA	<b>POST INSP. CONTACTS:</b> None	<b>JOINT INSP. AGENCY:</b> None	
<b>WEATHER:</b> Clear	<b>INSPECTOR'S SIGNATURE:</b>

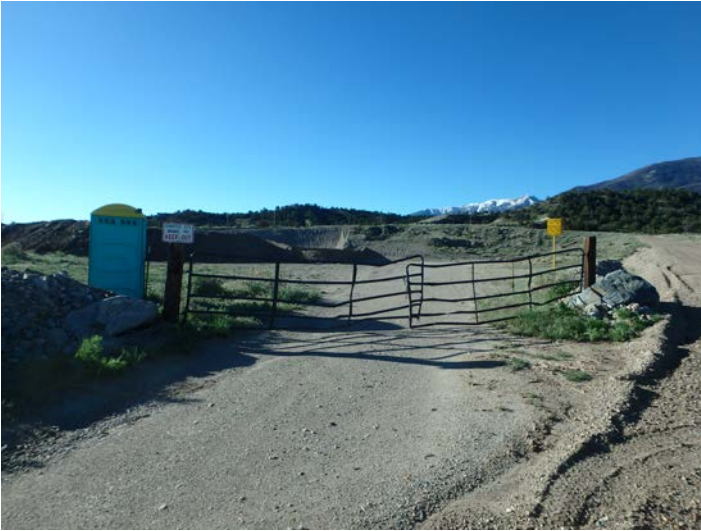
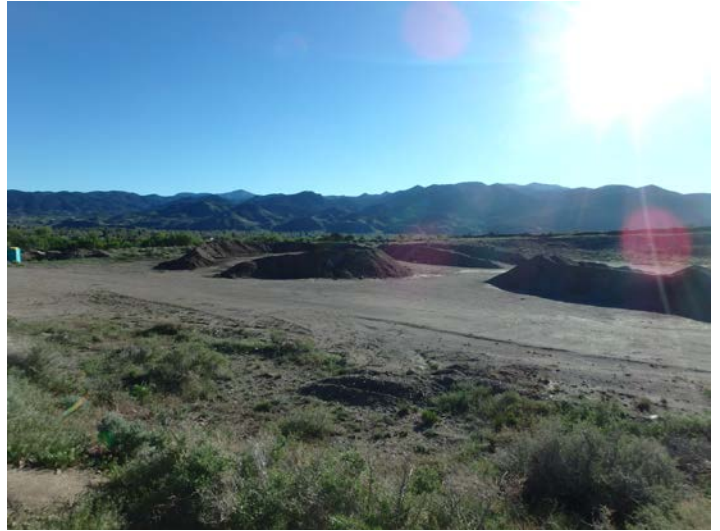
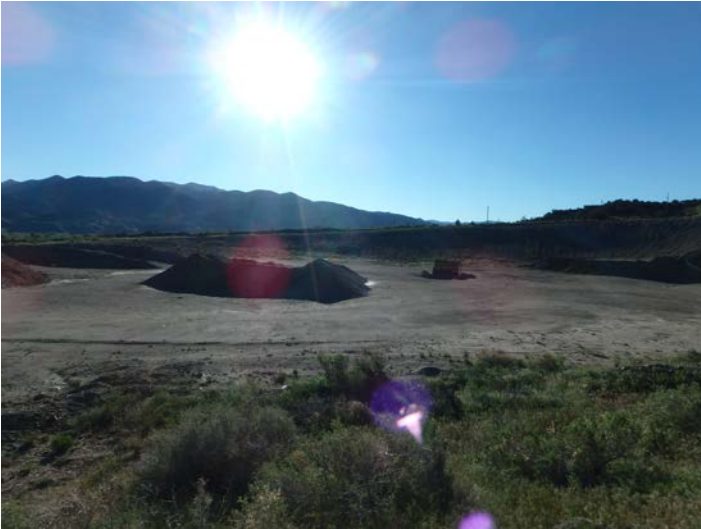
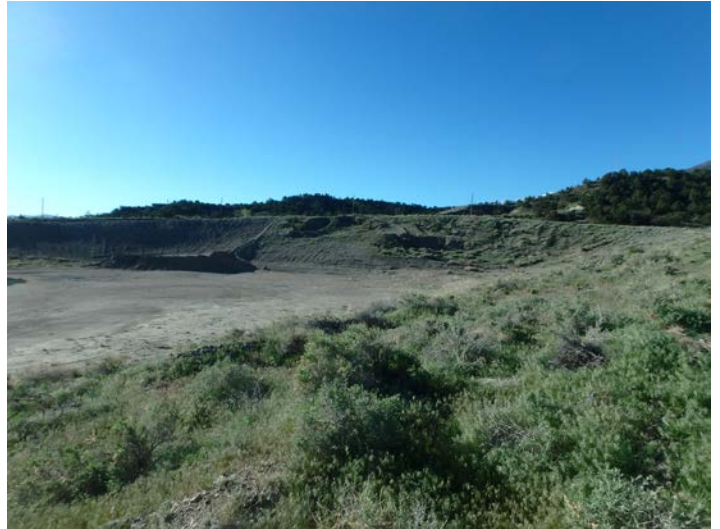
## **PHOTOGRAPHS**

The area disturbed by the operation is still contained within the original 9.72 acre pit located on the west side of the drainage. Slopes around the pit have been graded to a stable configuration and vegetation is well established. Topsoil and materials stockpiles are located on the pit floor. Slopes around the pit are grade to approximately 2H:1V.

The site is orderly and well-kempt. No problems or violations were noted during this inspection.
