MINERALS PROGRAM INSPECTION REPORT
PHONE: (303) 866-3567

MINE NAME: Reichert Pit	MINE/PROSPECTING ID#: M-2000-034	MINERAL: Sand and gravel	COUNTY: Larimer
INSPECTION TYPE: Surety Release Inspection	INSPECTOR(S): Brock Bowles	INSP. DATE: June 3, 2021	INSP. TIME: 09:00
OPERATOR: Martin Marietta Materials, Inc.	OPERATOR REPRESENTATIVE: Julie Mikulas	TYPE OF OPERATION: 112c - Construction Regular Operation	
REASON FOR INSPECTION: Surety Release Requested	BOND CALCULATION TYPE: None	BOND AMOUNT: \$354,733.00	
DATE OF COMPLAINT: NA	POST INSP. CONTACTS: None	JOINT INSP. AGENCY: None	
WEATHER: Clear	INSPECTOR'S SIGNATURE:

OBSERVATIONS

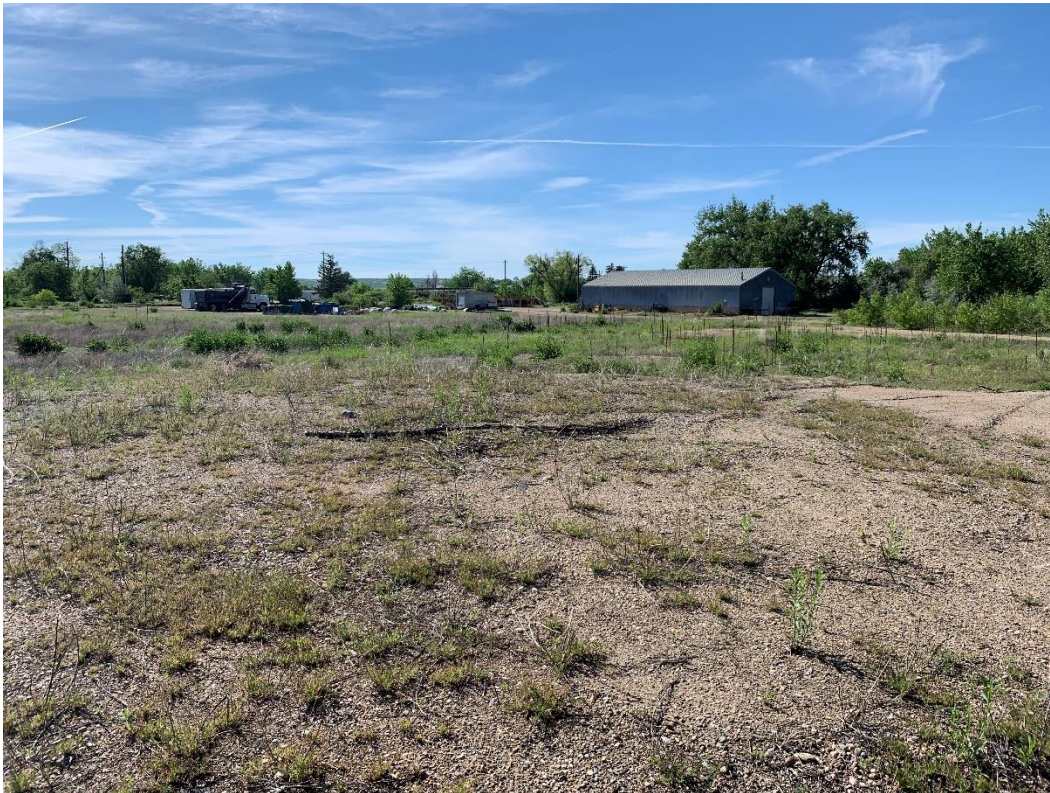
Photo 1 – Southeast section of permit area

The southeast section has a large metal building (approx. 100' x 50'), several vehicles, trailers and various other equipment scattered throughout the area (photo 1). The equipment seen on-site was non-mining related equipment.

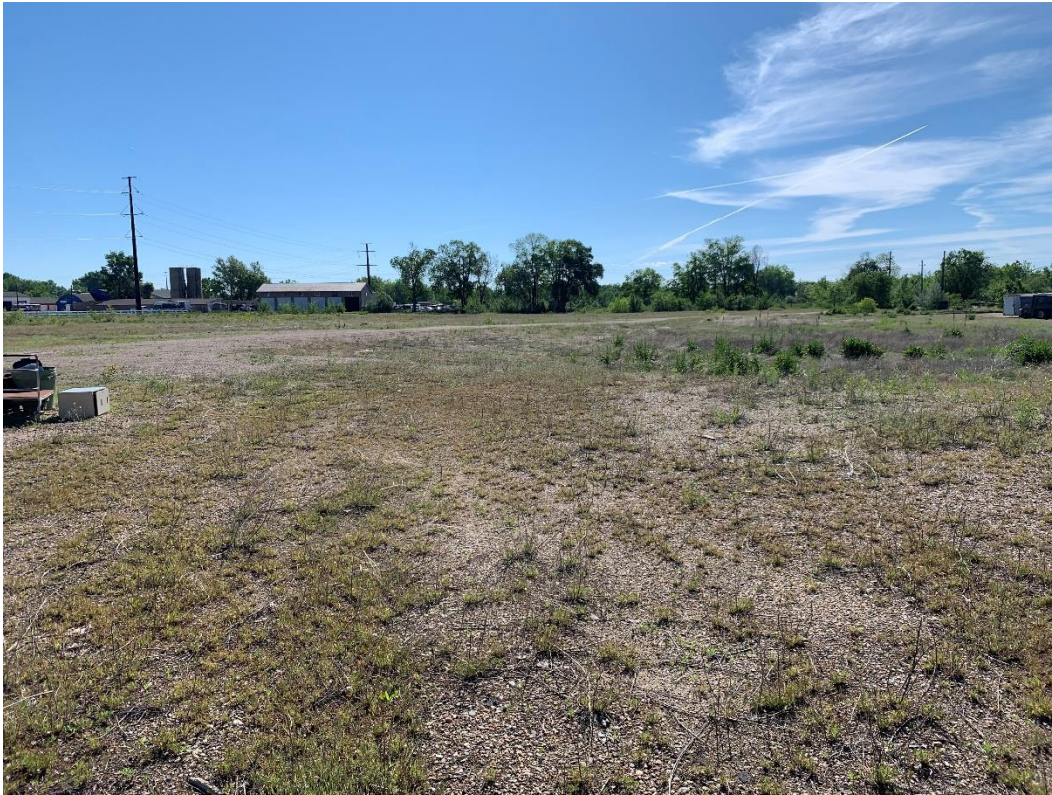
Photo 2 – Northeast section of permit area

The northeast section is mostly open and flat with an old storage shed and a couple of truck/trailers. This area was the stockpile storage area for the former concrete plant. The soil in these areas is a sand and gravel mixture. The vegetation in this area is sparse with some volunteer grasses and a few weeds (photo 2).

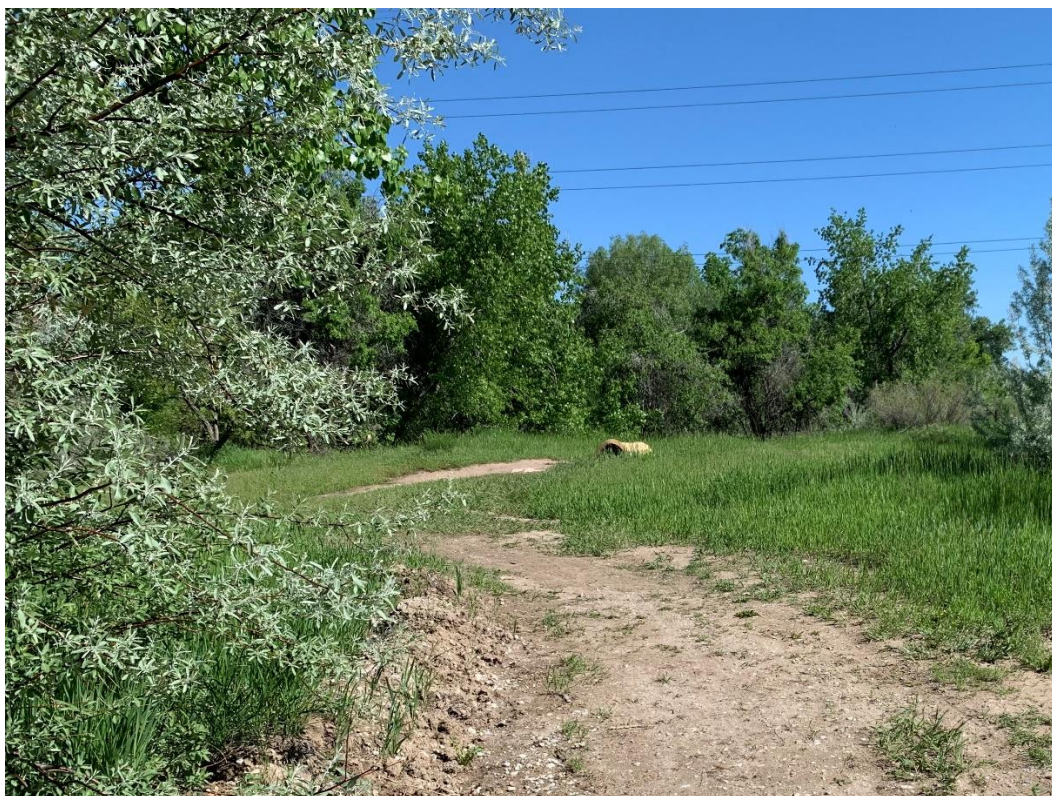
Photo 3 – Trees along the Big Thompson River

The southern and western permit boundary follows the Big Thompson River. The areas along the river have large mature trees with a dense understory of shrubs and grasses (photo 3).

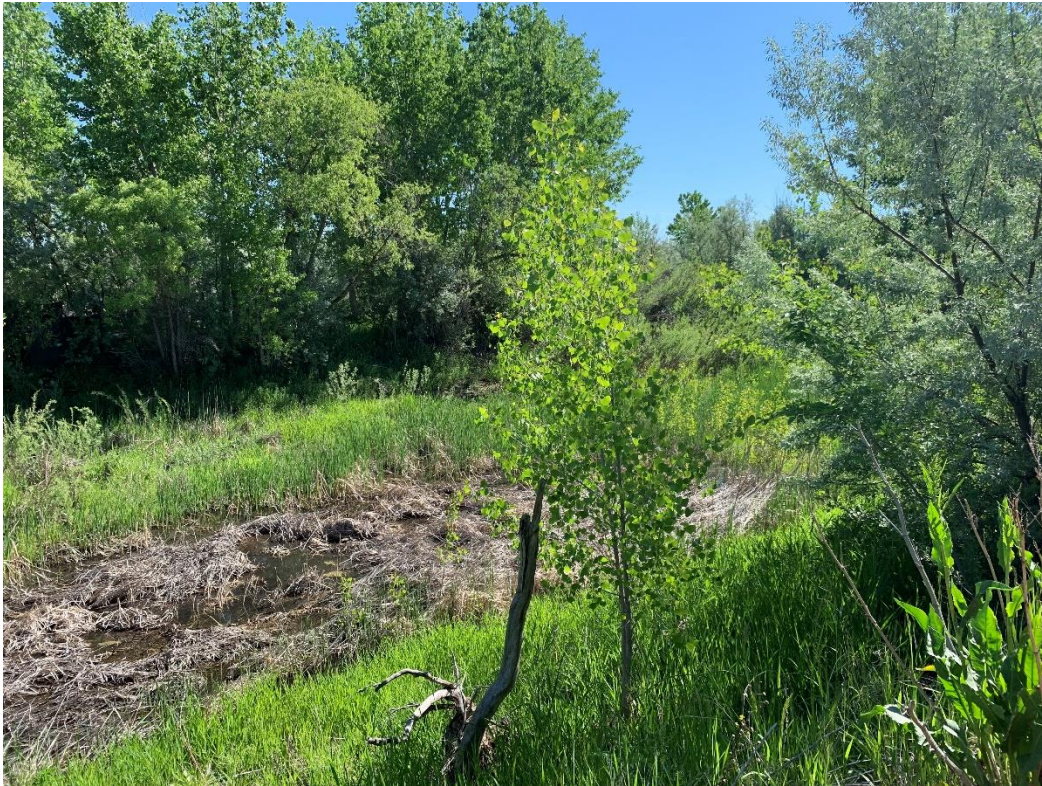
Photo 4 – Excavated pit area labeled as Truck Wash on Pre-Mining conditions map

The central permit area contained the pond to the north and the excavated truck wash/wetland to the south. These areas contained large trees and a dense understory of shrubs. The bottom of the truck wash area had a dense stand of tall grasses (photo 4).

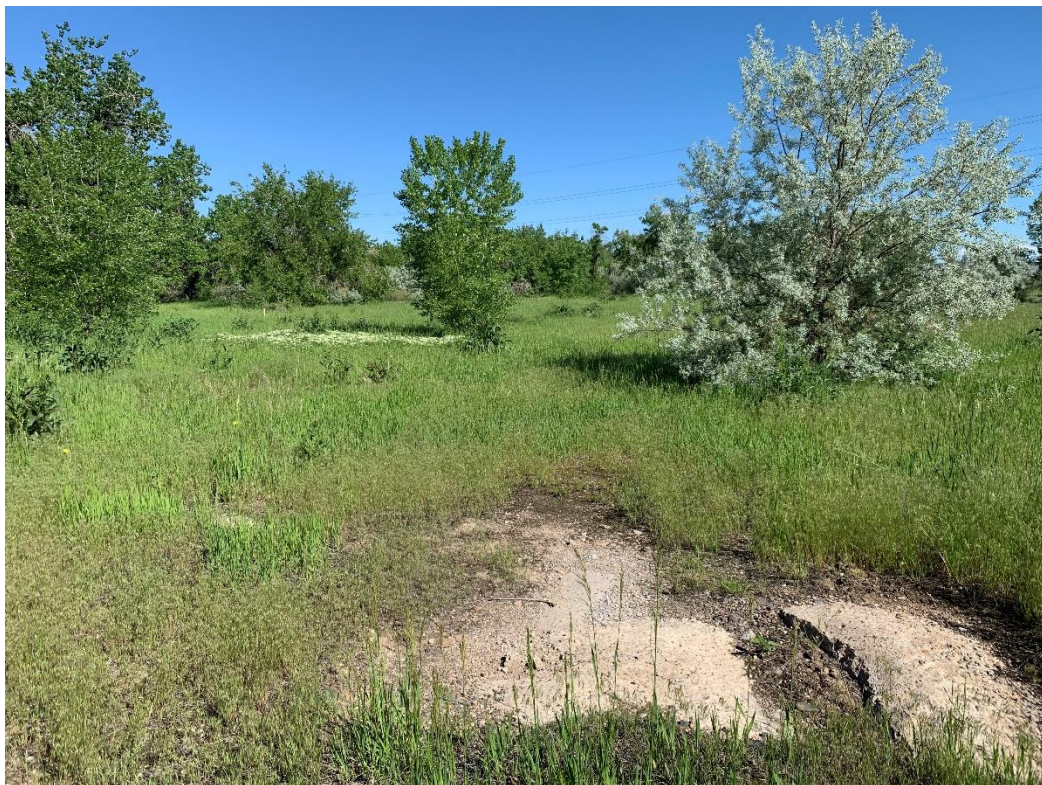
The western section had some scattered trees and shrubs. Grass covered most of the ground (photo 5). A patch of whitetop is in the middle of this area. MMM has scheduled the whitetop to be treated. Several homeless tents were seen in this part of the site.

Photo 5- Western Section, patch of whitetop on middle of photo
