**Re: Permit M-1977-341, Submittal of Annual Water Monitoring Report – Henderson Operations Groundwater Management Plan**

## **2020 Annual Water Monitoring Report Division of Reclamation, Mining and Safety**

Climax Molybdenum Company  
Henderson Operations  
P.O. Box 68  
Empire, CO 80438

**May 2021**

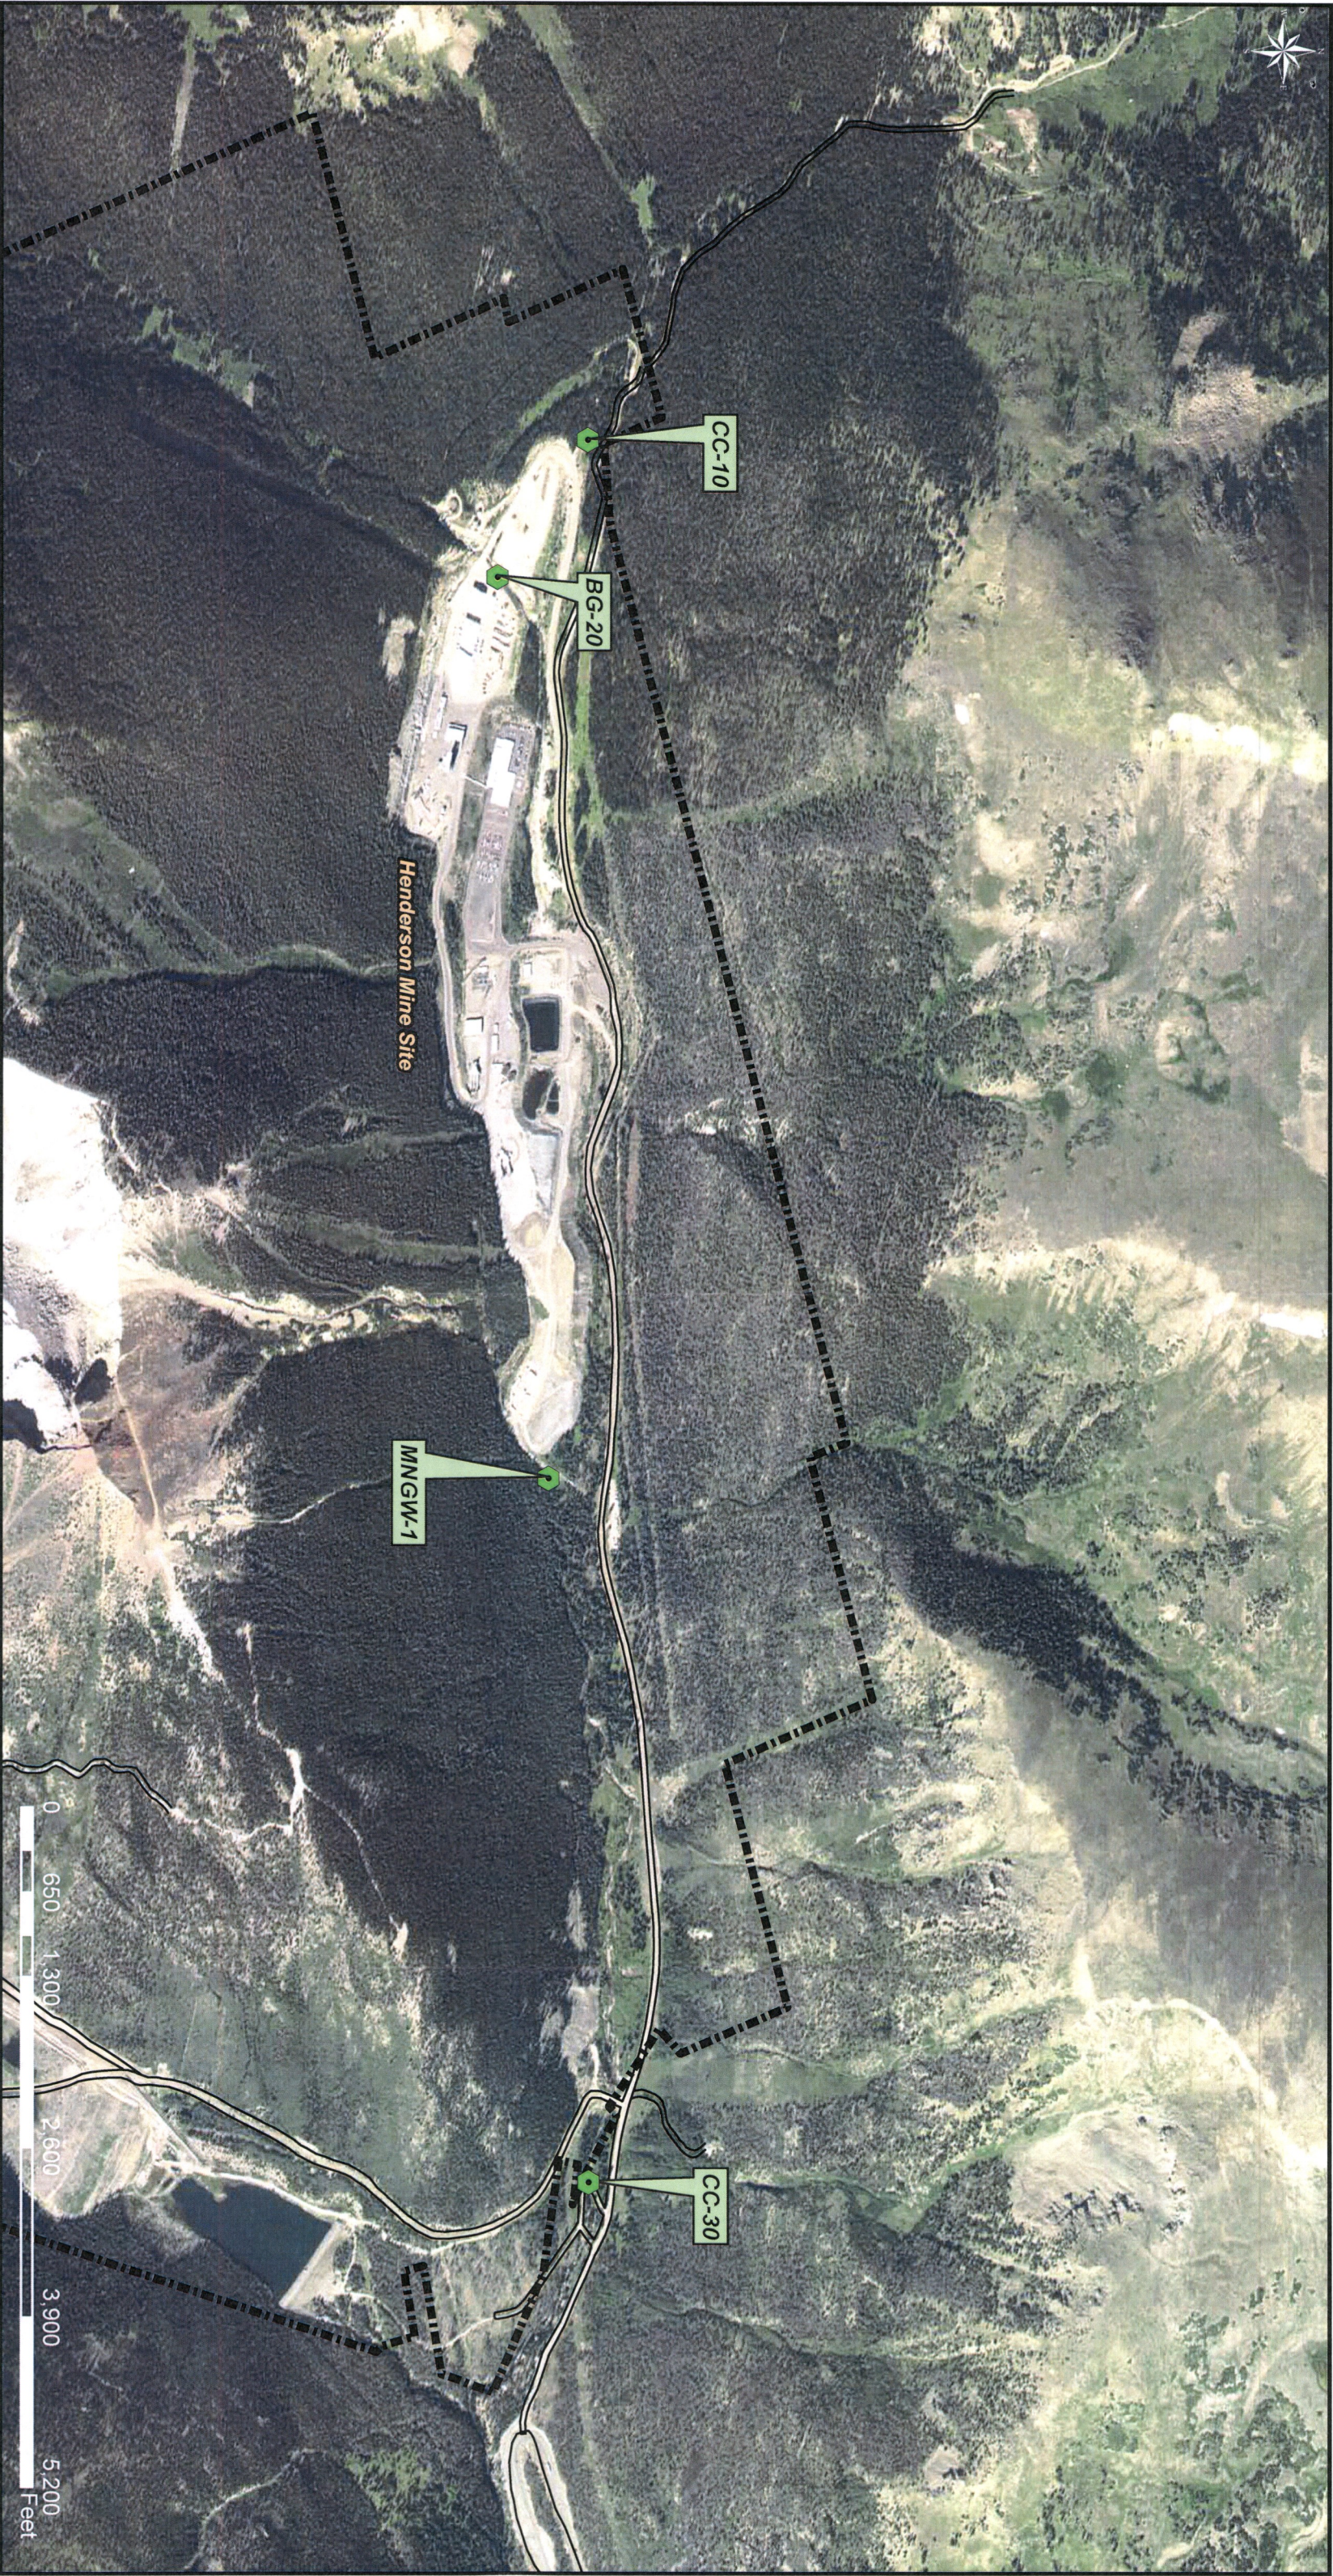
Figure 1, Monitoring Locations, Henderson Mine

To provide a better data set for trending purposes, the 2020 water quality data has been appended to the previous six years of data. This data can be seen in trend evaluation graphs as well as in the data tables. Note that for trending the analytical data, results reported below the laboratory detection limit are shown as a value of zero. All monitoring locations are depicted in Figures 1 and 2.

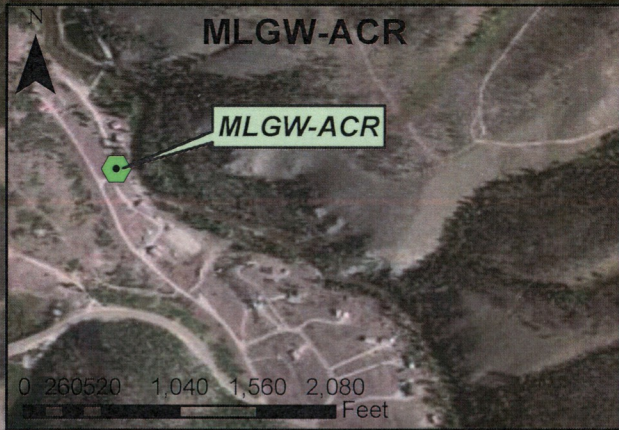
MAP FEATURES	
	Property Boundary
	Monitoring Location

REVISION	DATE
Initial Release	05/22/2013
Added MLGW-15, MLGW-17, and MLGW-ACR	05/29/2014
 3700 E. 41st Ave. Denver, CO 80216-6504 303-289-7520 www.aquionix.com

MLGW-15 is a deeper well paired with MLGW-7 located just downgradient of 1-Dam. Similar to MLGW-7, slight decreasing trends are observed for specific conductivity and sulfate.

MLGW-17 is a deep alluvial well located downgradient of 3-Dam. Although a trend of increasing dissolved iron and zinc concentrations was noted previously, most of the 2019 and all of the 2020 results indicate an overall decrease in concentrations.

Starting in the third trimester of 2019, changes to the MLGW-ACR sampling method likely caused disturbances to the solid-wall well construction indicated by the increase in iron concentrations and established the need for the well to undergo rehabilitation. The current results presented are not believed to be representative of background water quality. Well rehabilitation will be conducted.

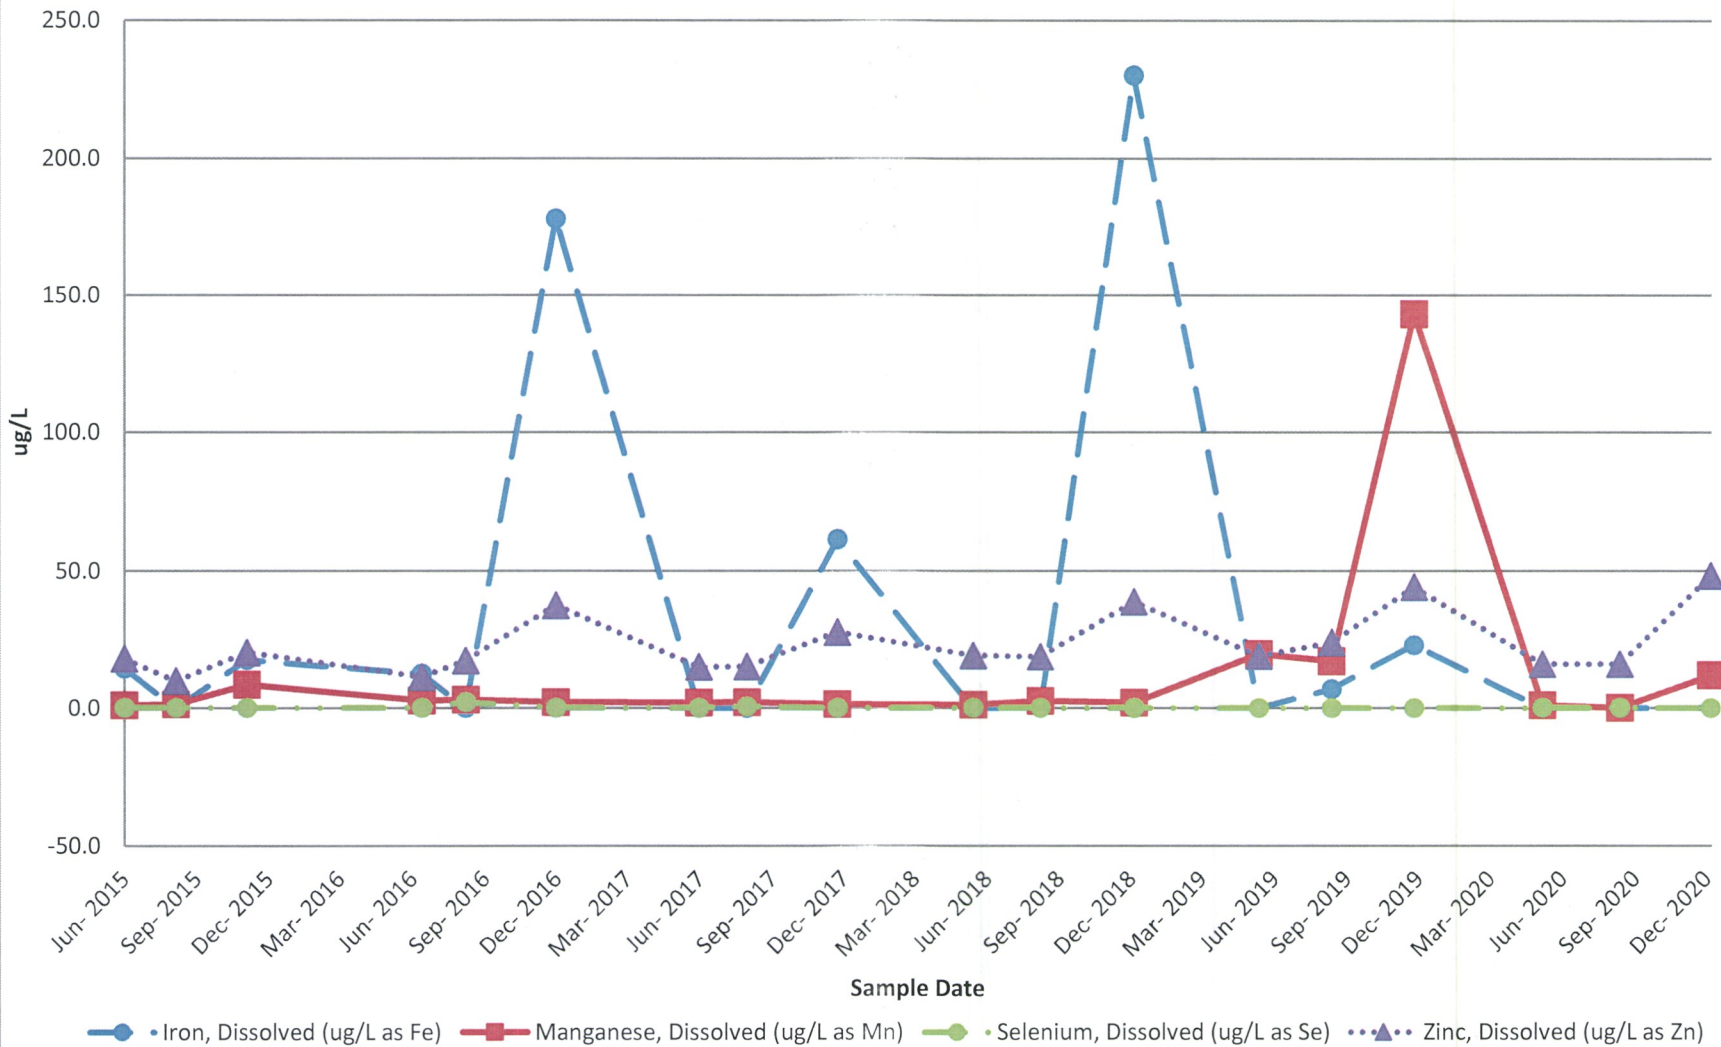
**Trend Evaluation 1**  
**MNGW - 1: Fe, Mn, Se, and Zn**  
**Henderson Mine**

Slightly increasing trends in dissolved zinc, continued to be monitored and those trends were confirmed with the 2020 data as well. While not significant, and with respect to dissolved zinc well below the NPL, this trend will continue to be monitored.

**Note: Concentrations below the laboratory reporting limit have been plotted as "0" on the above trend evaluation.**

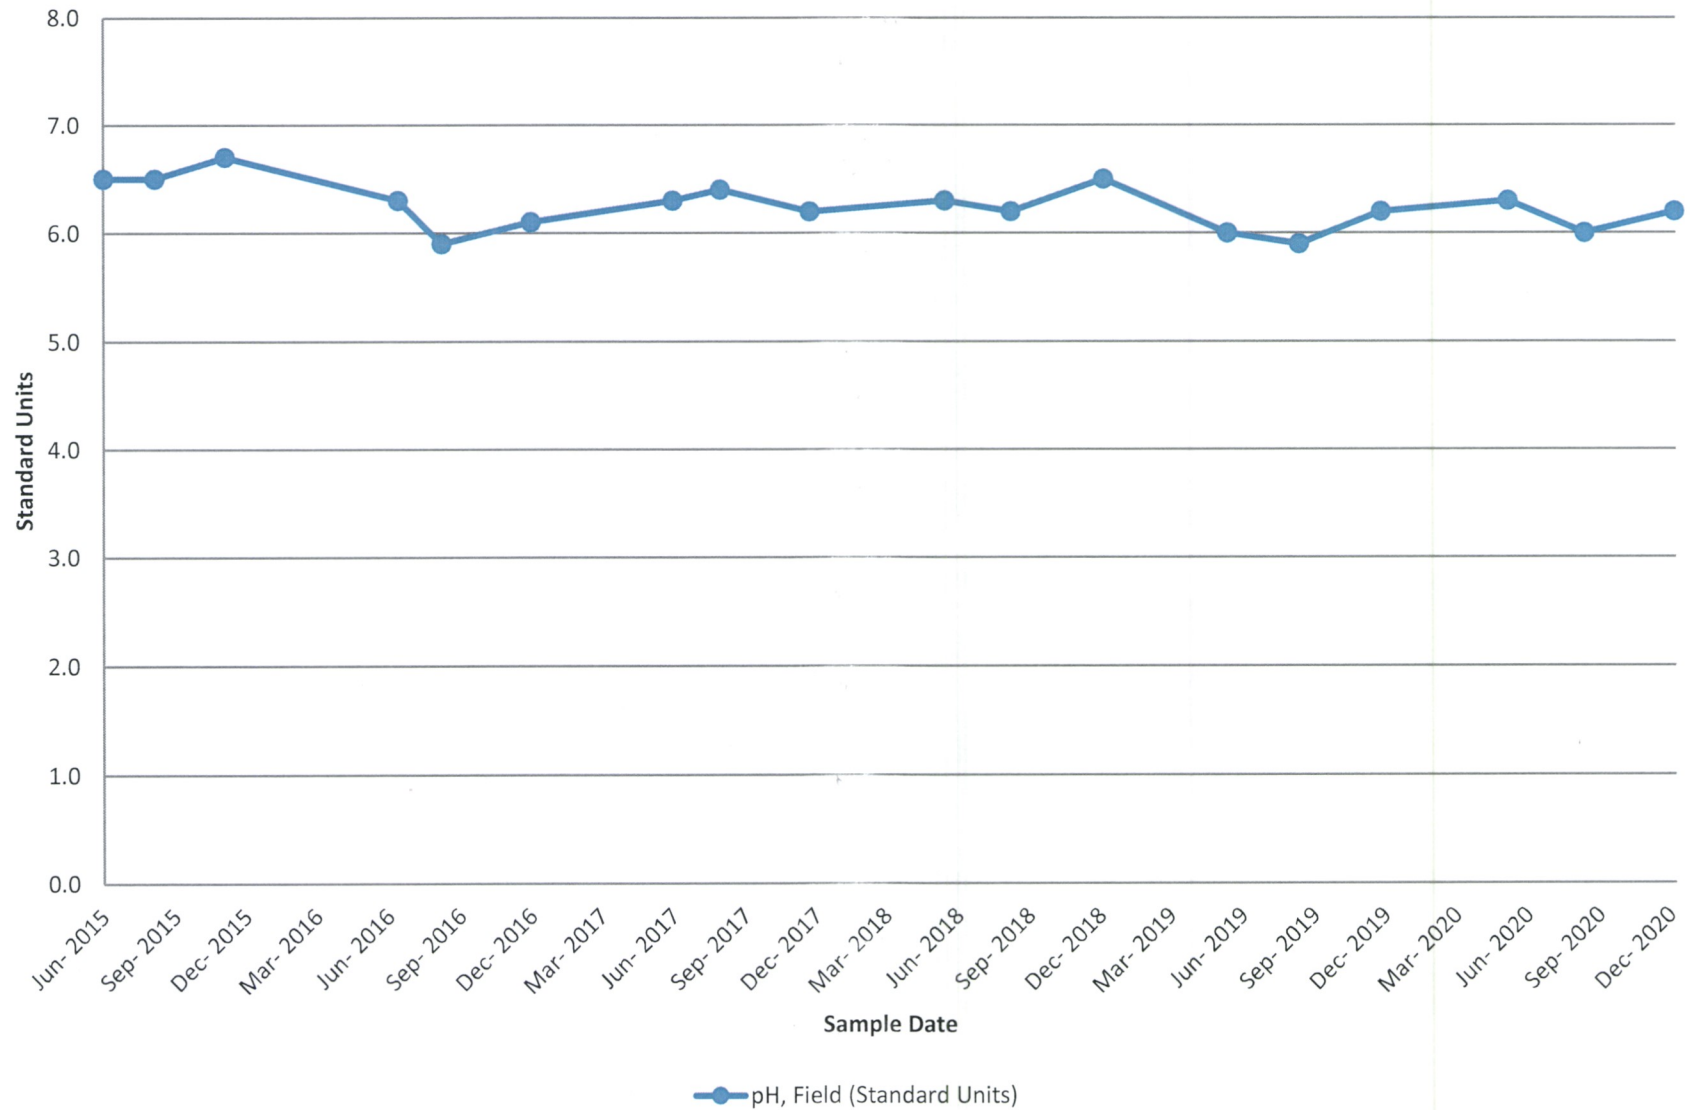
Trend Evaluation 3  
MNGW - 1: pH  
Henderson Mine

MNGW-1 is a shallow alluvial well located downgradient of the Henderson Mine operations. Values of pH below the established NPLs were seen during monitoring events in 2020: 6.3 standard units (s.u.) on 5/14/20, 6.0 s.u. on 8/20/20, and 6.2 s.u. on 12/14/20. In accordance with the GWMP, Henderson has provided notification to the DRMS upon reoccurring pH exceedances for POC wells, when necessary.

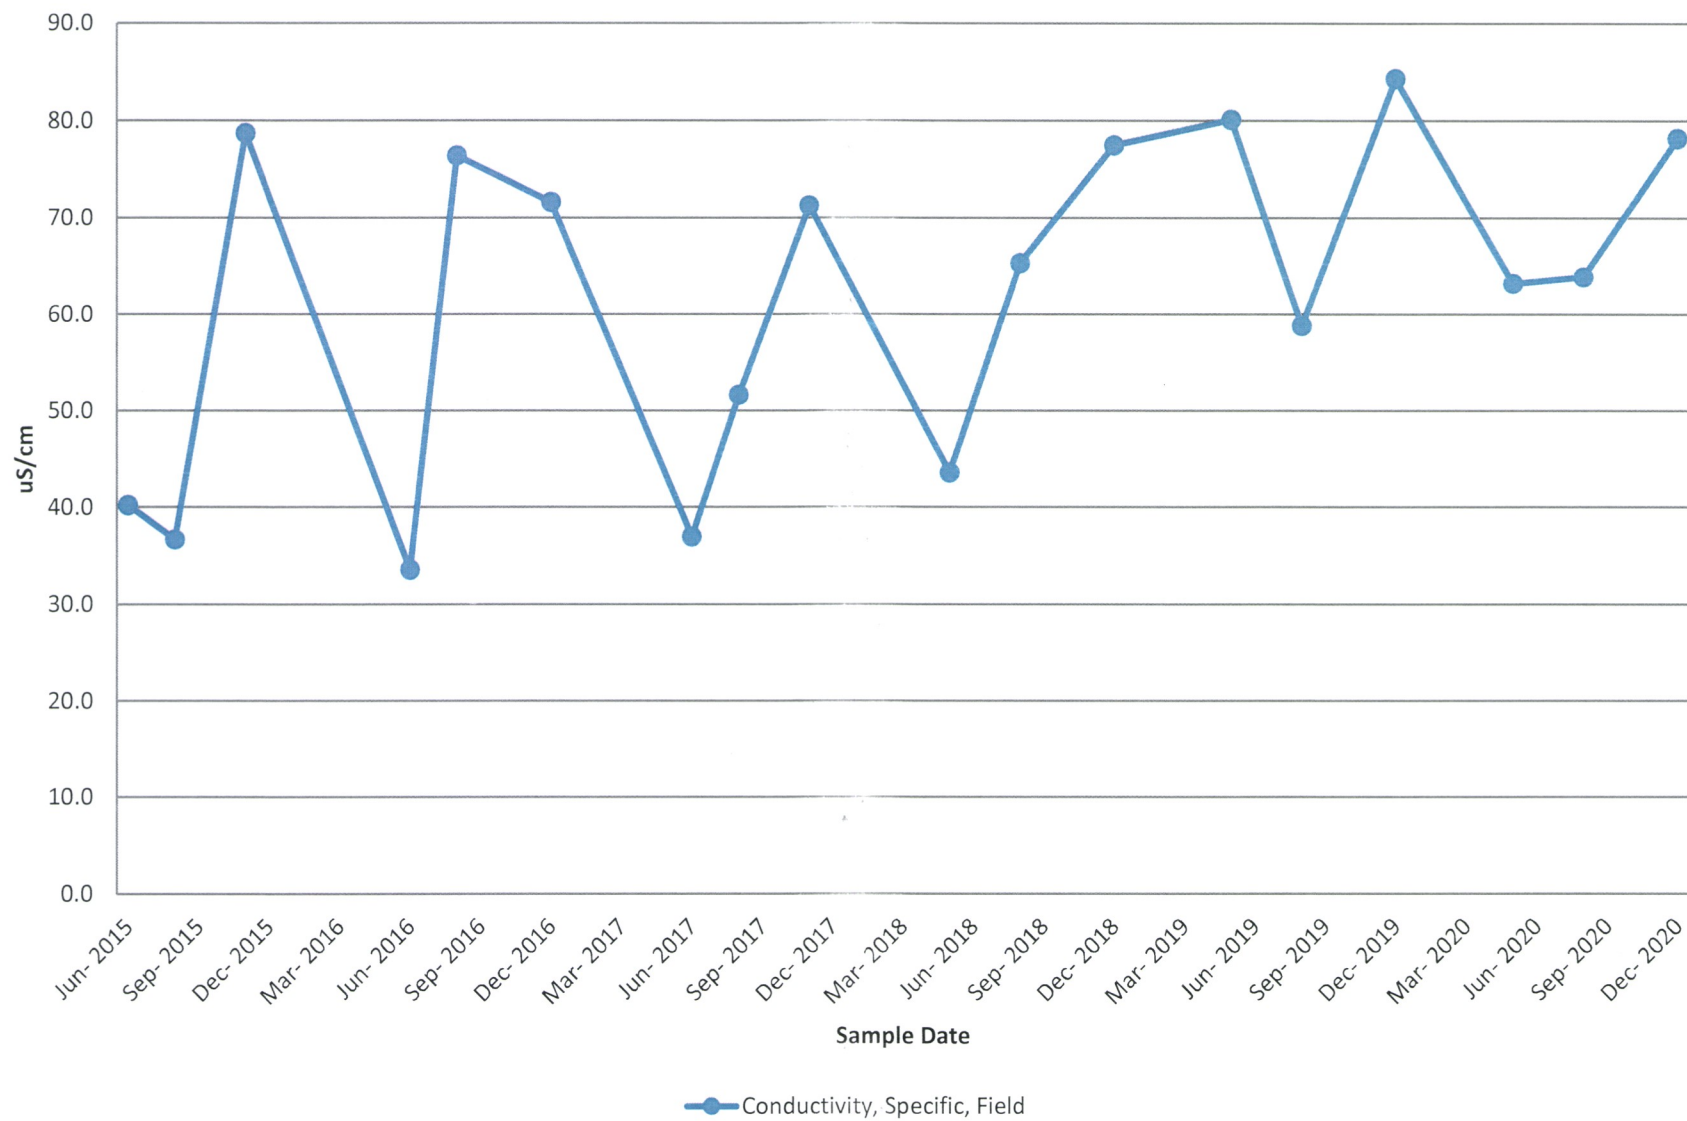
Trend Evaluation 6  
BG - 20: Specific Conductivity  
Henderson Mine

BG-20 is located upgradient of the Henderson Mine in Butler Gulch and serves as an indicator of background surface water quality. 2020 results indicate a continued increasing trend developing in specific conductivity and sulfate. While the 2020 results for specific conductivity remain within historical ranges, the sulfate result from the third trimester indicates an increase relative to historical data over the past six years. It should be noted that the difference between this result and the next highest value over the past six years is only 5.4 mg/L and the scale exaggerates this difference. Nevertheless, this will continue to be monitored following future Triannual events.

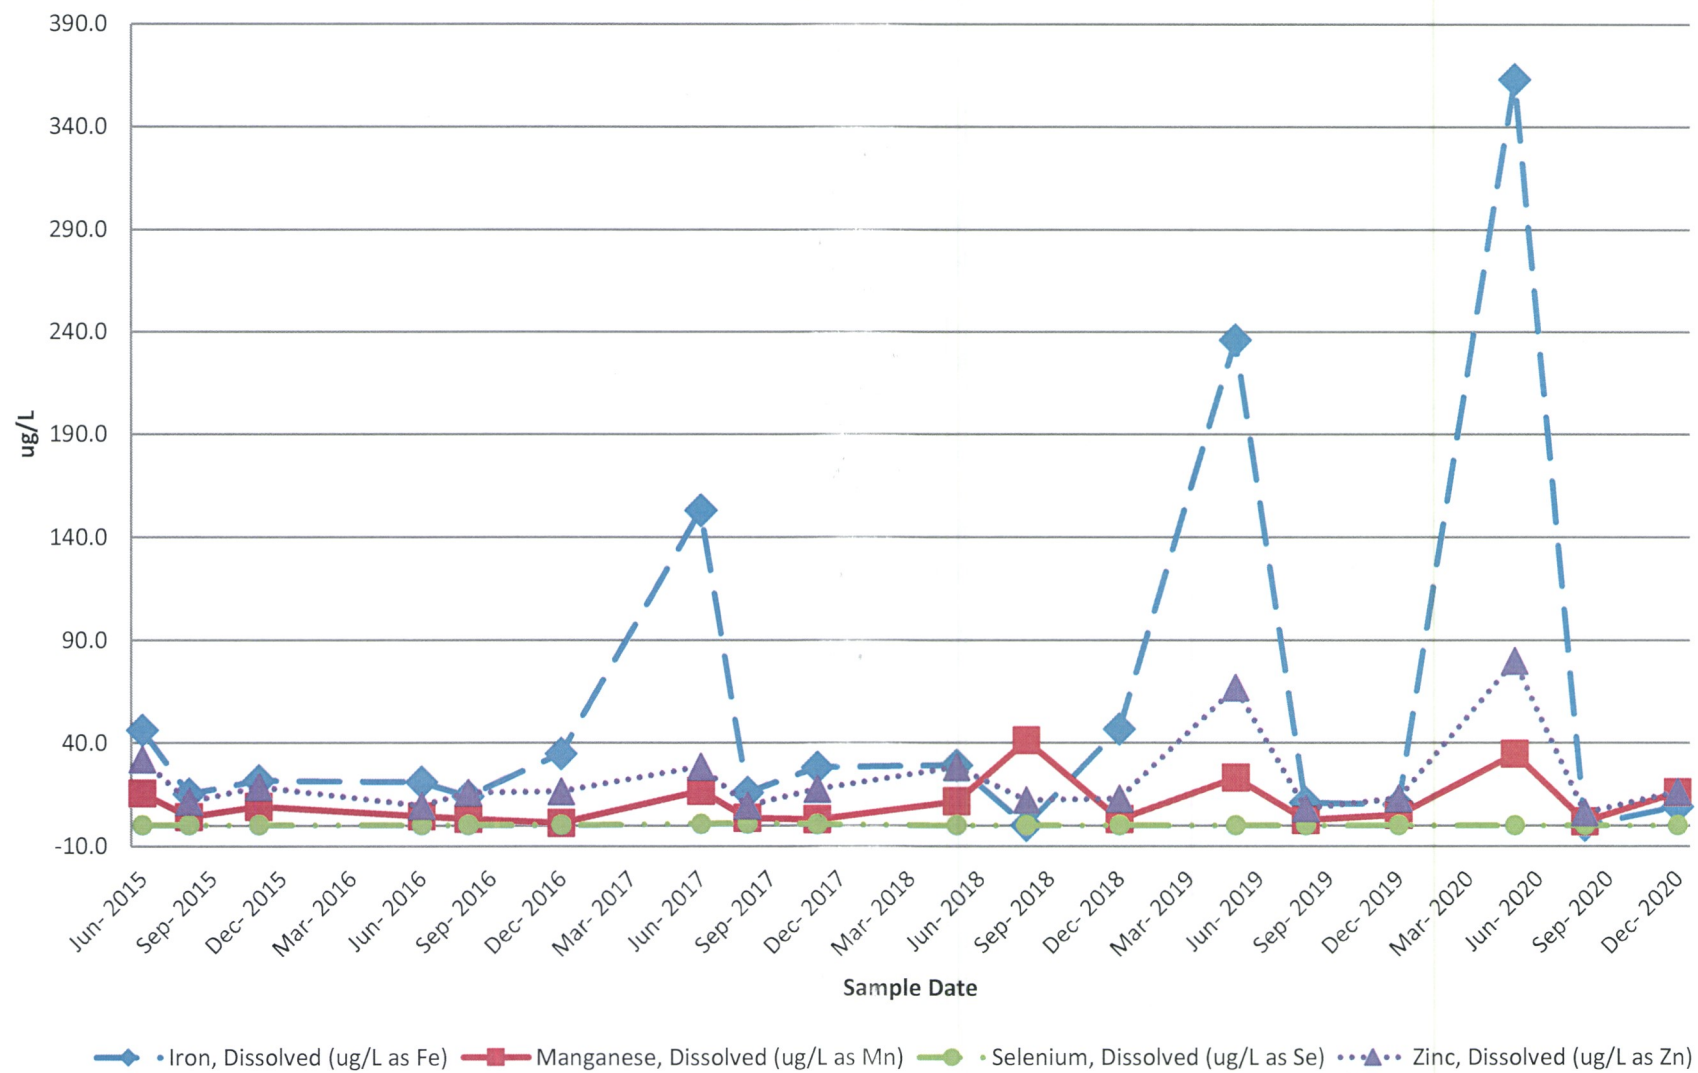
**Trend Evaluation 9**  
**CC - 10: Fe, Mn, Se, and Zn**  
**Henderson Mine**

CC-10 is also located upgradient of the Henderson Mine in the West Fork of Clear Creek and serves as another indicator of background surface water quality. An increase in dissolved iron and zinc concentrations during the spring run-off periods is observed and will continue to be monitored. Like BG-20, specific conductivity and sulfate concentrations indicate slightly increasing trends and will continue to be monitored.

**Note: Concentrations below the laboratory reporting limit have been plotted as "0" on the above trend evaluation**

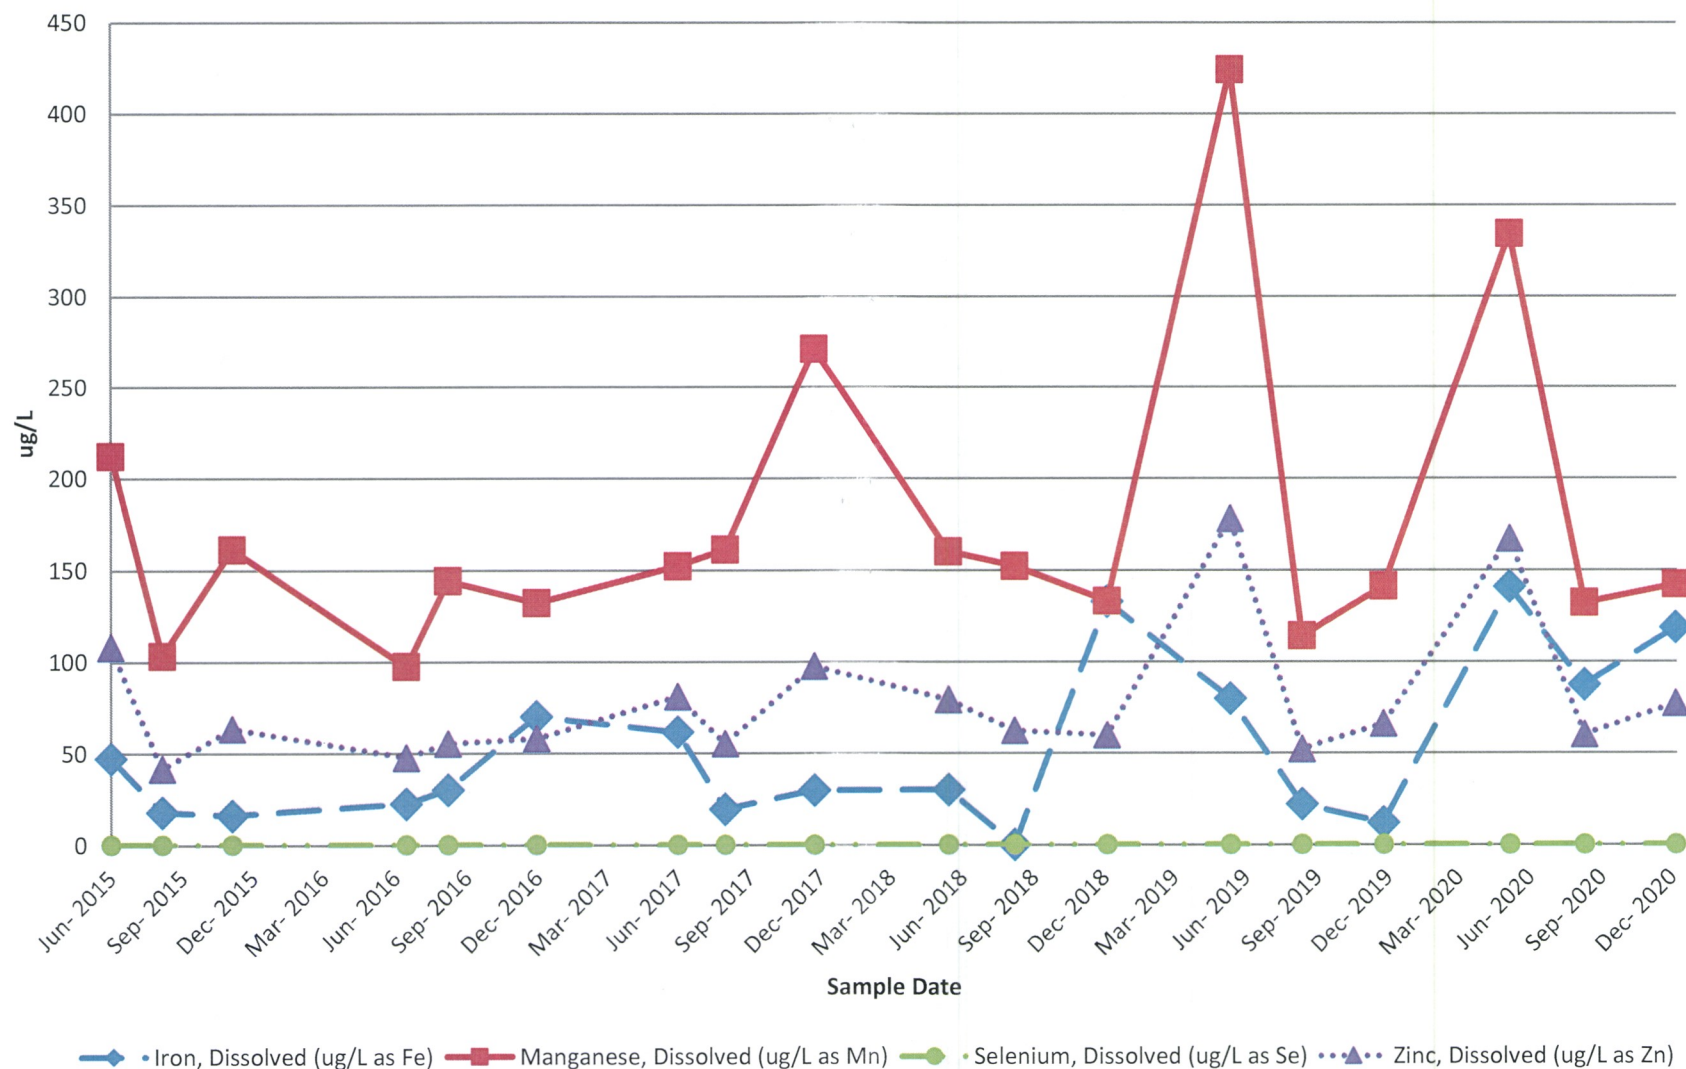
**Trend Evaluation 13**  
**CC - 30: Fe, Mn, Se, and Zn**  
**Henderson Mine**

CC-30 is located downgradient of the Henderson Mine in the West Fork of Clear Creek. Dissolved manganese and dissolved zinc on 5/20/19 were determined to be outliers using Rosner's statistical method. With the inclusion of 2020 results, there appears to be a developing trend of increasing concentrations of dissolved iron, manganese, and zinc. This trend will continue to be monitored in addition to performing statistical analyses following future sampling events.

**Note: Concentrations below the laboratory reporting limit have been plotted as "0" on the above trend evaluation**

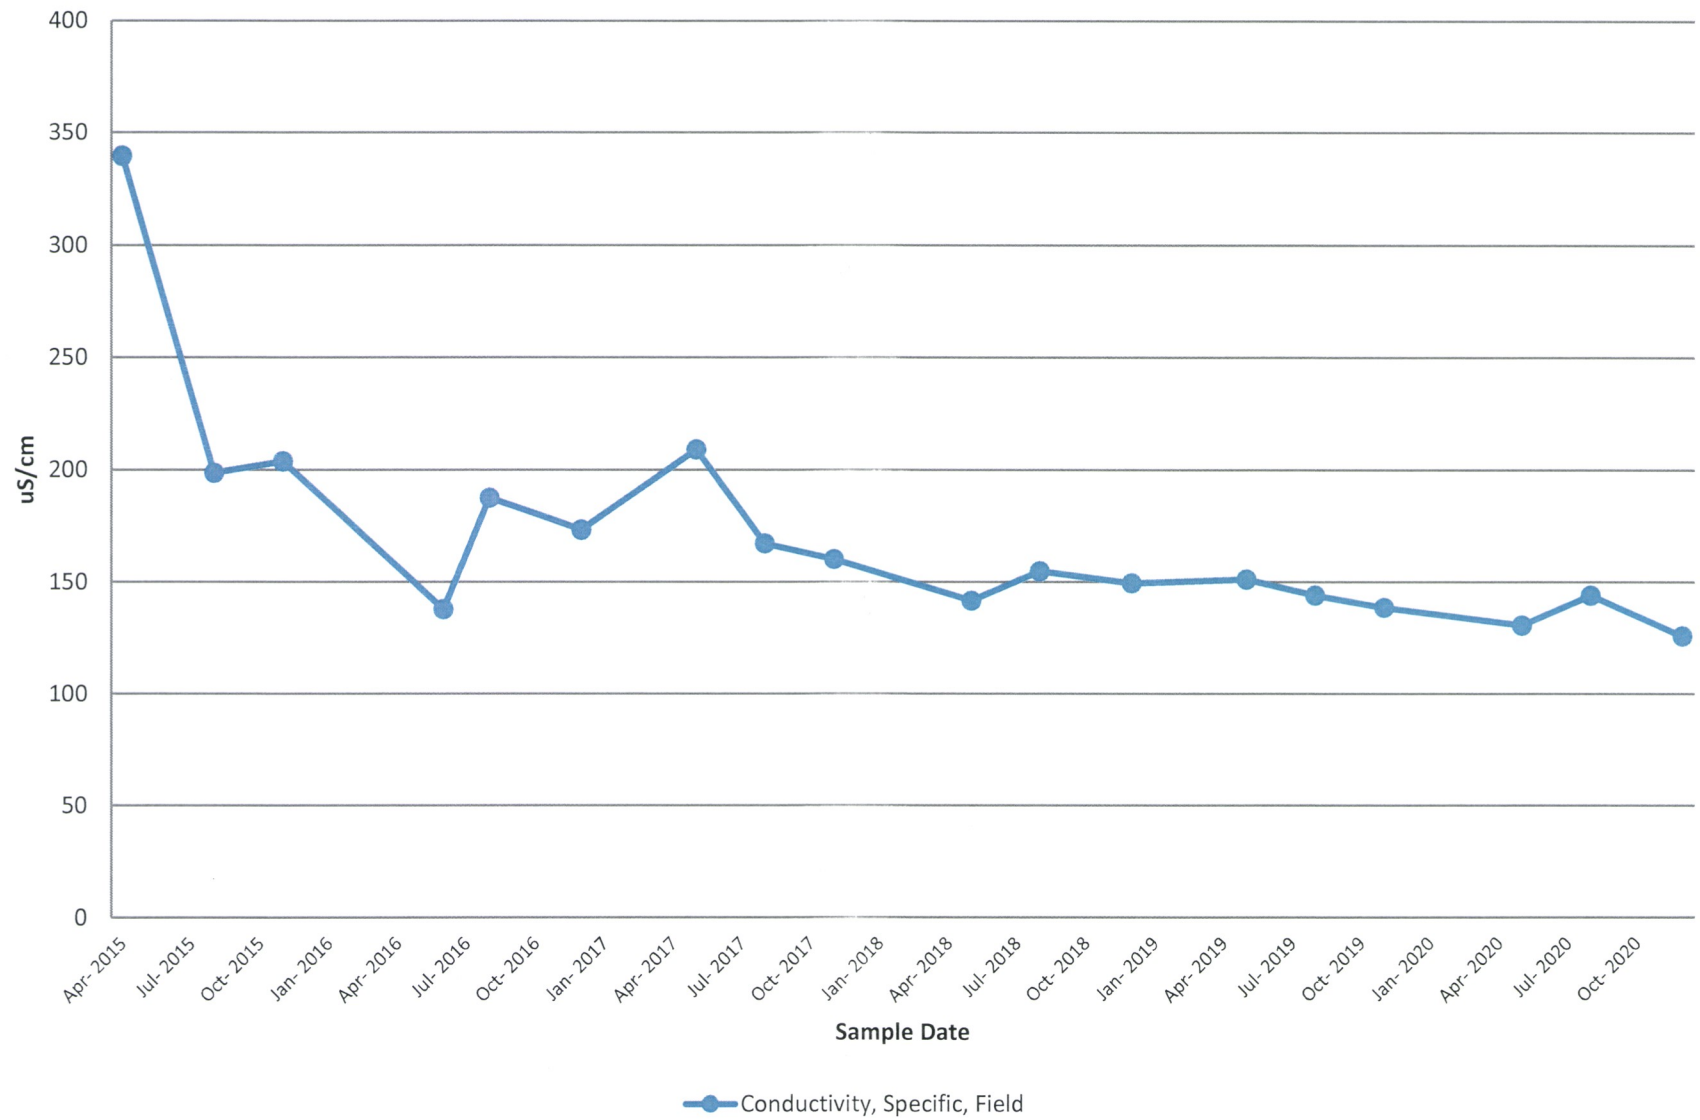
**Trend Evaluation 18**  
**MLGW - 7: Specific Conductivity**  
**Henderson Mill**

Henderson continues to note a slight decreasing trend in sulfate and specific conductivity.

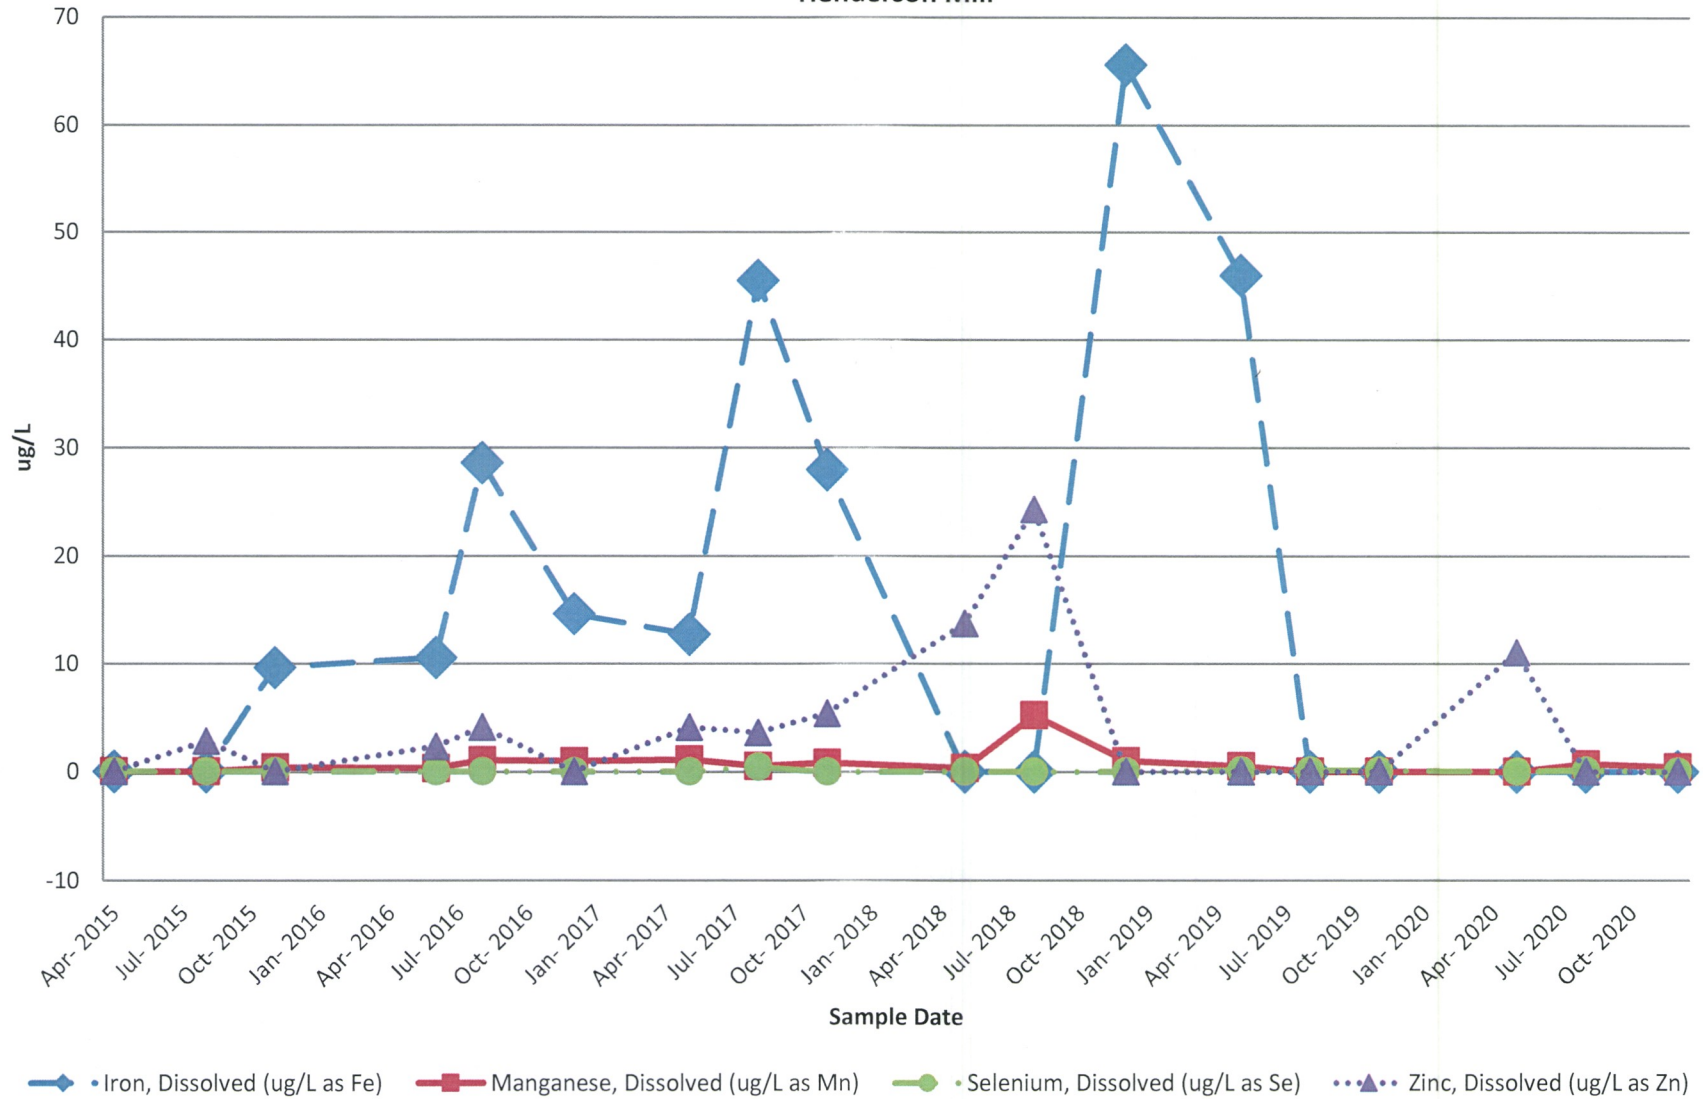
Trend Evaluation 25  
MLGW-17: Fe, Mn, Se, and Zn  
Henderson Mill

Note: Concentrations below the laboratory reporting limit have been plotted as "0" on the above trend evaluation

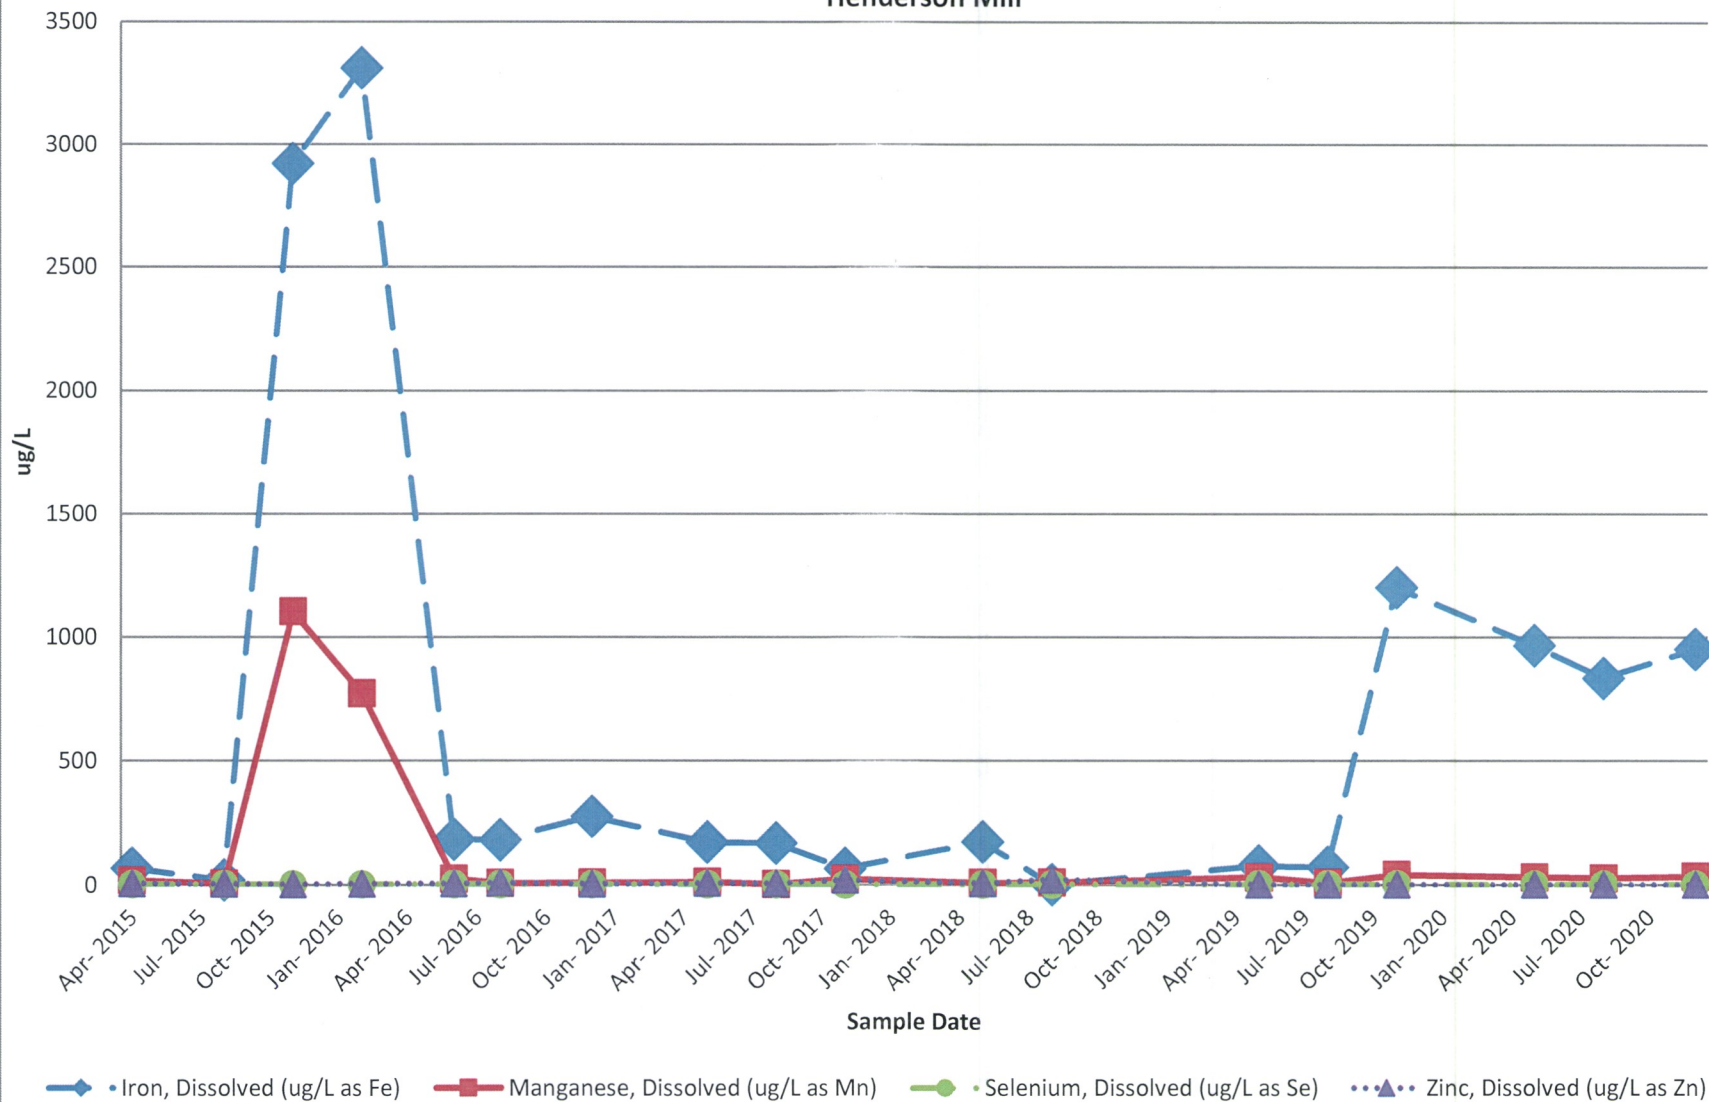
**Trend Evaluation 29**  
**MLGW-ACR: Fe, Mn, Se, and Zn**  
**Henderson Mill**

**Note: Concentrations below the laboratory reporting limit have been plotted as "0" on the above trend evaluation**

Altogether, this has been an effort to establish an accurate representation of the ambient groundwater conditions far downstream from Henderson operations. Henderson will continue to evaluate the data collected at MLGW-ACR following future sampling events to better understand these data.

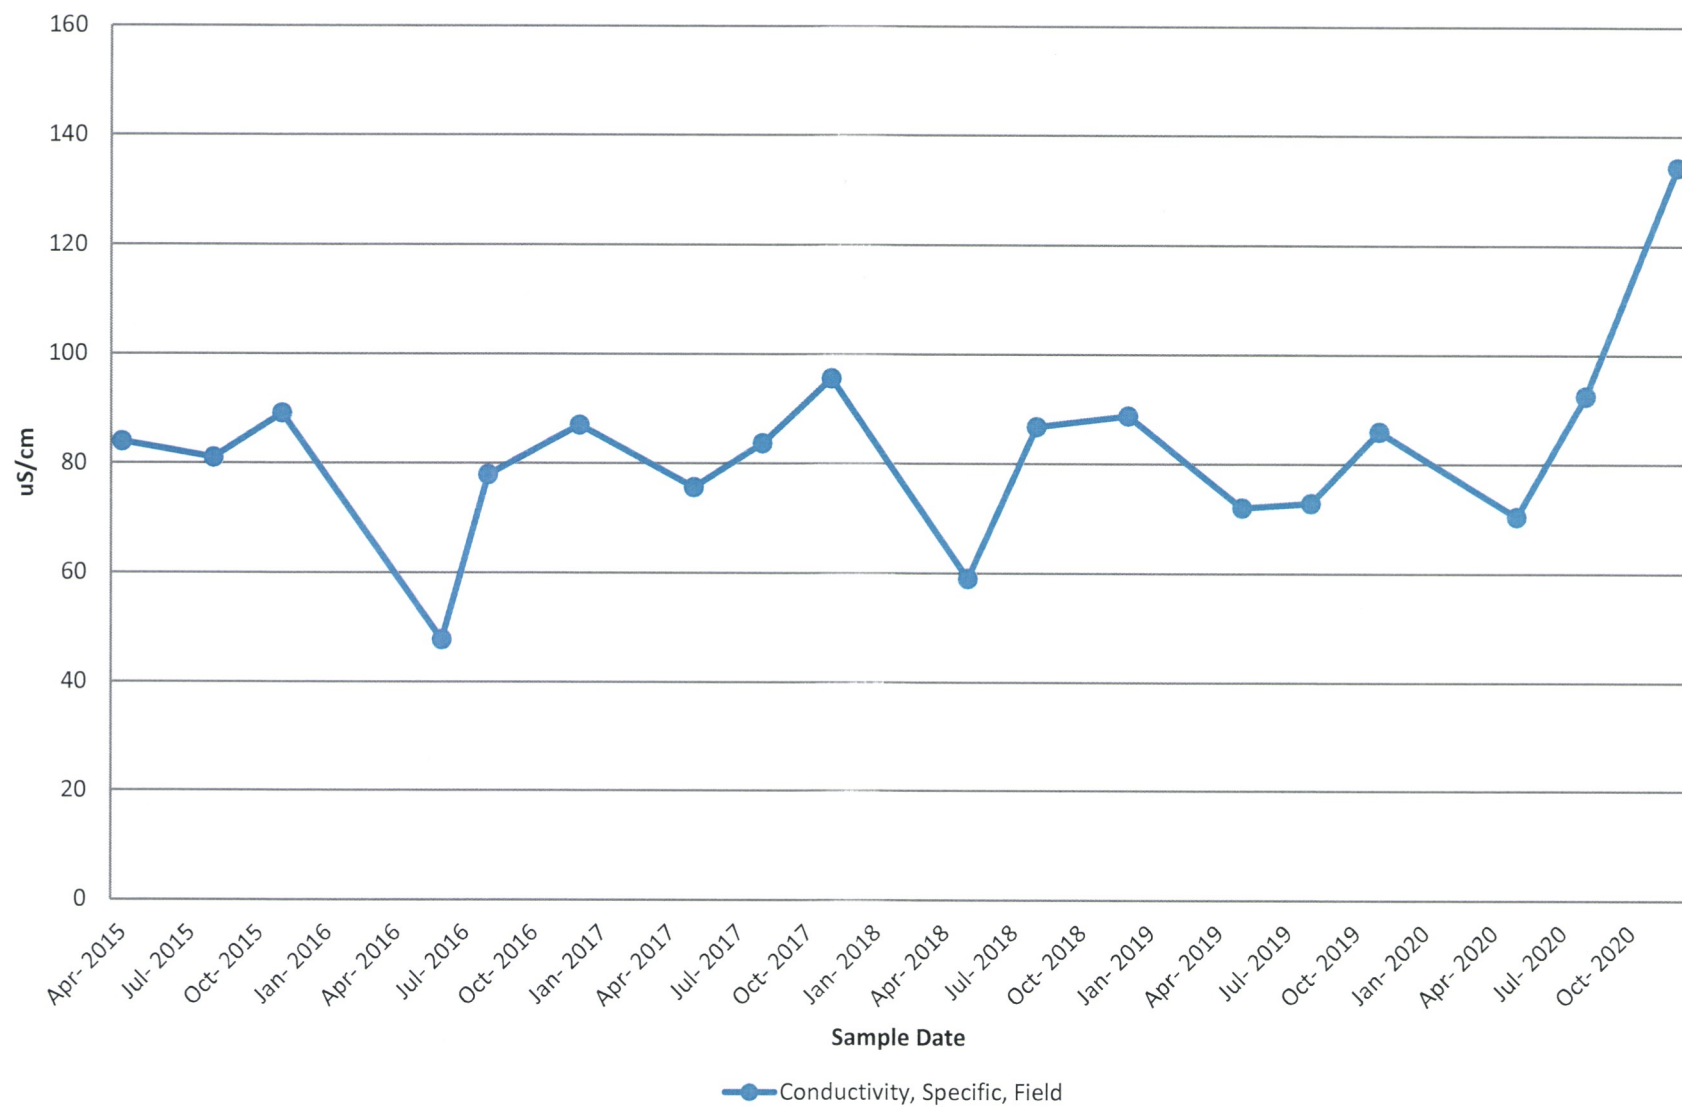
Trend Evaluation 34  
WFR - 20: Specific Conductivity  
Henderson Mill

WFR-20 is located upgradient of the Henderson Mill in the Williams Fork River and serves as an indicator of background surface water quality. A small increase in specific conductivity and sulfate during the second and third trimesters, respectively, during the summer and low-flow months might correlate with influence from Williams Fork wildfire activity. Firefighting efforts and rainfall can mobilize suspended and dissolved material into surface water. Although an increase in pH and metal concentrations was not observed, WFR-20 will continue to be monitored while the newly burned area remains susceptible to increased erosion.
