**Re: Permit M-1977-341, Submittal of Annual Water Monitoring Report – Henderson Operations Groundwater Management Plan**

## **2020 Annual Water Monitoring Report Division of Reclamation, Mining and Safety**

Climax Molybdenum Company  
Henderson Operations  
P.O. Box 68  
Empire, CO 80438

**May 2021**

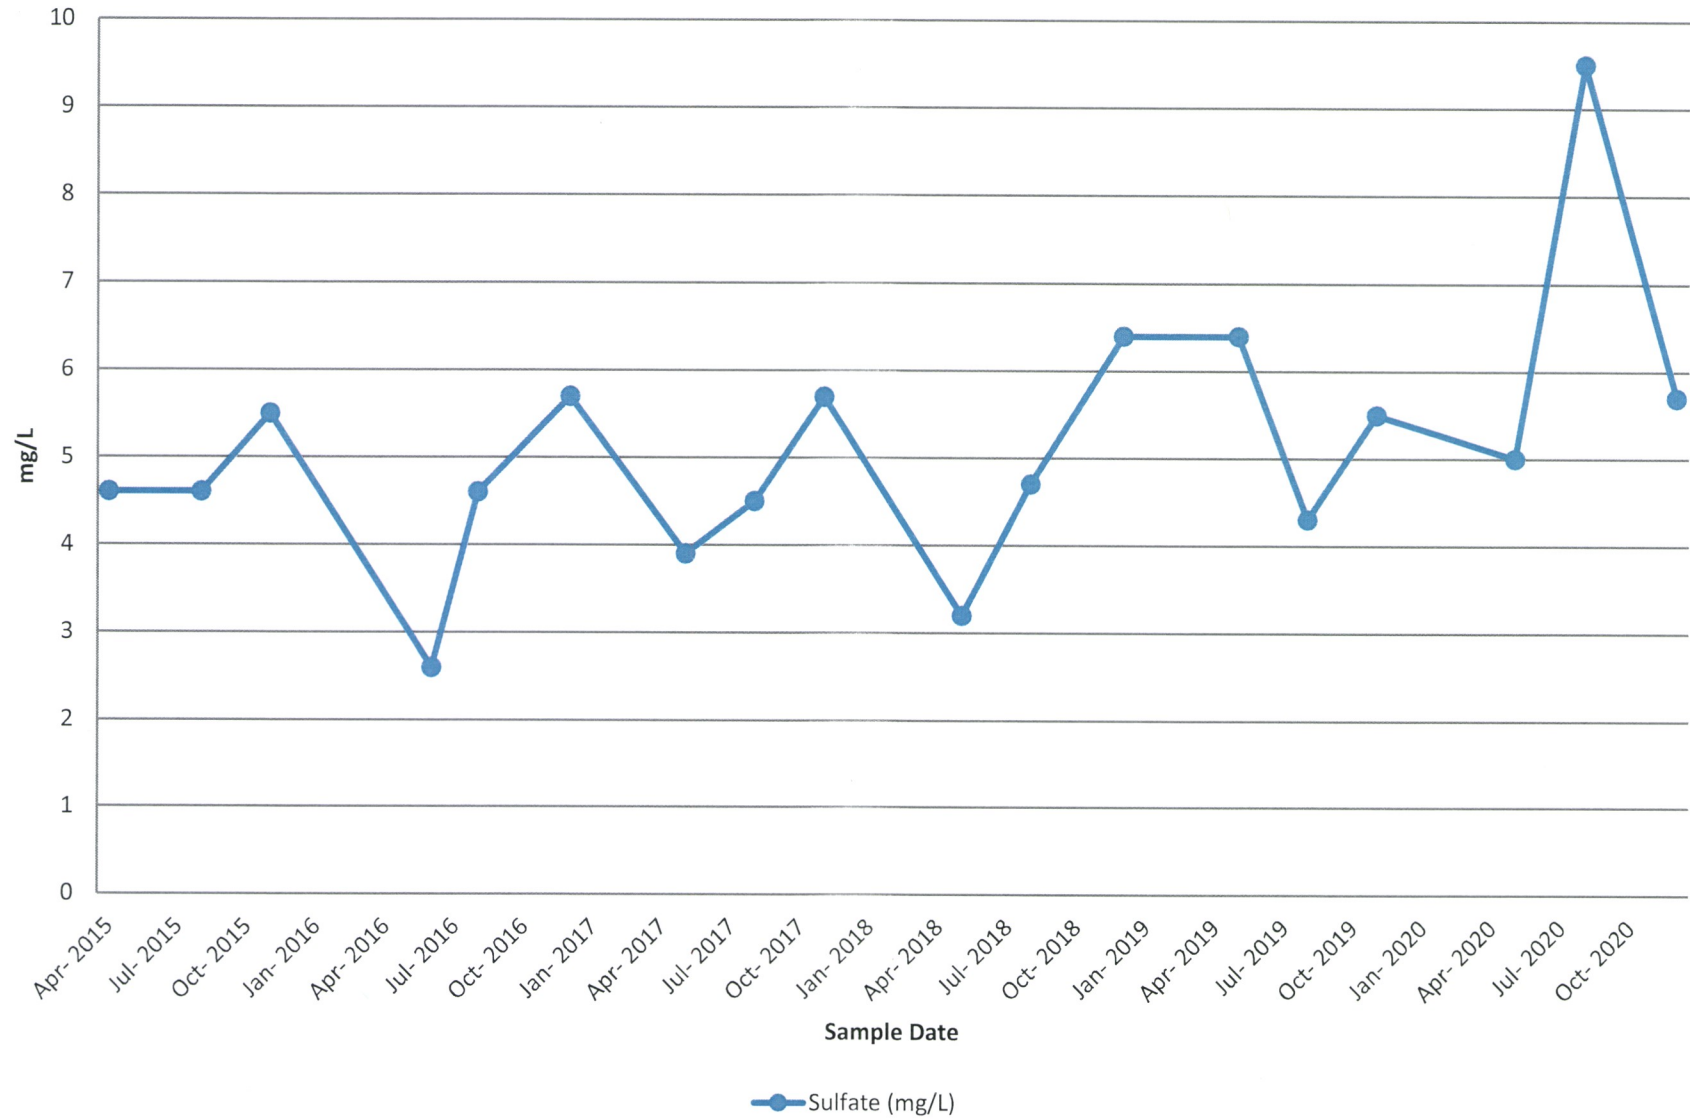
Trend Evaluation 36  
WFR - 20: Sulfate  
Henderson Mill

WFR-20 is located upgradient of the Henderson Mill in the Williams Fork River and serves as an indicator of background surface water quality. A small increase in specific conductivity and sulfate during the second and third trimesters, respectively, during the summer and low-flow months might correlate with influence from Williams Fork wildfire activity. Firefighting efforts and rainfall can mobilize suspended and dissolved material into surface water. Although an increase in pH and metal concentrations was not observed, WFR-20 will continue to be monitored while the newly burned area remains susceptible to increased erosion.

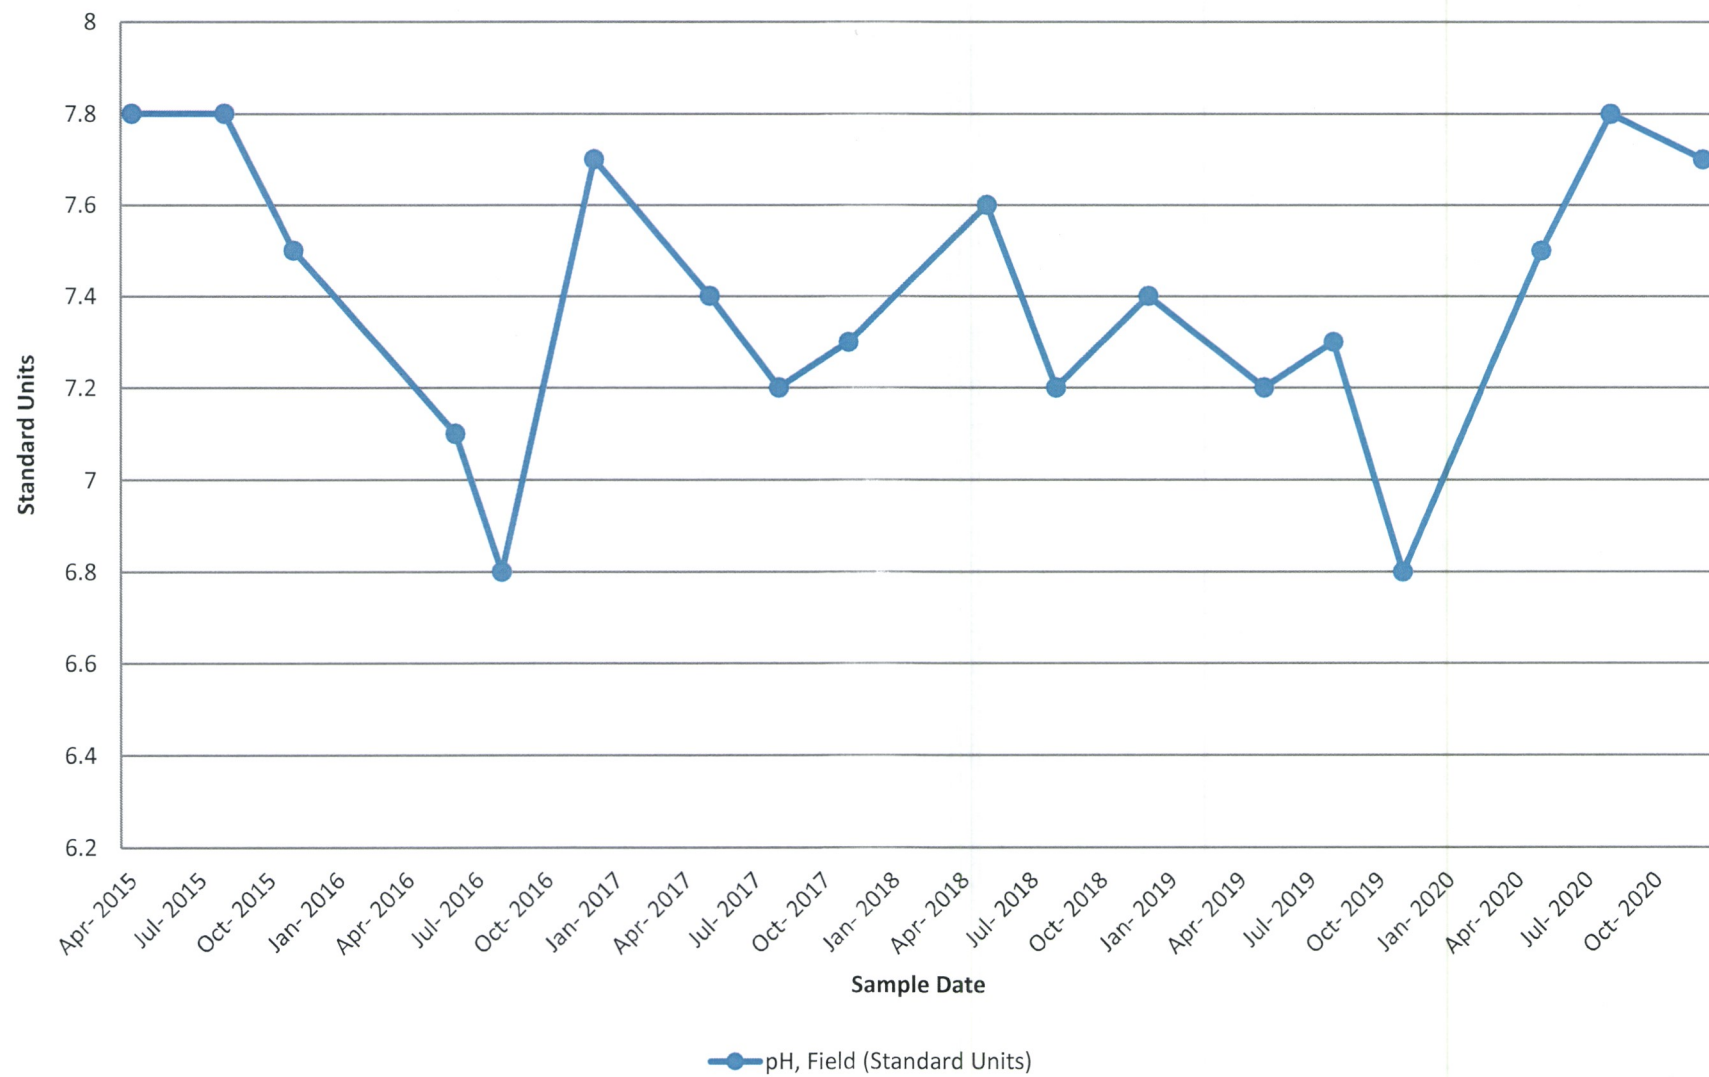
### Trend Evaluation 39

WFR-40 is located downgradient of the Henderson Mill in the Williams Fork River. Although still within historical levels, pH and sulfate concentrations measured in 2020 increased relative to 2019 which may relate to the Williams Fork fire activity. Increased pH and major ion loading into adjacent surface water are common responses from runoff interacting with a recently burned area. WFR-40 will continue to be monitored to determine potential influences from the recent fire activity.
