MINERALS PROGRAM INSPECTION REPORT
PHONE: (303) 866-3567

MINE NAME: Home Ranch	MINE/PROSPECTING ID#: M-2021-047	MINERAL: sand	COUNTY: Routt
INSPECTION TYPE: Illegal(Unpermitted Operation)	INSPECTOR(S): Tabetha Lynch	INSP. DATE: June 8, 2021	INSP. TIME: 12:00
OPERATOR: Home Ranch LLC	OPERATOR REPRESENTATIVE: Michael Moon	TYPE OF OPERATION: IM - Is it Mining	
REASON FOR INSPECTION: Citizen Complaint	BOND CALCULATION TYPE:	BOND AMOUNT: No Bond Held	
DATE OF COMPLAINT: 5/26/2021	POST INSP. CONTACTS: None	JOINT INSP. AGENCY: None	
WEATHER: Clear	INSPECTOR'S SIGNATURE:

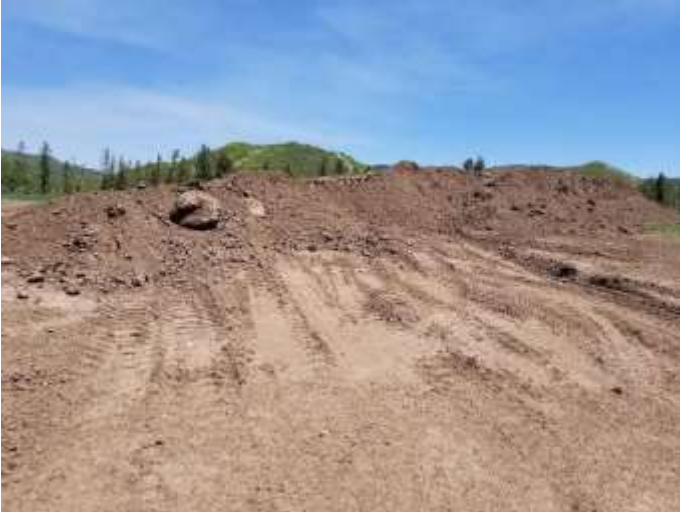
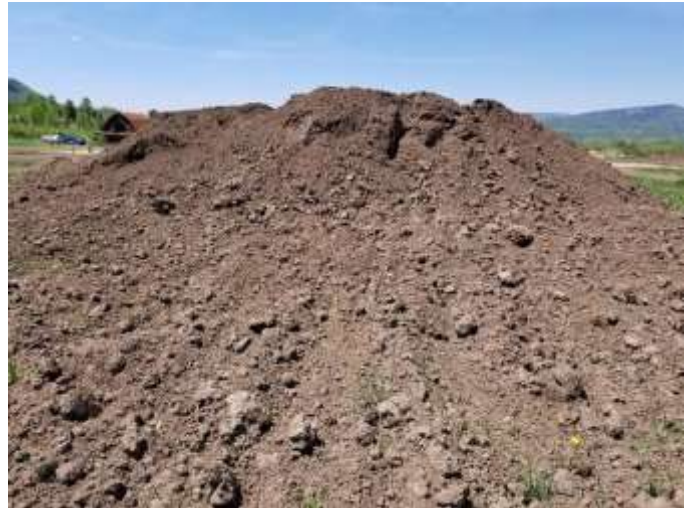
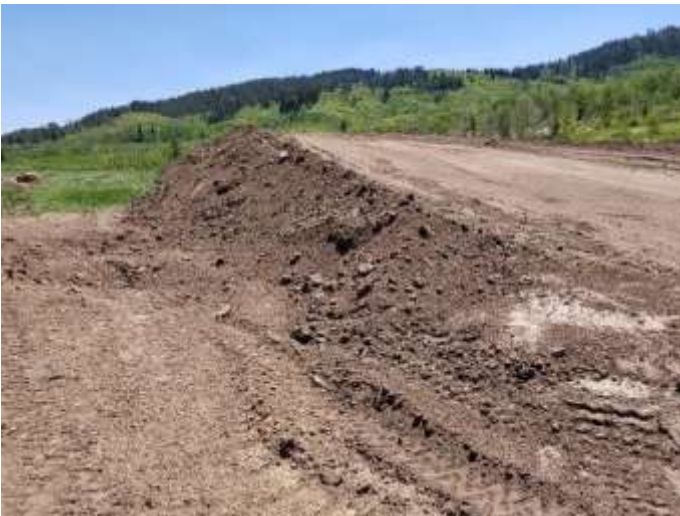
PHOTOGRAPHS

The Division, myself and Jason Musick met Michael Moon at the horse arena and adjacent topsoil pile, the material in question. Home Ranch is located just south of Clark, Colorado at 27315 Home Ranch Rd. Section 27, Township 9, Range 85.

The property representative, Michael Moon, stated that they had been trading excess topsoil from the construction of a horse arena for pit run. The Division acquired GPS data to determine the disturbance associated with the topsoil pile, which was approximately 0.4 acres in size and sloped to approximately 10-15 ft high. It was indicated that no additional material had left the site since the complaint was made and no additional material was planned to be removed from the property without acquiring a permit.

C.R.S. 34-32.5-103(13) defines a "mining operation" as the development or extraction of a construction material from its natural occurrences on affected land. The term includes, but is not limited to, open mining and surface operations. C.R.S. 34-32.5-103(3) defines a "construction material" as rock, clay, silt, sand, gravel, limestone, dimension stone, marble or shale extracted for use in the production of nonmetallic construction products. C.R.S. 34-32.5-103(1) defines "Affected Land" as the surface of an area within the state where a mining operation is being or will be conducted, which surface is disturbed as a result of an operation. Affected lands include, but shall not be limited to, private ways, roads (except those roads that were constructed for purposes unrelated to the operation that were in existence before a permit application was filed with the office, and will not be substantially upgraded to support the operation); land excavations, explorations sites, drill sites or working, refuse banks or spoil piles, evaporation or settling ponds, work, parking, storage, or waste discharge areas, and areas in which structures, facilities, equipment, machines, tools or other materials or property that result from or are used in such operations are situated. Given these definitions, the activities at the Home Ranch are considered to be incidental and no corrective action is needed as long as no additional topsoil leaves the site.
