Subject: Summary of Instrumentation Monitoring
2nd Quarter 2021
Bowie Coal Waste Disposal Area No. 2
Paonia, Colorado

SUBJECT: Summary Report, 2nd Quarter 2021, Inclinator and Active Vibrating Wire Piezometer Data April – June 2021, Bowie Mine #2 Coal Waste Disposal Area (CWDA) #2

INSTRUMENTATION SITE PLAN

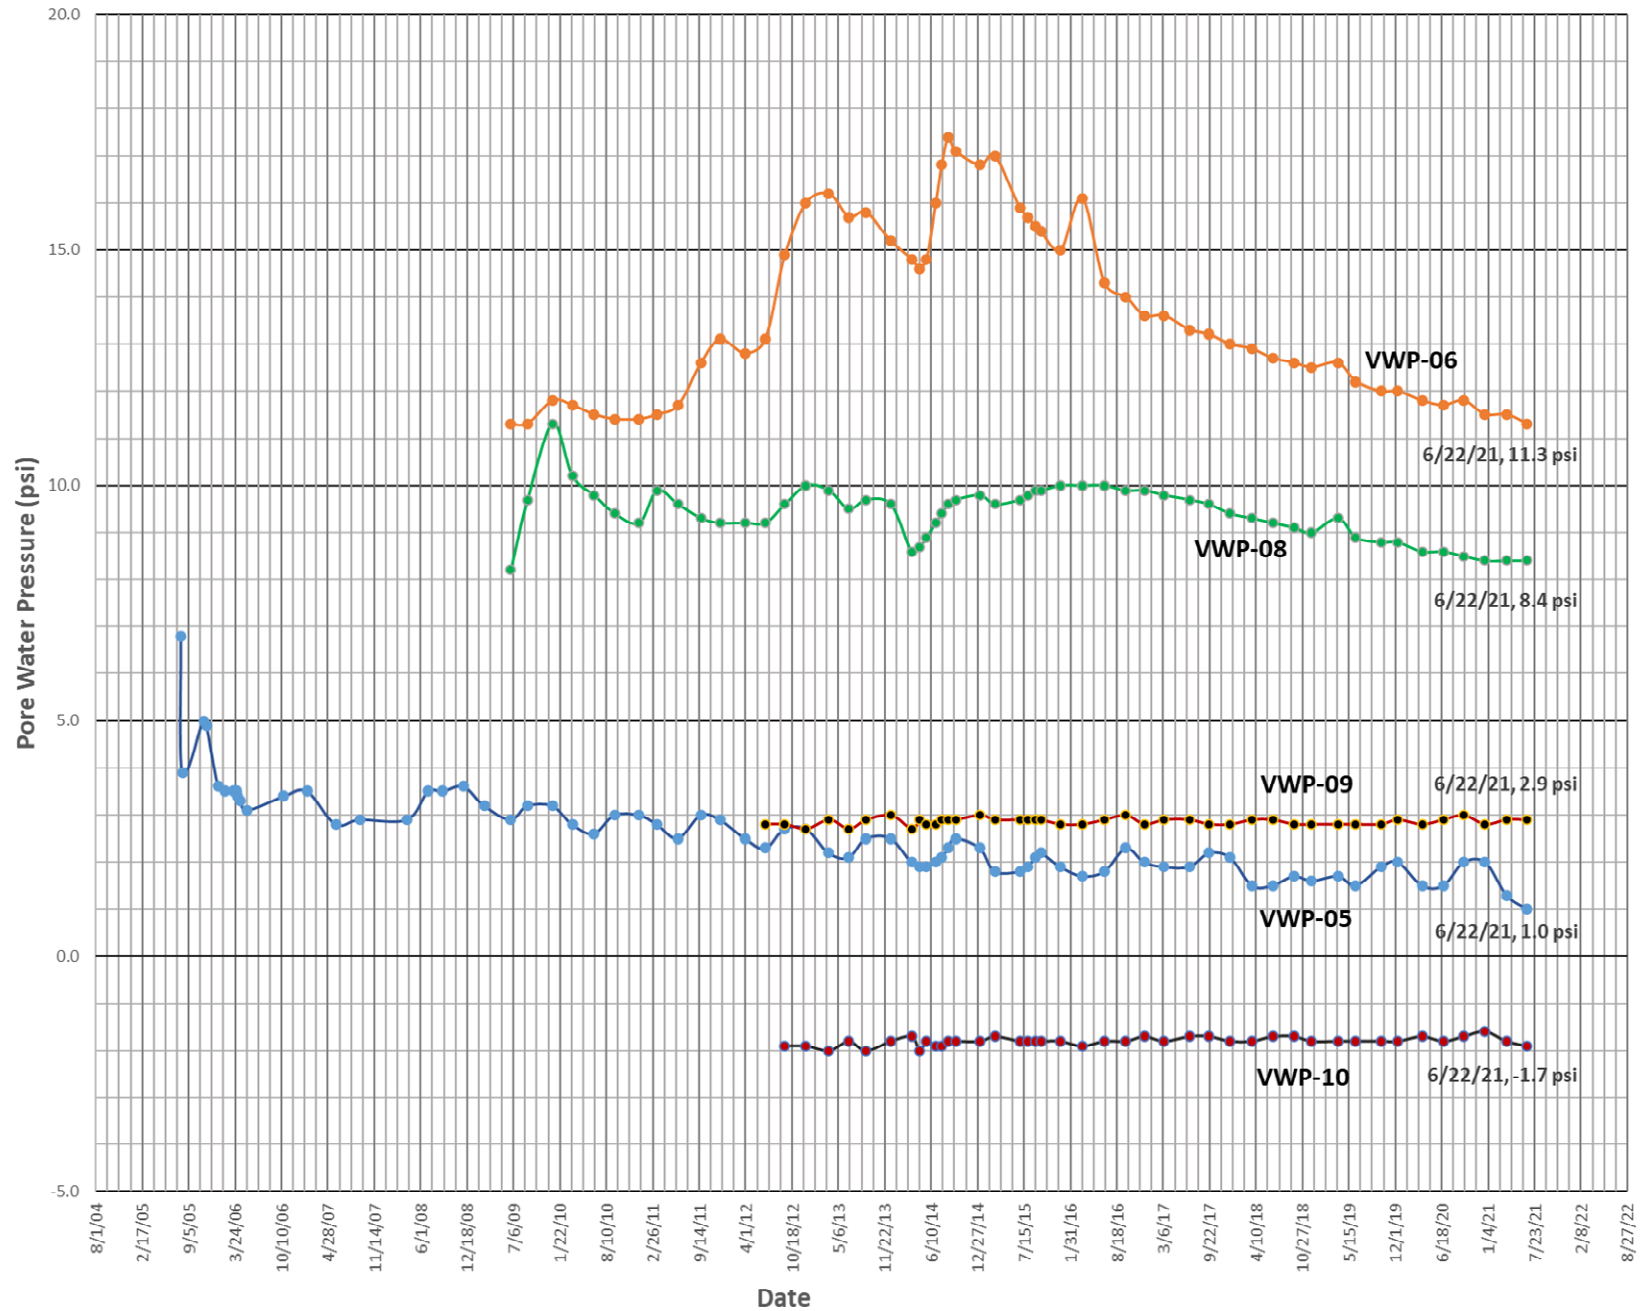
Figure 2 - Bowie Mine #2 - CWDA #2
Active Vibrating Wire Piezometer Data

As seen on Table 1 and Figure 2, the VWP readings and trends are consistent with recent and historic readings. Pore pressure readings changed by small amounts (0 to -0.5 psi) since the readings one year ago (Q2 2020). When compared with a last quarter (Q1 2021), pore pressures also changed by small amounts (-0.3 to +0.2 psi). Although four of the five VWP's remain steady or have general declining trends in pore pressure over the life of the VWP's, one of the piezometers (VWP-05) exhibits seasonal cyclical behavior since installation. This piezometer shows low pore pressures for Q1 and Q2 and higher pressures for Q3 and Q4, with a net loss of 5.8 psi over the lifetime of that VWP. The other four VWP's have experienced net changes of 0.2 psi or less since installation.

The physical locations of the piezometers are shown on the attached Instrumentation Site Plan (Map 1). As seen on this map, five of the original piezometers were damaged, and some were replaced. Currently, there are five active VWP's, and three of them are adjacent to inclinometers. The graph of historical VWP data from May 16, 2005 through May 21, 2014 is presented in Figure 1. A graph of measured pore pressures of active piezometers is presented on the attached Figure 2 and is presented numerically in Table 1 below.
