Report from preoperations inspection at Harris Pit

MINERALS PROGRAM INSPECTION REPORT
PHONE: (303) 866-3567

MINE NAME: Harris Pit	MINE/PROSPECTING ID#: M-2021-015	MINERAL: Sand and gravel	COUNTY: Kiowa
INSPECTION TYPE: Preoperation Inspection	INSPECTOR(S): Robert Zuber, P.E.	INSP. DATE: August 3, 2021	INSP. TIME: 09:40
OPERATOR: Kiowa County	OPERATOR REPRESENTATIVE: Allen Watts, Foreman	TYPE OF OPERATION: 112c - Construction Regular Operation	
REASON FOR INSPECTION: Normal I&E Program	BOND CALCULATION TYPE: None	BOND AMOUNT: No Bond Held	
DATE OF COMPLAINT: NA	POST INSP. CONTACTS: None	JOINT INSP. AGENCY: None	
WEATHER: Clear	INSPECTOR'S SIGNATURE:

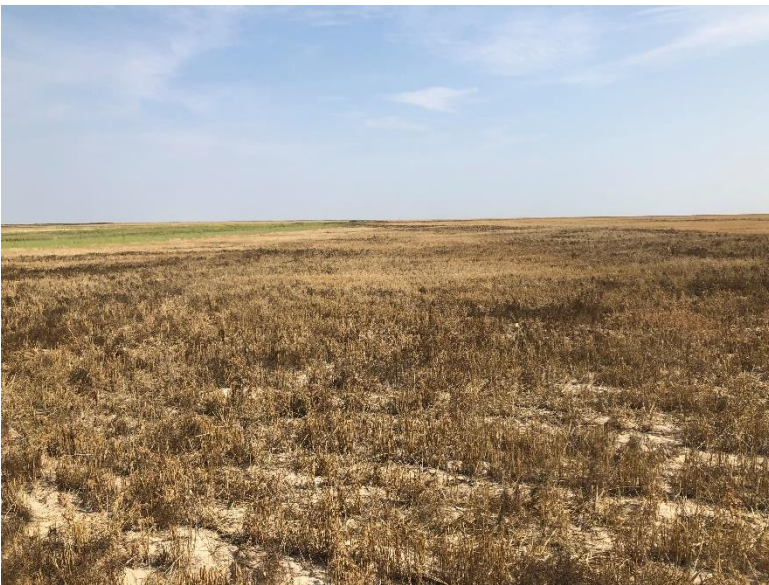
Southeast corner of site, looking north

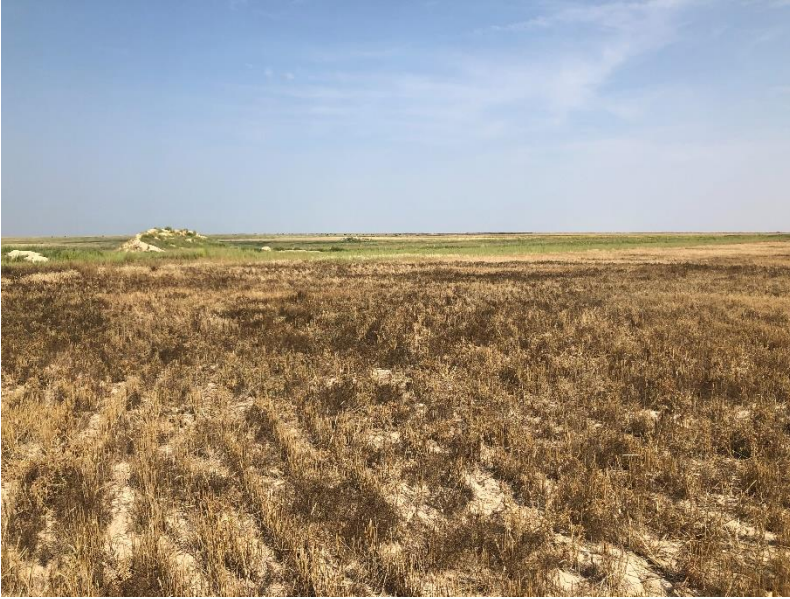
The County has dug test pits to check the availability of gravel at this site. The total disturbed area is less than 1,200 square feet, based on a conservative estimate by the Division inspector. The deepest pit was approximately five feet deep.

The disturbance from the test pits has not caused sediment to be transported from the disturbed area.

Area around test pits, south side of site

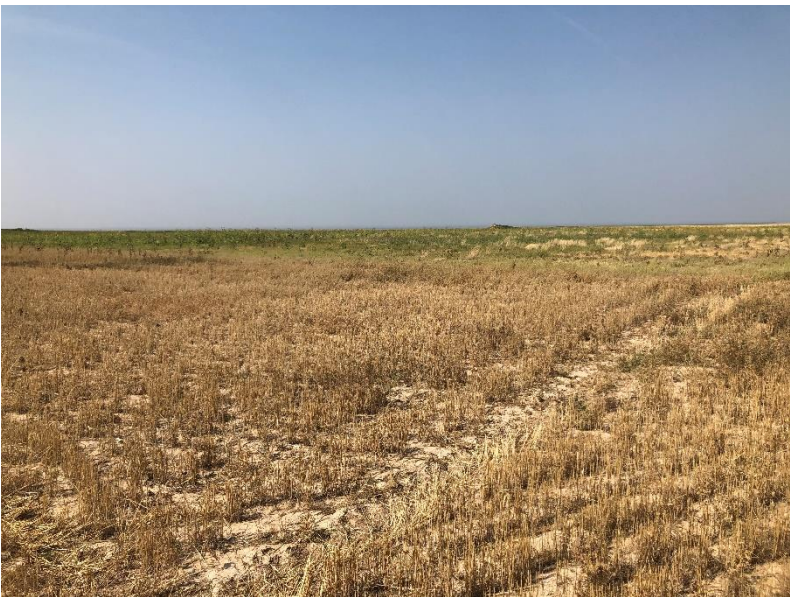
Good stands of grass were seen on the west side of the site. In other areas, sunflowers and kochia were dominant species. Wheat stubble was seen around the edges of the site. Bindweed was seen in some areas.

Northeast corner, looking southwest (wheat stubble in foreground)

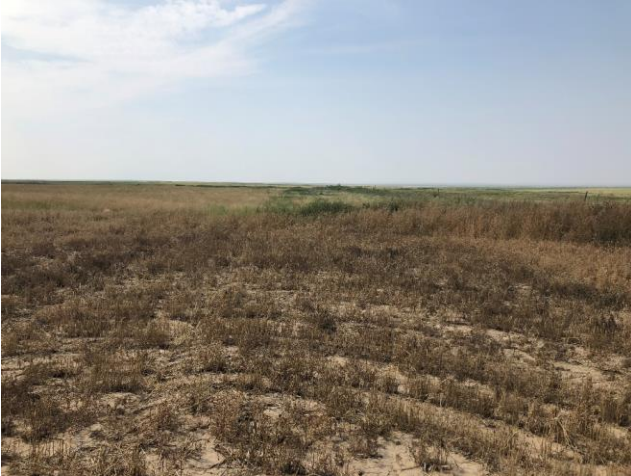
Northwest corner, looking south – fence posts are approximately 100 feet west of proposed permit area

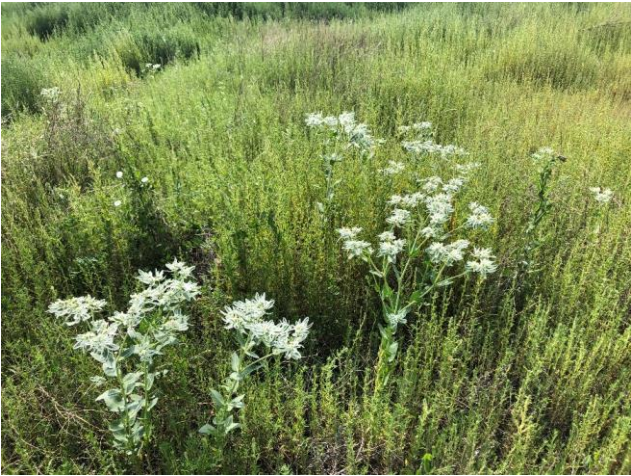
Snow on the Mountain (not a noxious species)
