Re: SEMA Construction, Inc., Motorcross Borrow Pit, File No. M-2019-041, Complaint Against Mining Operation (CT-02), Complaint Response

MINERALS PROGRAM INSPECTION REPORT PHONE: (303) 866-3567

MINE NAME:	MINE/PROSPECTING ID#:	MINERAL:	COUNTY:
Motorcross Borrow Pit	M-2019-041	Borrow material	Weld
INSPECTION TYPE:	INSPECTOR(S):	INSP. DATE:	INSP. TIME:
Monitoring	Peter Hays	July 29, 2021	09:00
OPERATOR:	OPERATOR REPRESENTATIVE:	TYPE OF OPERATION:	
SEMA Construction, Inc.	Gavin Madsen	111 - Construction by Goverment Agency

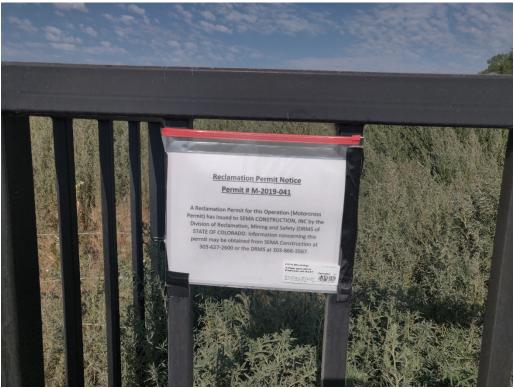
Motorcross Pit mine sign

The Division mine sign and boundary markers as required by Rule 3.1.12 were observed during the inspection.

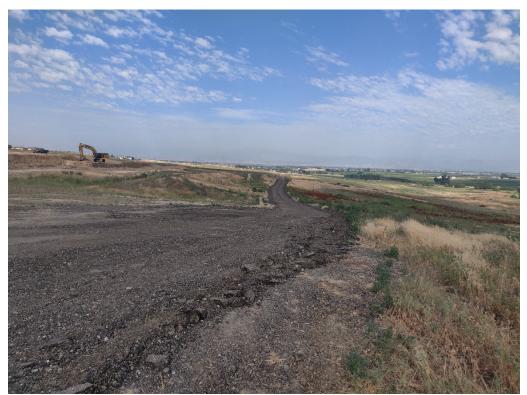
The approved pre-existing site access road is located off of the I-25 Frontage Road. The Operator has been accessing the site from the northwest corner of the property off of WCR 7 as stated in the complaint. During the inspection the Operator stated, the road was pre-existing and no improvements were required to use the road. The road was observed to have an asphalt surface during the inspection. Based on Google Earth images dating back to 1999 the road does appear to be pre-existing and was used for the former motorcross site. However, the Google Earth images show a two-track dirt road, not an asphalt surfaced road. The road dimensions were estimated at 3,650 feet long by 15 feet wide. The Division estimated approximately 1.25 acres have been disturbed by the construction of the secondary access road.

The Division believes the Operator surfacing the road with asphalt is a substantial upgraded to support the mining operation and is therefore affected land pursuant to Rule 1.1(3).

View of the access road off of WCR 7 from the east end of the road looking west

Land has been affected outside of the approved permit boundary. This is a possible violation at this time pursuant to C.R.S. 34-32.5-109(1) for failure to first obtain from the Board or Office a reclamation permit prior to engaging in a new operation. Also, this is a possible violation at this time pursuant to C.R.S. 34-32.5-116(4)(i) for failure to protect areas outside of the affected land from slides or damages occurring during the mining operation and reclamation.

These possible violations will require a hearing before the Mined Land Reclamation Board (MLRB). The schedule and other details for the MLRB hearing will be provided under a separate document to be sent via certified mail to the Operator.

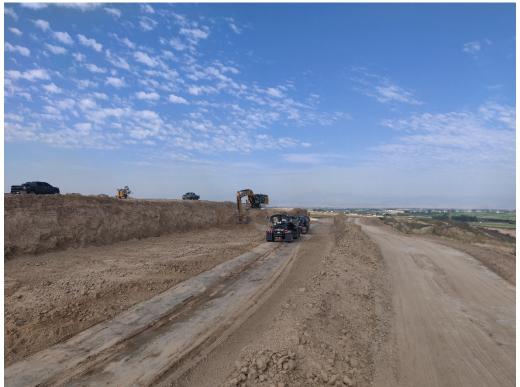
Mining operations have commenced at the site. Active excavation and material hauling by trucks were observed during the inspection. The site will be mined from north to south with topsoil stockpiles along the north and east permit boundaries. The maximum mining depth will be 55 feet and 1,216,440 cubic yards of material is anticipated to be removed from the site. Groundwater will not be encountered by the mining operation.

View of the mining excavation located in the northeast corner of the site

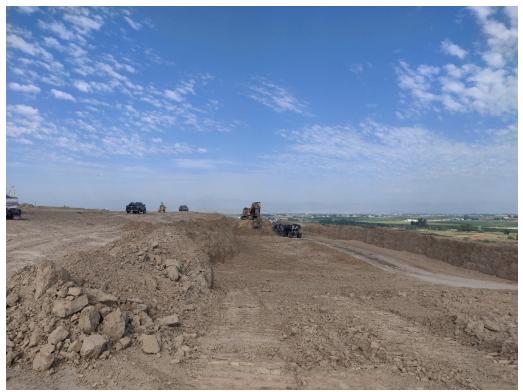
View of the mining excavation located in the northeast corner of the site
