# Technical Memo

**Project:** Aggregate Industries – LYONS QUARRY RECLAMATION PROJECT

**Subject:** Migratory Bird Pre-Construction Clearance Nesting Survey

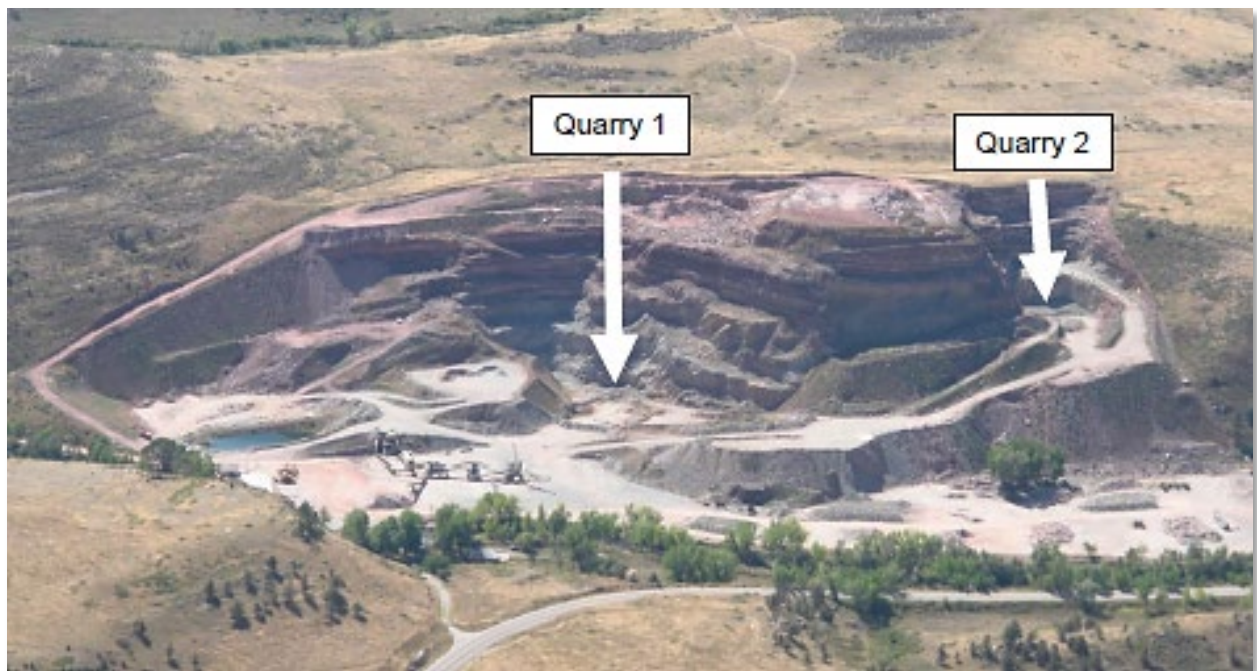
**Figure A: Overview of Project Area / Mine Site**

A pedestrian survey was conducted within the survey area by one HDR avian biologist on July 2, 2021, and again on July 22, 2021, in search of visual, auditory, or behavioral signs indicative of nesting birds. During the surveys, special emphasis was given to the exposed highwall adjacent to the three open mine quarries. The highwall provides suitable nesting substrate for various bird species and will also incur the majority of the Project disturbances. Trees and shrubs along the South St. Vrain Creek could also support nesting birds and therefore the riparian area was surveyed for nesting activity. Other surveyed areas include shrub dominated uplands and the ponded area adjacent to Quarry 1.

Prior to the nesting survey, a desktop review was conducted of the Project area to identify previously recorded raptor nests or other bird species that could nest in the area. The desktop analysis involved the review of publicly available data such as the eBird online database along with proprietary sources including a Colorado Parks and Wildlife (CPW) database of known raptor nests throughout Colorado. Coordination was also conducted with BCPOS regarding recent survey data of nesting birds in the Project area. Based upon the desktop review, agency coordination, and proposed project disturbance area, a survey area was identified for assessment. The survey area encompassed all potentially suitable nesting habitat that would be impacted during the proposed Project activities (see **Figure A** and **Appendix A-Figure 2**).
