**COLORADO**  
Division of Reclamation,  
Mining and Safety  
Department of Natural Resources

<b>Permit Number:</b> X-2017-234-02 <b>Mine Name:</b> West Panel State Expansion <b>Operator:</b> Williams Fork Land Company <b>Operator Address:</b> Ms Tonia Perkins P.O. Box 187 Craig , CO 81626	<b>County:</b> Moffat <b>Operation Type:</b> Coal exploration <b>Permit Status:</b> Active <b>Ownership:</b> Private
	<b>Operator Representative Present:</b>  Tonia Perkins
<b>Operator Representative Signature: (Field Issuance Only)</b>

<b>Inspection Start Date:</b> July 27, 2021 <b>Inspection Start Time:</b> 10:00 <b>Inspection End Date:</b> July 27, 2021 <b>Inspection End Time:</b> 11:00		<b>Inspection Type:</b> Coal Exploration Inspection <b>Inspection Reason:</b> Surety Release Requested <b>Weather:</b> Clear	
<b>Joint Inspection Agency:</b>  None		<b>Joint Inspection Contacts:</b>  	
<b>Post Inspection Agency:</b>  None		<b>Post Inspection Contacts:</b>  	
<b>Inspector(s):</b>  Tabetha Lynch	<b>Inspector's Signature:</b>

**Inspection Topic Summary**

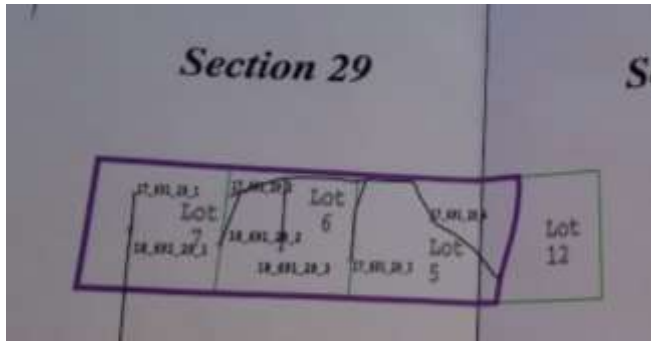
These sites were partially released by the Division while additional vegetation was established. This year these 3 sites displayed adequate vegetation with little noxious or invasive vegetation observed. No evidence of instability or erosion was observed during the on the ground inspection of the sites. All holes were sealed and covered with topsoil. Holes were checked for markers on the SL1 inspection with brass caps displaying the hole number. Following the SL2 inspection, these sites (listed below) were partially released and adequate bond was retained by the Division to provide revegetation should the Division be required to conduct final reclamation of the sites. Abandonment reports were received by the Division 10/4/2018. Photos of markers with brass caps displaying the hole numbers were provided to the Division at the time of the SL2 inspection. These pads were re-seeded in October of 2020 via tractor and new vegetation was observed. The area has been very dry and under drought conditions. The vegetation cover determination was made on the comparison of the area surrounding the disturbed pads.

Photos of reclaimed sites are provided in the photos below.
