## Daniels Sand Pit 2, Permit No. M-1973-007-SG

September 14, 2021

Regarding: Daniels Sand Pit 2, Permit No. M-1973-007-SG  
Slope Stability Monthly Monitoring Report

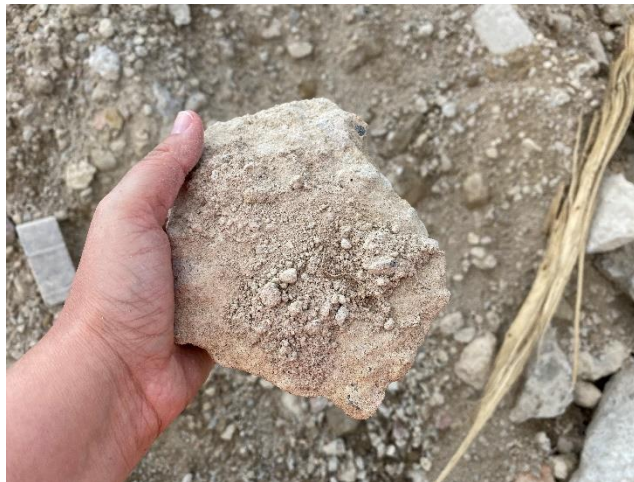
Photo 1. Recycled concrete

- Weather: 50-77°, partially cloudy, wind 5-10 mph, light rain
- Visual observation:
  - No tension cracks
  - No toe erosion
  - No moisture changes
  - No sloughed slope surfaces
- Construction sequence discussion
  - Onsite recycled concrete was pushed into the New Wash Fines Ponds up to 80 feet

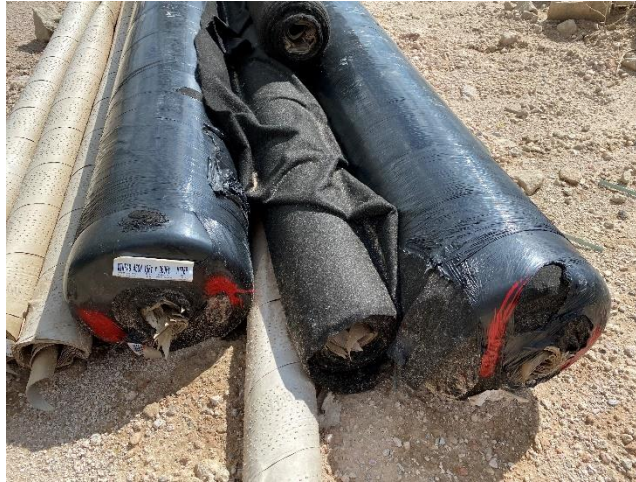
Photo 2. Onsite geotextile

- Vegetation (including Cotton Wood Trees) was removed from the mine slope
- Woven geotextile (WinFab 450N 15ftx360ft NTPEP) was placed over the recycled concrete (overlay approximately 2 ft)

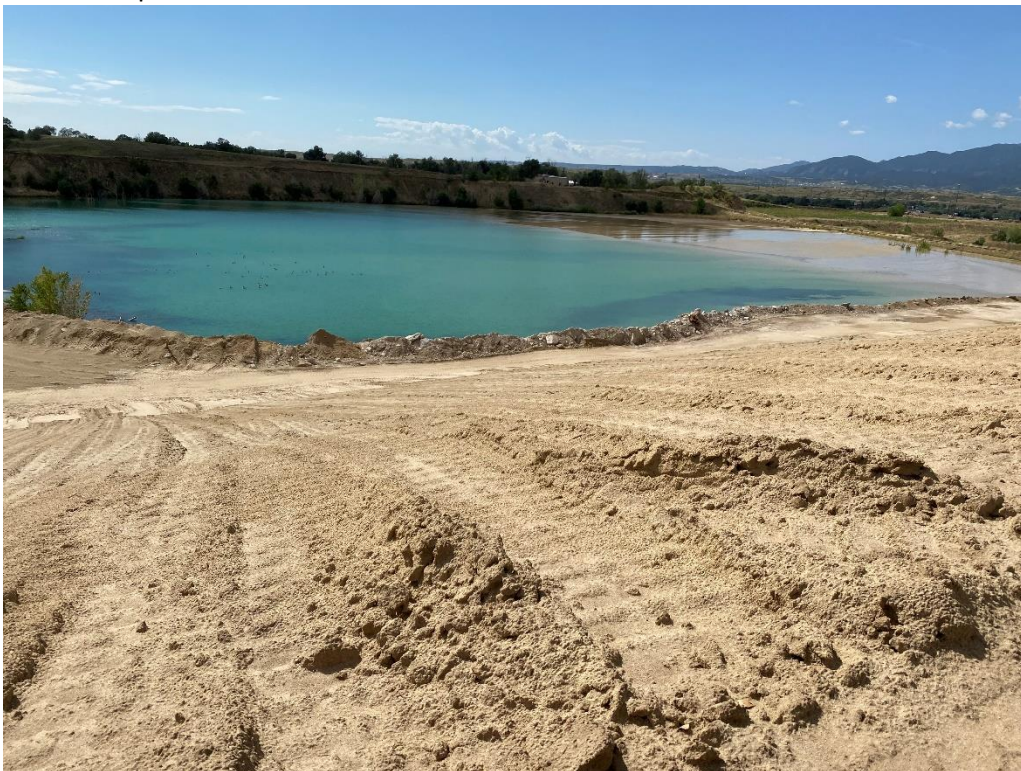
Photo 3. Buttress slope with equipment tracks

- Sand was placed in 12 to 18 inch loose lifts. Mostly onsite sand, some imported native sand (located on other side of the property)
- Compaction with dozer

- At this time, the buttress slope varies from 3H:1V to 4H:1V
- Preparation for final lift
  - Stockpiled sand located at crest of embankment
  - Will be completed within a month
  - Working on obtaining materials for seeding
