NT Creek inspection report

PERMIT INFORMATION

Permit Number: C-1981-025	County: Garfield			
Mine Name: North Thompson Creek Mine	Operation Type: Underground			
Operator: MINREC, Inc.	Permit Status: Inactive			
Operator Address:	Ownership: Private			
Mr. Stan Muhr				
P.O. Box 117	Operator Representative Present:			
Grand Junction, CO 81502				
	Stan Muhr, Jim Stover			
Operator Representative Signature: (Field Issuance Only)

A complete inspection was conducted by Rob Zuber of DRMS on September 13, 2021. Per Rule 3.03.2(2), this inspection was part of the requirements for the operator's application for final bond release, SL-07.

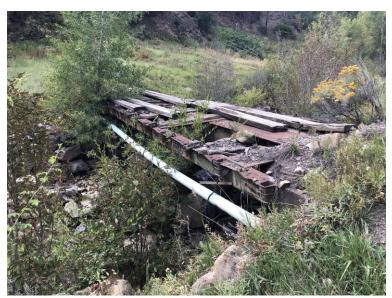
The pipeline across the creek (attached to a bridge) that carries mine water to the treatment system appeared very stable.

Pipe carrying mine water to the treatment system

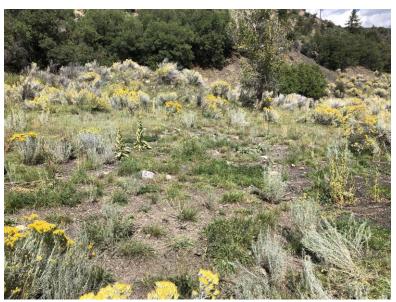
The area where pond cleanings have been dumped was in good condition.

Pond cleaning dump area

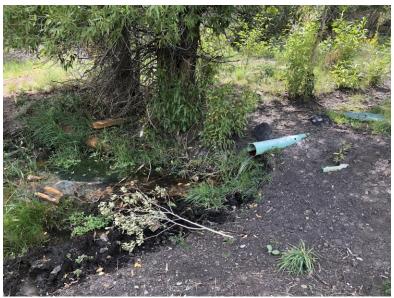
The water discharging from the pipe at the top of the system was relatively clear, and (unlike in the past), there was very little staining on the ground below the pipe. The water discharging from Pond 9 was very clear, with no mineral staining on the soil and no odor. It flowed into the channel that directs the water to the Refuse Pond, and there was no discharge to the creek (Outfall 01).

Discharge from pipe at top of treatment system

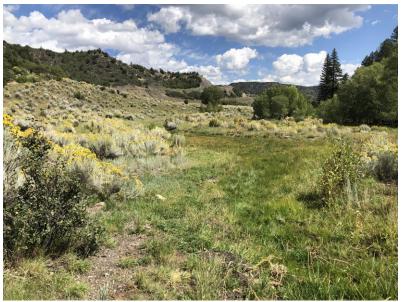
No problems were identified with ditches between the ponds or the aeration ditch above the Long Pond. The ditch above the Refuse Pond (which was breeched in September 2020) was functioning along its entire length.

Aeration ditch above the Long Pond

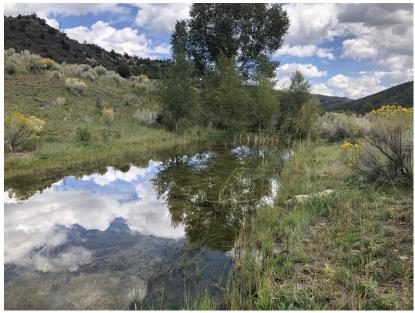
No problems were identified with the ponds. All of the on-site ponds were inspected: the Long Pond, Treatment Pond T-1, Treatment Pond T-2, the Polishing Pond (Pond P-9), and the Refuse Pond. All of the ponds except the Refuse Pond were discharging. The Refuse Pond contained some water, well below the spillways, and the embankment was in good condition.

Downstream end of Long Pond

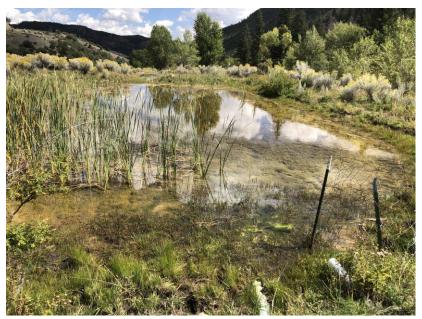
The cattails in the upper ponds is sparse. Many cattails were seen around Pond P-9.

Pond T-1, with Pond T-2 in background

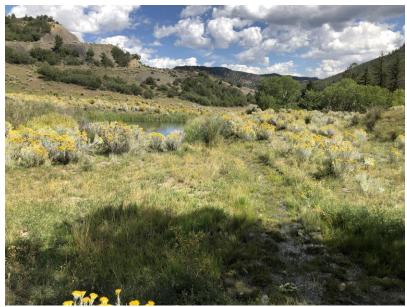
Pond P-9, with considerable number of cattails

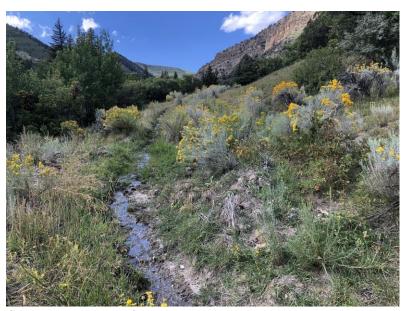
Channel above the Refuse Pond

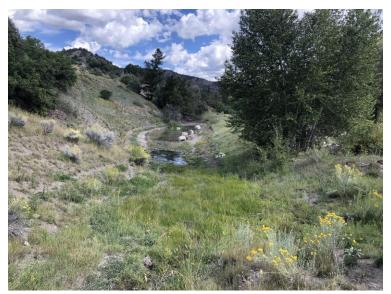
The Refuse Pond, with inlet in foreground

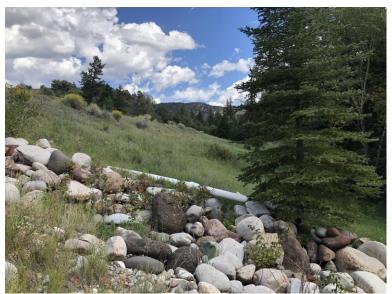
Refuse Pond discharge pipe (not flowing) and embankment
