Project No.: 191

Regarding: Daniels Sand Pit 2, Permit No. M-1973-007-SG
Slope Stability Monthly Monitoring Report – Revised

Lithos Engineering (Lithos) has been retained by Aggregate Industries to implement a slope stability monitoring plan for the Fountain Mutual Ditch within Daniels Sand Pit 2. Monthly monitoring will occur for the first year after construction completion. Lithos Engineering (Lithos) visited the site on September 14, 2021 and was escorted by Grant Smith (Daniels Sand Plant Manager). Site notes and photographs are presented below:

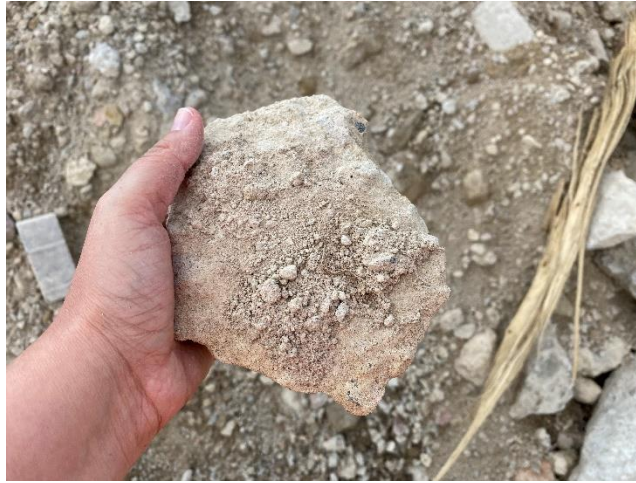
- Weather: 50-77°, partially cloudy, wind 5-10 mph, light rain
- Visual observation:
 - No tension cracks
 - No toe erosion
 - No moisture changes
 - No sloughed slope surfaces
- Construction sequence discussion
 - Onsite recycled concrete was pushed into the New Wash Fines Ponds up to 80 feet

Photo 1. Recycled concrete

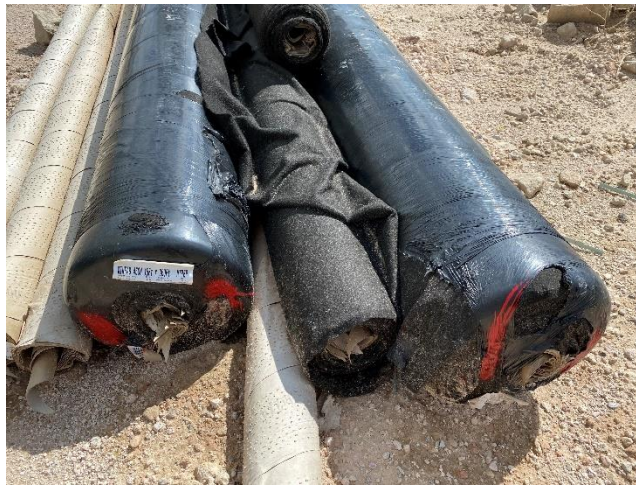
- Vegetation (including Cotton Wood Trees) was removed from the mine slope
- Needle-punched nonwoven geotextile intended for drainage, separation and filtration applications. (WinFab 450N 15ftx360ft NTPEP) was placed over the recycled concrete (overlap approximately 2 ft)

Photo 2. Onsite geotextile

The report below has been modified to include the correct geotextile nomenclature. Construction included a Winfab 450n which is a needle-punched nonwoven geotextile intended for drainage, separation and filtration applications.

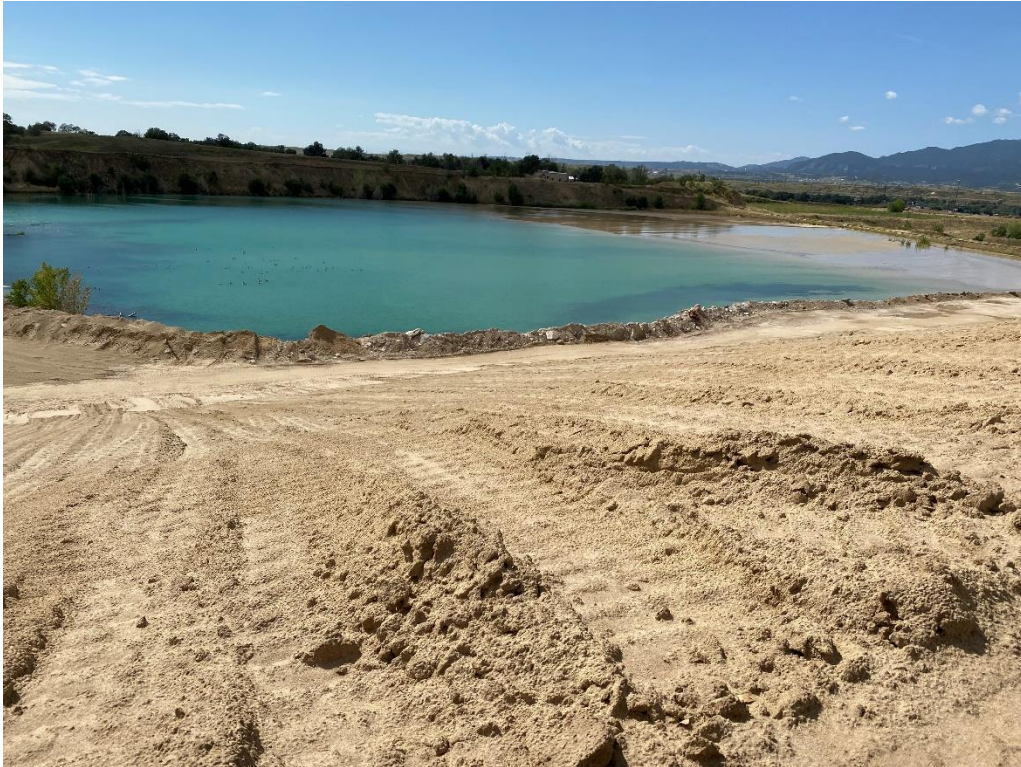
- Sand was placed in 12 to 18 inch loose lifts. Mostly onsite sand, some imported native sand (located on other side of the property)
- Compaction with dozer

Photo 3. Butress slope with equipment tracks

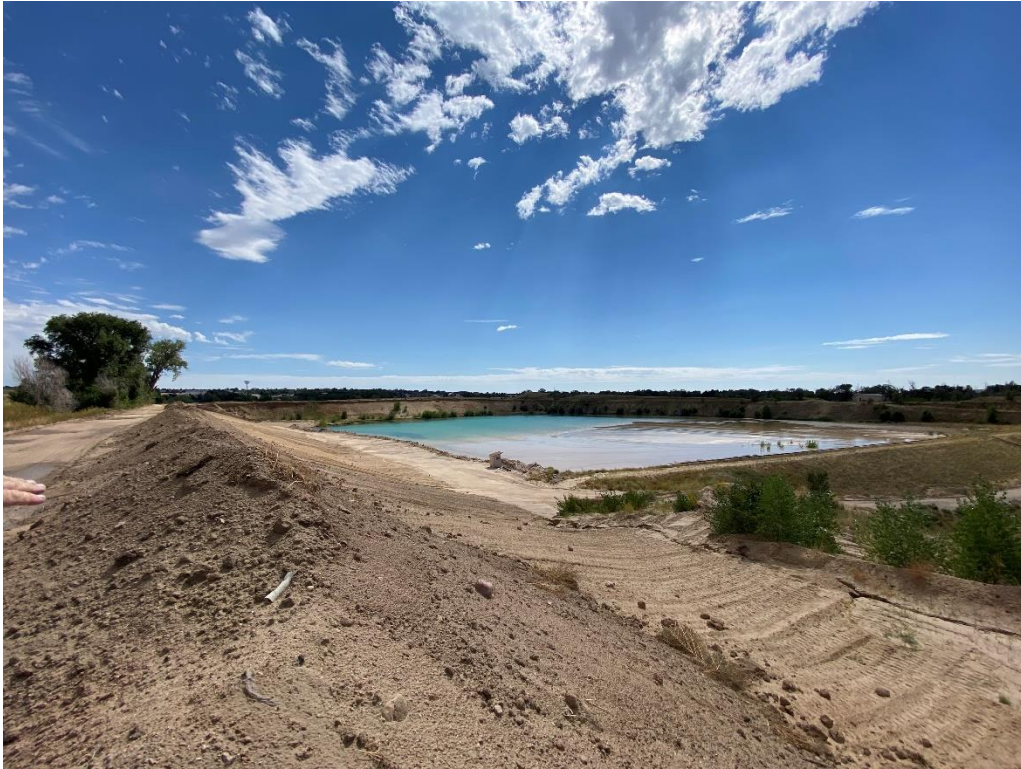
- At this time, the buttress slope varies from 3H:1V to 4H:1V
- Preparation for final lift
 - Stockpiled sand located at crest of embankment
 - Will be completed within a month
 - Working on obtaining materials for seeding

Photo 4. Stockpiled sand for final lift
