MINERALS PROGRAM INSPECTION REPORT
PHONE: (303) 866-3567

MINE NAME: Luke the Duke Gravel Pit	MINE/PROSPECTING ID#: M-2013-036	MINERAL: Gravel	COUNTY: La Plata
INSPECTION TYPE: Monitoring	INSPECTOR(S): Lucas West	INSP. DATE: August 25, 2021	INSP. TIME: 11:10
OPERATOR: Luke The Duke, LLC	OPERATOR REPRESENTATIVE: Penny Miller (Landowner)	TYPE OF OPERATION: 110c - Construction Limited Impact	
REASON FOR INSPECTION: Normal I&E Program	BOND CALCULATION TYPE: None	BOND AMOUNT: \$5,869.00	
DATE OF COMPLAINT: NA	POST INSP. CONTACTS: None	JOINT INSP. AGENCY: None	
WEATHER: Clear	INSPECTOR'S SIGNATURE:

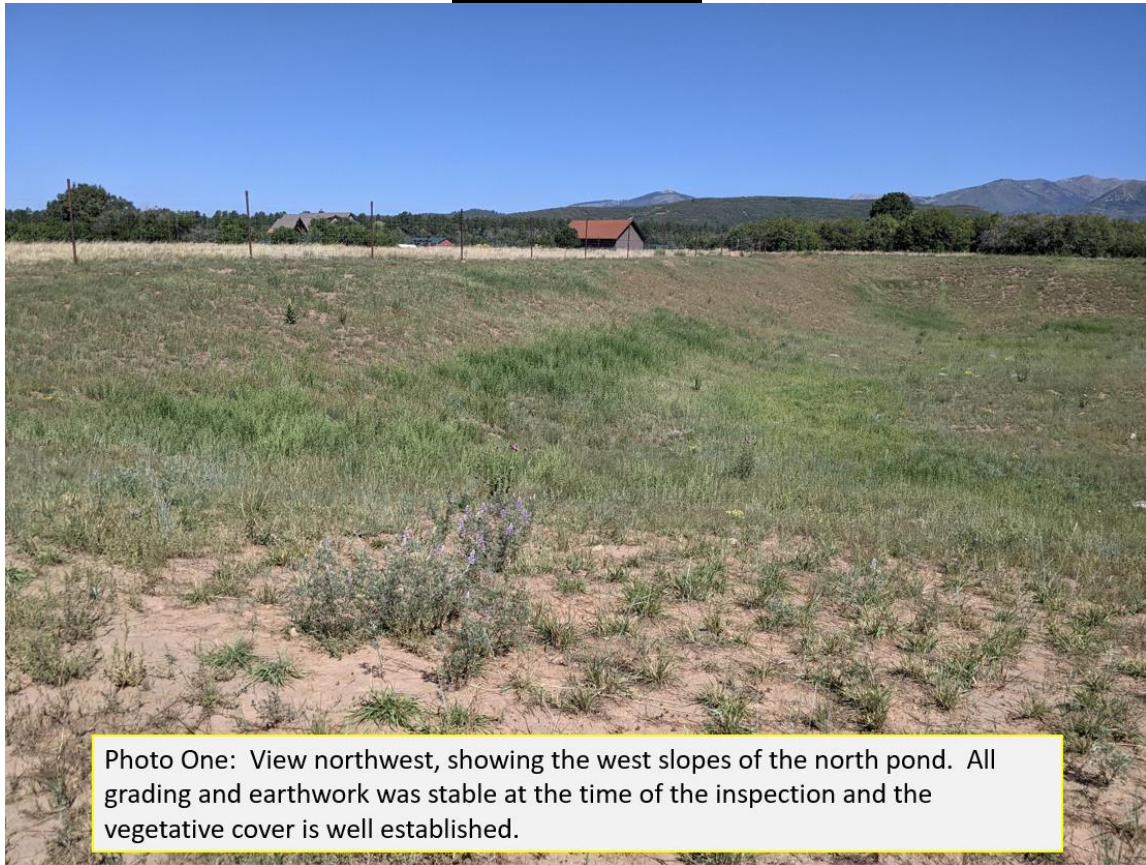
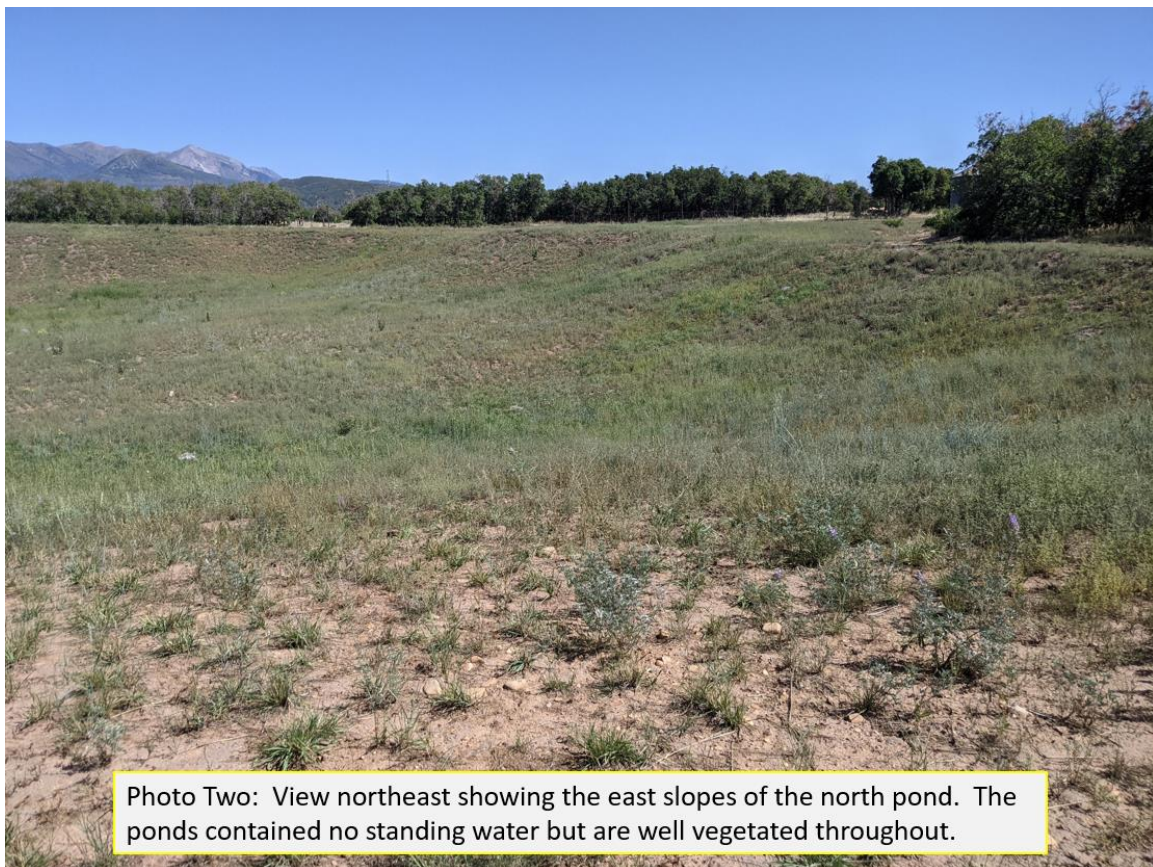
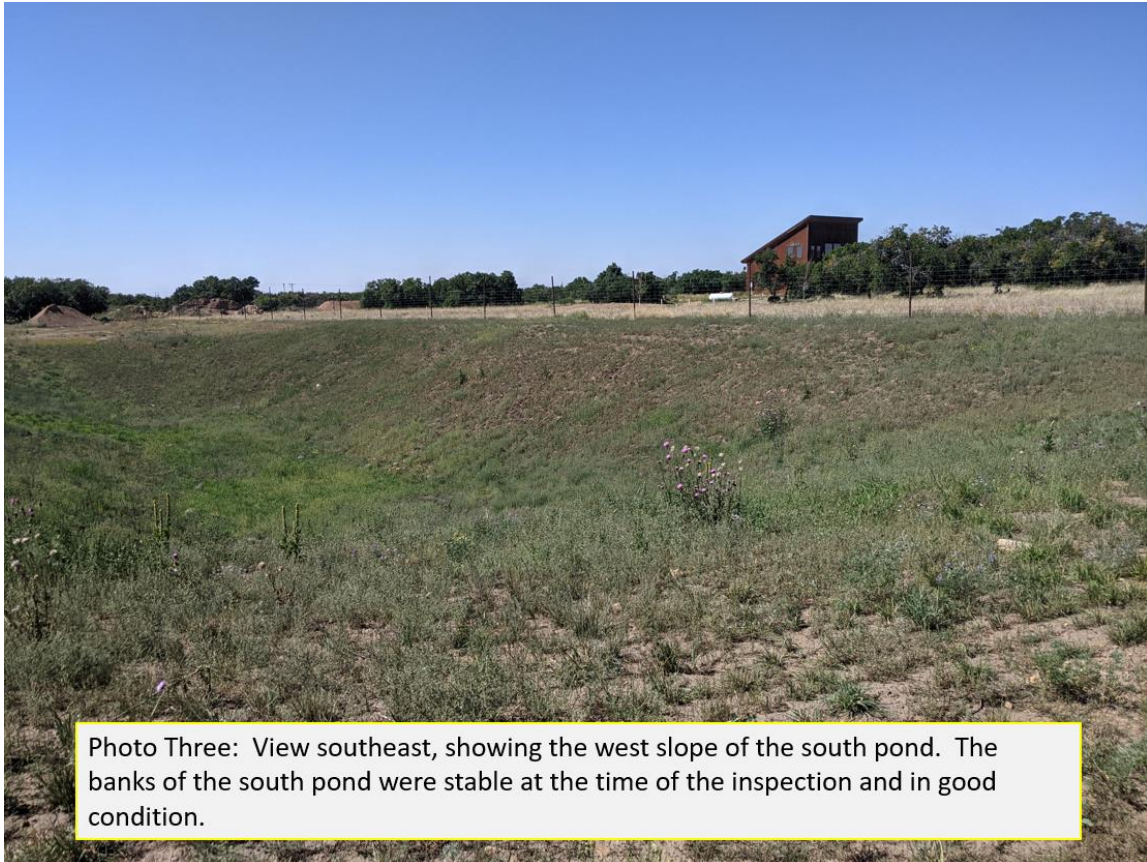
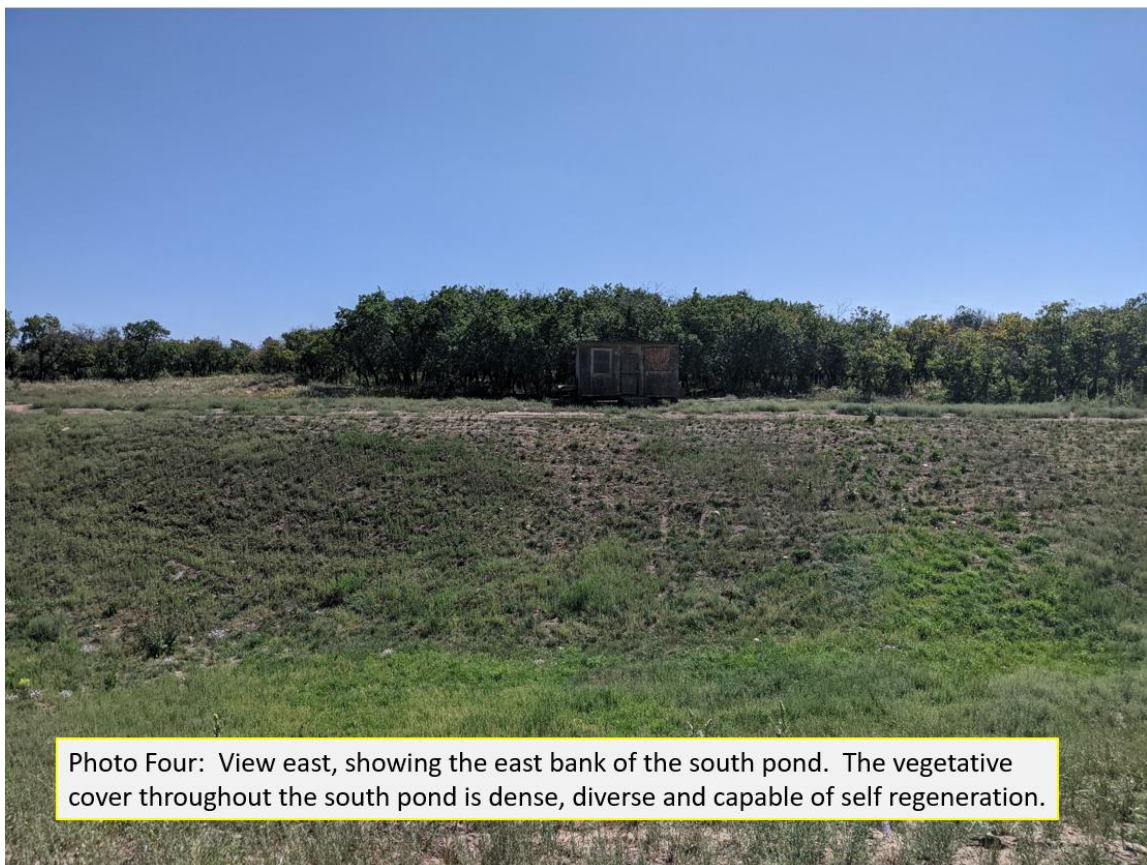
The proper mine identification signage was posted at the entrance to the site and the permit boundaries were clearly marked. The site was not active and no mining or reclamation equipment was observed on site. Since the previous inspection conducted by the Division, the Operator has completed the remaining reclamation of the site which included revegetation and ongoing weed treatment of the site. All sloping and grading throughout the site was stable at the time of the inspection. The slopes of the North Pond seen in Photos One and Two were in good condition and appear to be shallower than 3H: 1V. The sloping around the South Pond, shown in Photos Three and Four was also in good condition and stable at the time of the inspection. The slopes have been set at a 3H: 1V configuration. Both ponds, and the upland areas in the entire permitted area have had the topsoil replaced at a depth of 12-18 inches. The sloping, grading and replaced topsoil are all in excellent condition and no signs of settling slumping or erosion was noted during the inspection.

Also visible in the four photos is the well-established vegetative cover. Prior to the Division's previous inspection the Operator had seeded the affected lands and has since been conducting weed maintenance and mowing operations to assist the establishment of the reclamation species. The vegetative cover on all affected lands is dense, diverse and shows multiple year's biomass indicating that the vegetation is self-sufficient. Vegetative cover has been achieved in accordance with the approved Reclamation Plan. Another example of the vegetation can be seen in Photo Five.
