**MINERALS PROGRAM INSPECTION REPORT**  
**PHONE: (303) 866-3567**

| <b>MINE NAME:</b><br>Phil Sheridan Lode | <b>MINE/PROSPECTING ID#:</b><br>M-1988-081 | <b>MINERAL:</b><br>Gold and silver | <b>COUNTY:</b><br>Boulder |
| <b>INSPECTION TYPE:</b><br>Monitoring | <b>INSPECTOR(S):</b><br>Amy Eschberger | <b>INSP. DATE:</b><br>September 16, 2021 | <b>INSP. TIME:</b><br>10:00 |

This inspection of the Phil Sheridan Lode (Permit No. M-1988-081) was conducted by Amy Eschberger of the Division of Reclamation, Mining and Safety (Division) at the request of the operator's daughter Janice Wheeler, to discuss final reclamation of the site. The operator was represented by Ms. Wheeler and Dennis Covey during the inspection. The operator, Harry Covey, passed away in late June of this year. Ms. Wheeler is working with our office to provide the necessary documents demonstrating Mr. Covey is deceased, and that she is the executor of his estate. Any questions regarding these documents should be forwarded to our bonding specialist, Sara Stevenson-Benn via telephone at 303-866-3567, ext. 8148, or via email at [sara.stevenson-benn@state.co.us](mailto:sara.stevenson-benn@state.co.us).

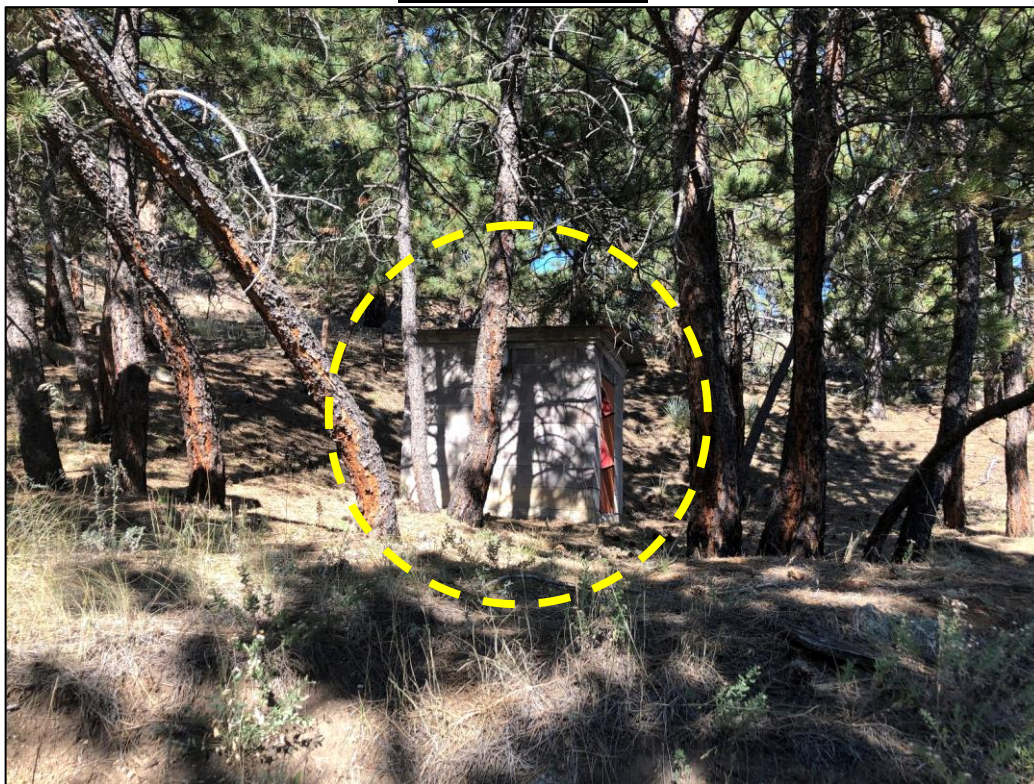
**Photo 1.** View looking north at (empty) powder storage building (circled) located W/NW of mining area. This building will remain for reclamation.

On the hillside west of the mining area, accessed by a separate gated entrance, there are two small cinder-block sheds which were constructed to house the powder and blasting caps (in the larger shed) and the detonators (in the smaller shed). According to the operator, these sheds have been empty for many years. The permit file indicates the operator had the appropriate explosives permits in place during the 1990's when blasting was conducted on site. However, the explosives permits were not maintained after operations ceased, and the on-site storage of explosives was discontinued. Per the approved reclamation plan, these two buildings will remain for residential storage.

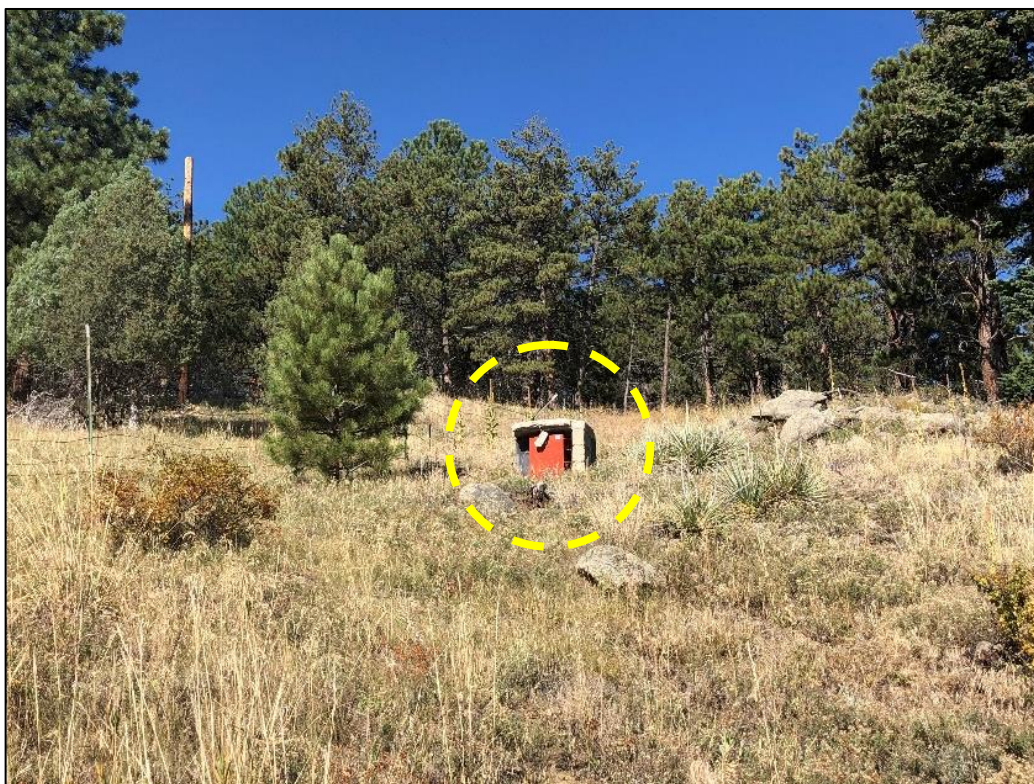
**Photo 2.** View looking north at (empty) detonator storage building (circled) located W/NW of mining area. This building will remain for reclamation.

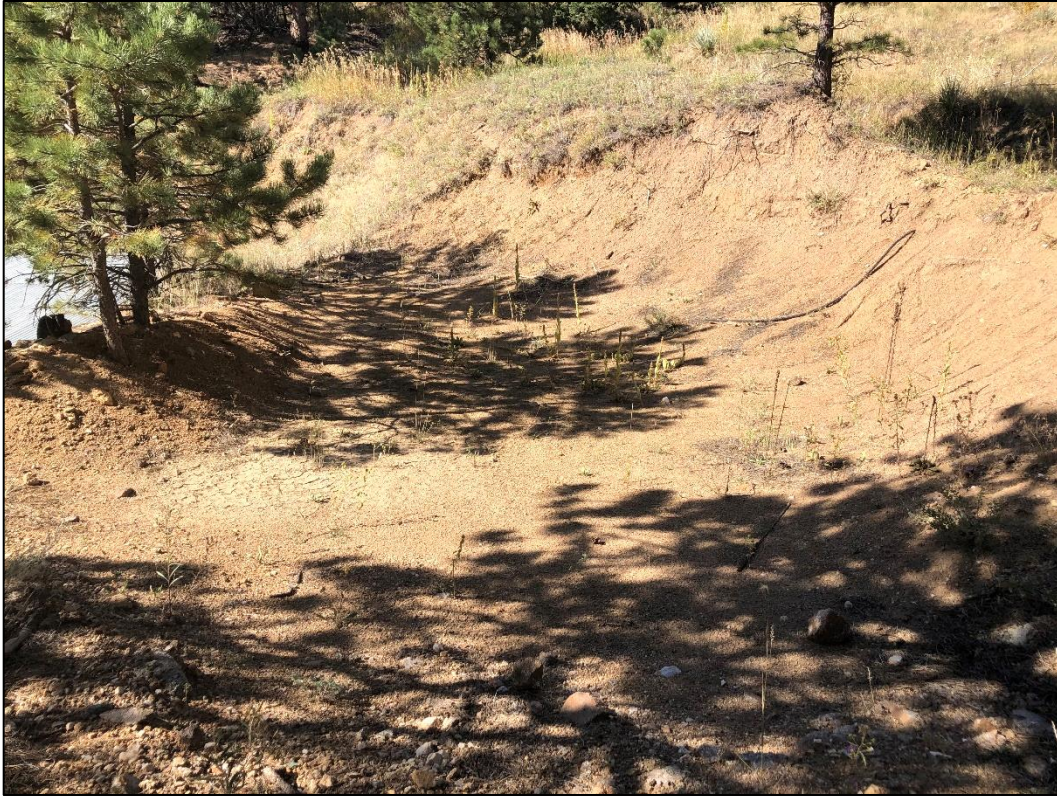
**Photo 3.** View looking southwest across leveled area on hillside W/NW of mining area which was used for stockpile storage. This area must be graded to 3H:1V, retopsoiled, and revegetated for reclamation.

A leveled area approximately 0.1 acre in size exists on the hillside between the explosives storage area and the mining area where, according to the permit file, waste rock and/or development material had been stored at one time. This area will need to be graded, retopsoiled and seeded for reclamation. There is enough space available west/northwest of this area in order to cut the slope back to 3H:1V using the bank material as fill. The downgradient, bedrock portion of the slope may require some additional fill material in order to achieve a 3H:1V slope configuration. A grassed over topsoil stockpile is stored at the northeastern edge of the permit area, just outside of the fenced enclosure. The land underneath this stockpile would need to be ripped and revegetated after the topsoil is used for reclamation. Mr. Covey inquired about possibly importing some

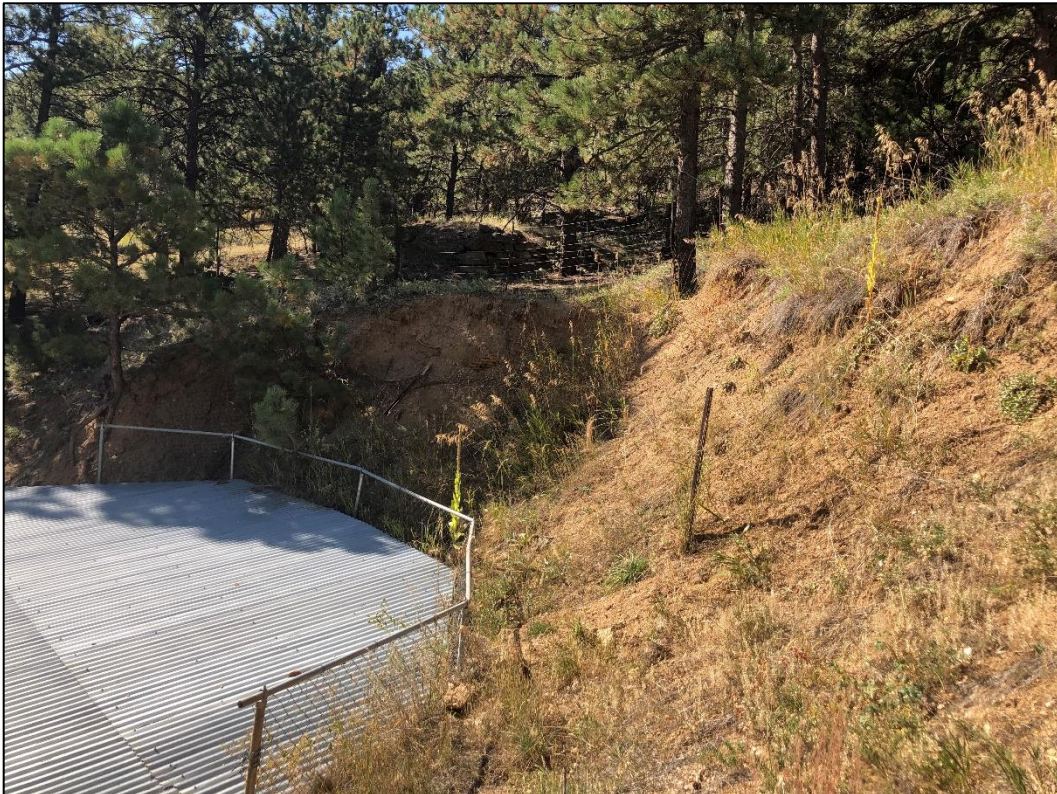
**Photo 4.** View looking southwest across steep slope behind winch house (roof of winch house visible at bottom, left). This slope must be graded to 3H:1V, unless reclamation plan is revised to leave winch house and steeper slopes in this area.

For reclamation, the steep slope banks in the mining area must be graded to 3H:1V and the disturbed area retopsoiled and revegetated. Mr. Covey inquired about revising the approved reclamation plan to leave some slopes steeper than 3H:1V, particularly those adjacent to the winch house. At this time, grading the slopes behind the winch house would require removal of the winch house and concrete blocks built into the bedrock behind the winch house, and possibly some blasting in order to lay back the steep bedrock slopes. If the operator proposes (in a Technical Revision) to keep the winch house for reclamation, this would greatly simplify the reclamation required in this area. If such a proposal is submitted, the operator would need to specify in the revised reclamation plan which portions of the slopes would remain steeper than 3H:1V and explain how leaving these steeper slopes would be consistent with the residential post-mining land use. Mr. Covey also inquired about revising the approved seed mixture for the site. This could be done through the same Technical Revision submittal.

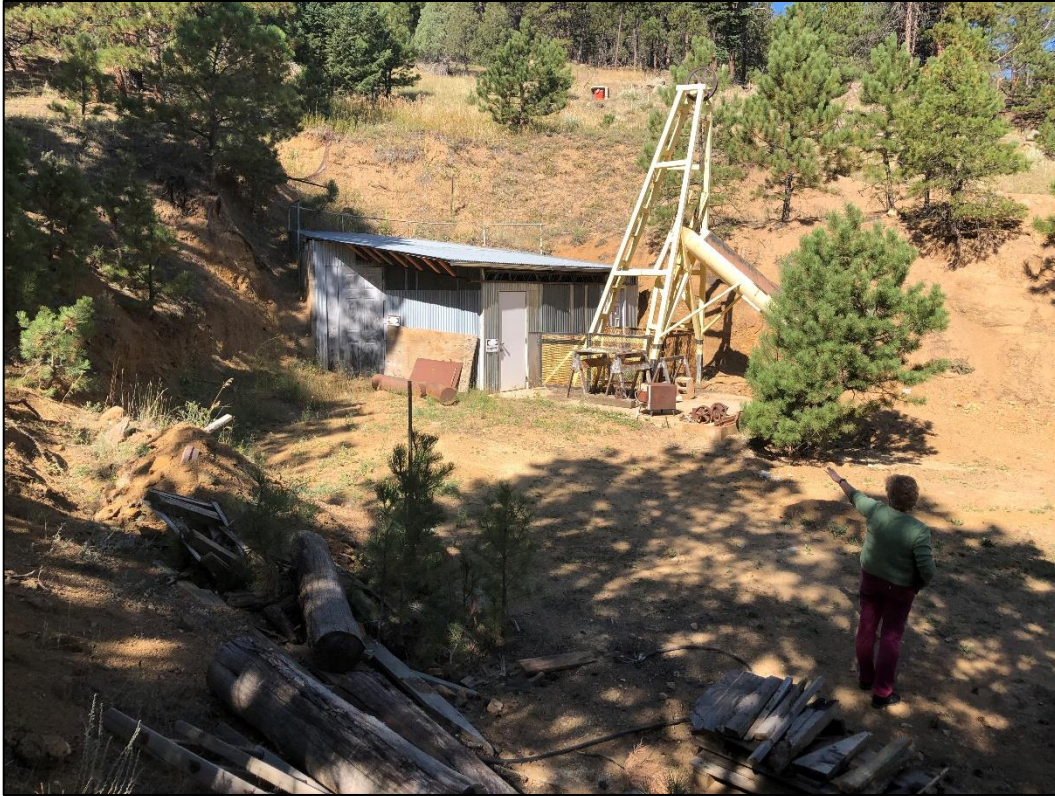
**Photo 5.** View looking southwest across mining area, showing winch house and headframe which must be removed, unless reclamation plan is revised to leave winch house (headframe must be removed). Steep slopes encircling this area must be graded to 3H:1V, and the area retopsoiled and revegetated for reclamation.

sits on a concrete slab and includes a large steel winch and a hole in the bedrock that is approximately 12 feet deep. The back wall of the winch house is built into the bedrock with concrete blocks. For reclamation, the operator would need to remove the winch house, all components inside (including the winch), and the headframe, and either backfill or cap the hole inside the winch house.

Mr. Covey inquired about leaving the winch house for residential storage, as was approved for the other buildings present on site. The Division explained this could be proposed through a Technical Revision (form enclosed). However, the winch and headframe would still need to be removed for reclamation as they are considered strictly mining-related structures, and leaving them would not be consistent with the approved residential post-mining land use. In the Technical Revision, the operator should also address how the hole inside the winch house will be reclaimed, either backfilled or capped. Mr. Covey indicated they do have some steel that was cut for this opening some years ago. Therefore, they may propose to secure the opening with a steel cap. If the operator must import fill material from off-site (outside of the permit area) to fill the hole or for any other reclamation purposes, this proposal must also be submitted through the Technical Revision process. Such a proposal must address all applicable requirements of Rule 3.1.5(9), including a narrative describing the approximate location(s) of the proposed backfill activity, the approximate volume of material to be backfilled, a signed affidavit certifying the material is clean and inert, the approximate dates the proposed activity will commence and end, an explanation of how the backfilled site will result in a post-mining configuration that is compatible with the approved post-mining land use, and a general plan stating how the material will be placed and stabilized in a manner to avoid unacceptable settling and voids.

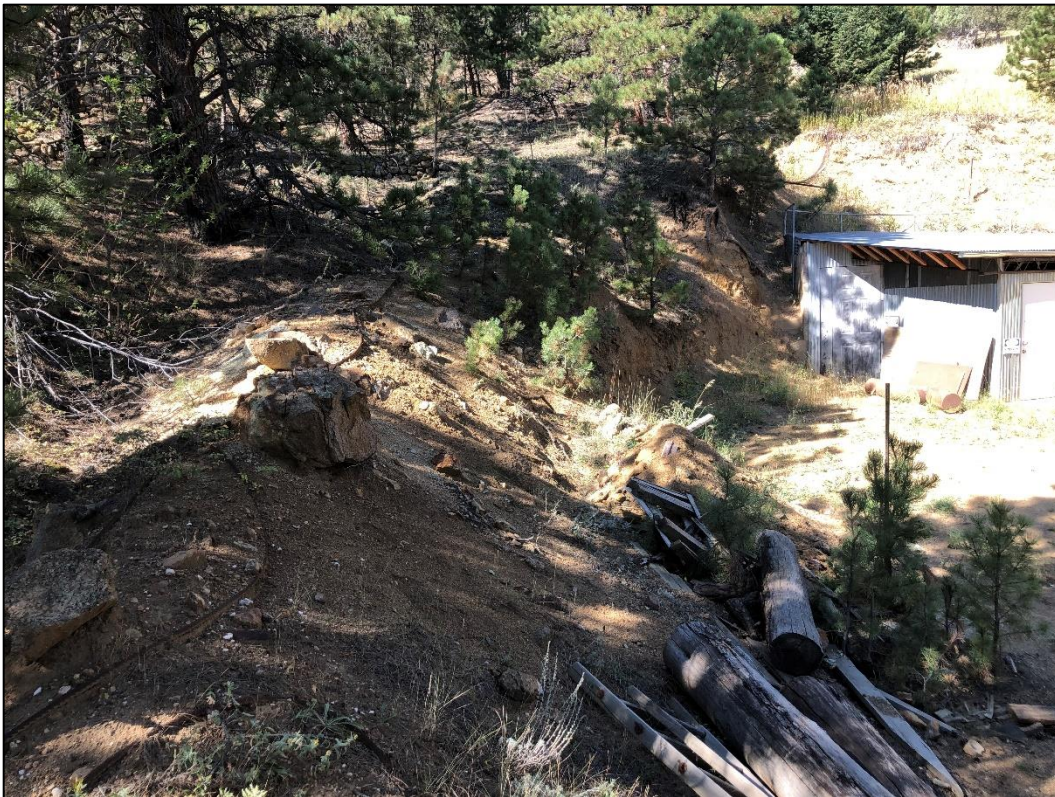
**Photo 6.** View looking southwest across southern slope of mining area. This slope must be graded to 3H:1V for reclamation. Steeper bedrock slopes behind winch house (at right) may remain if reclamation plan is revised to leave winch house and steeper slopes in this area.

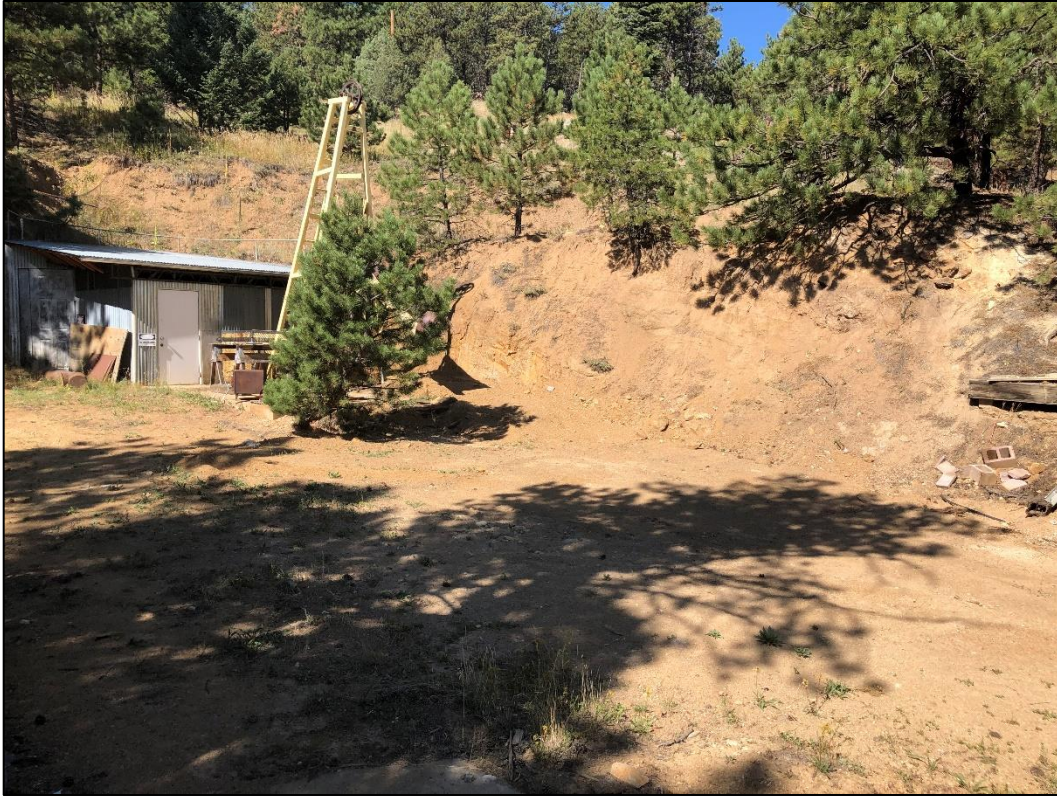
**Photo 7.** View looking northwest at northern slope of mining area which must be graded to 3H:1V for reclamation.

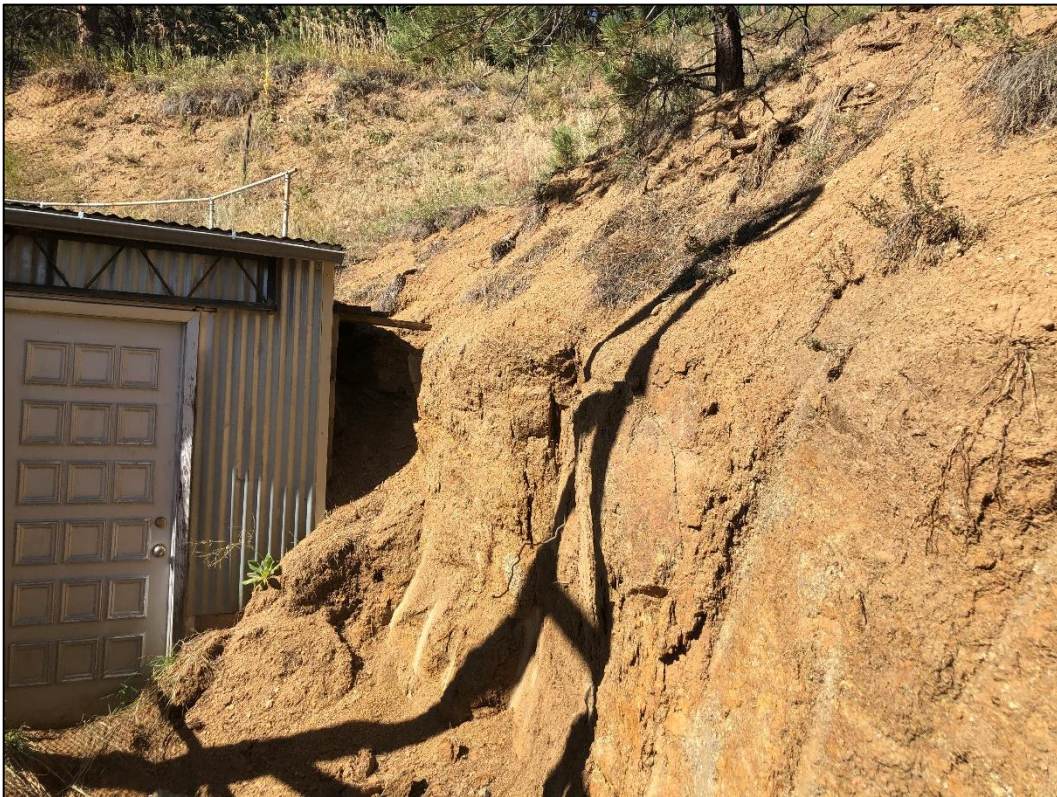
**Photo 8.** View looking southwest across steep northern slope adjacent to winch house. This slope must be graded to 3H:1V for reclamation. Steeper bedrock slopes behind winch house may remain if reclamation plan is revised to leave winch house and steeper slopes in this area.

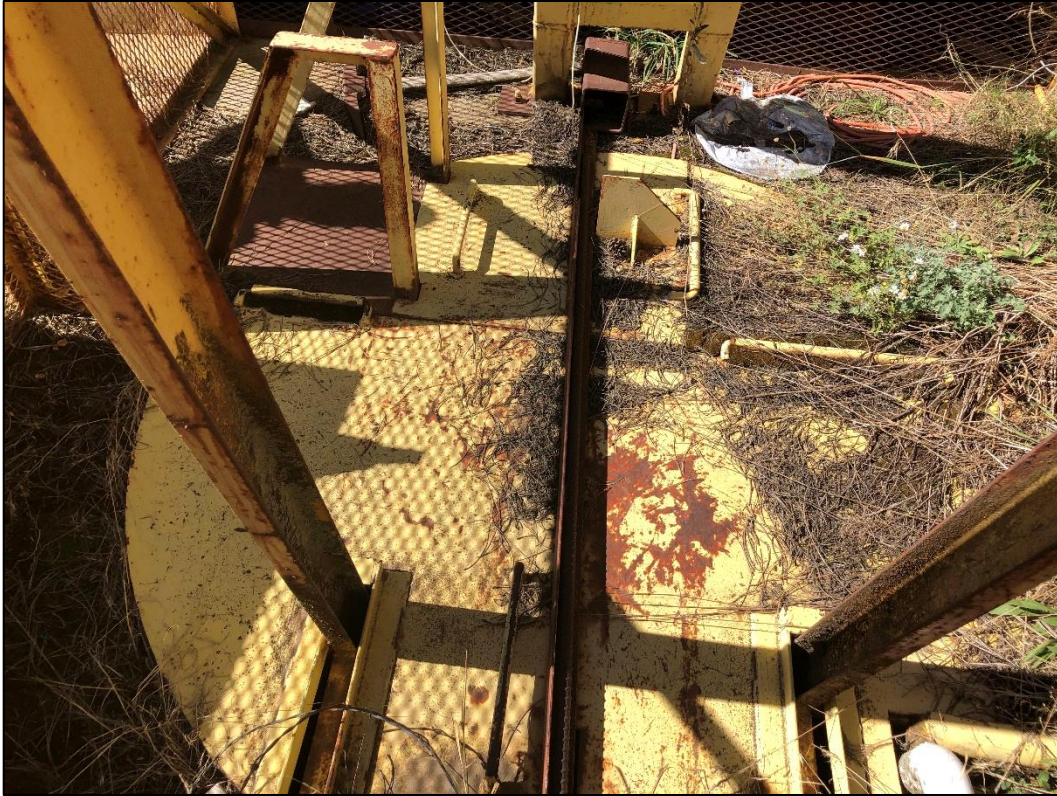
**Photo 9.** View of Phil Sheridan Shaft collared in concrete slab, and capped and secured by covered locking device. Shaft area is enclosed by metal fencing.

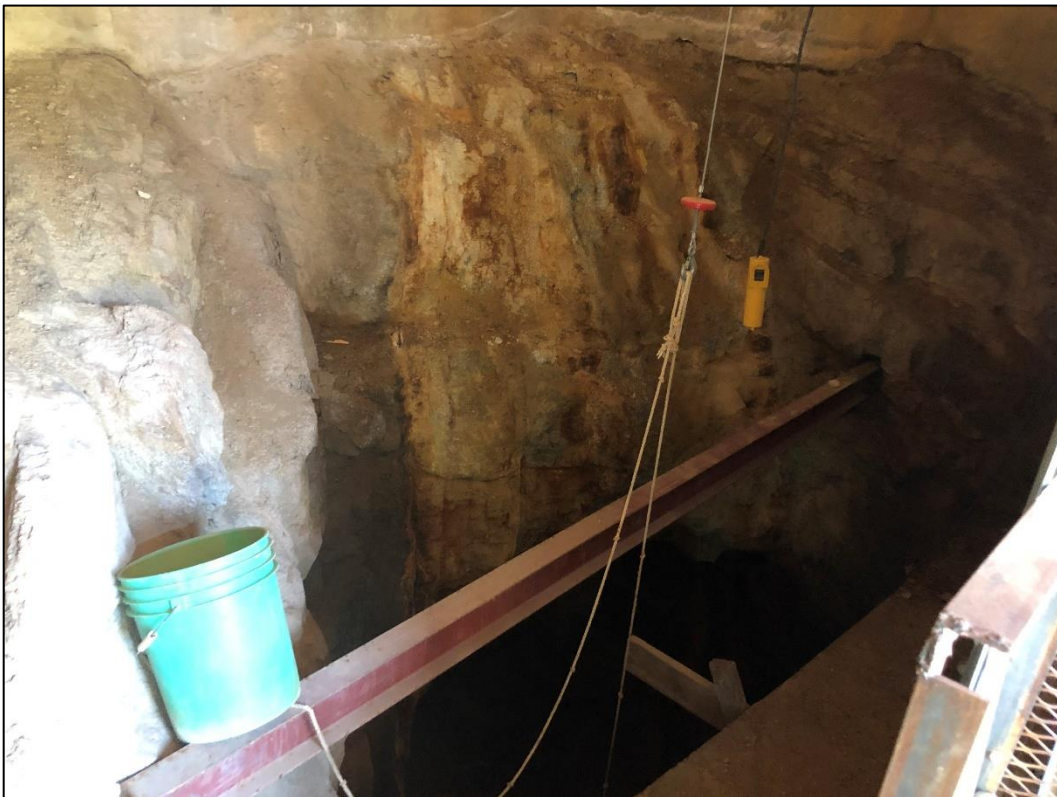
**Photo 10.** View inside winch house, showing hole in bedrock which must be capped or backfilled for reclamation.

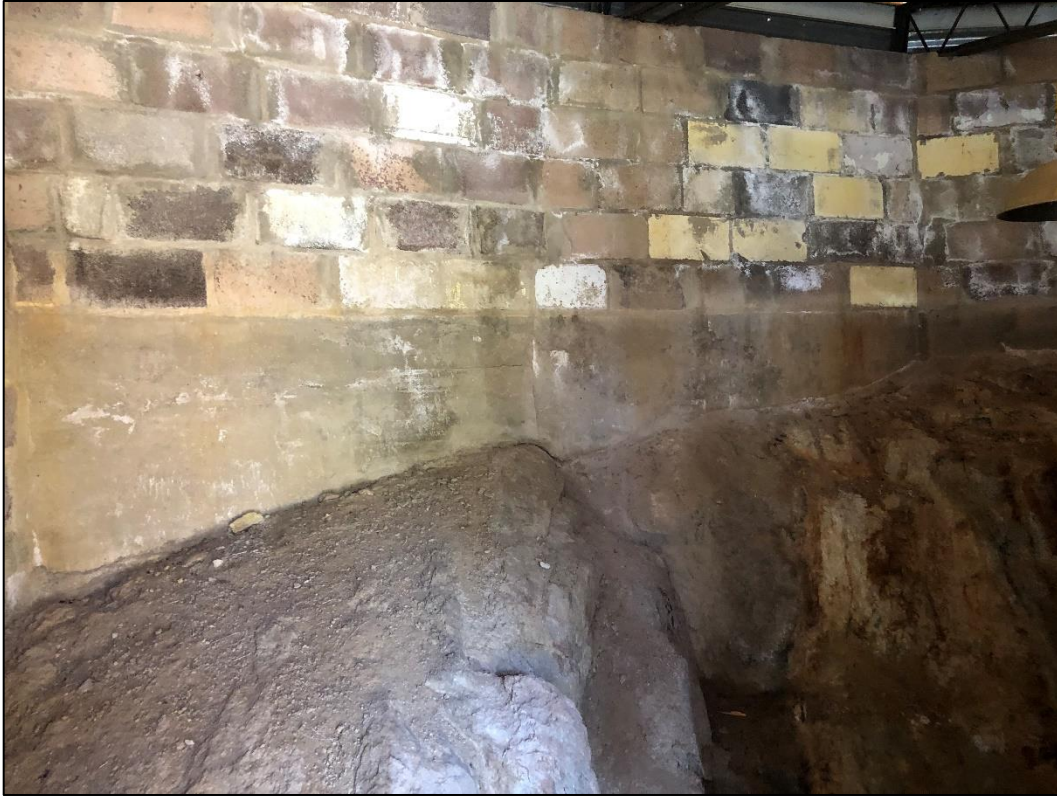
**Photo 11.** View inside winch house, showing concrete wall built into bedrock which would need to be demolished and removed from site unless reclamation plan is revised to leave winch house. Hole inside building (at bottom right) must be capped or backfilled for reclamation.

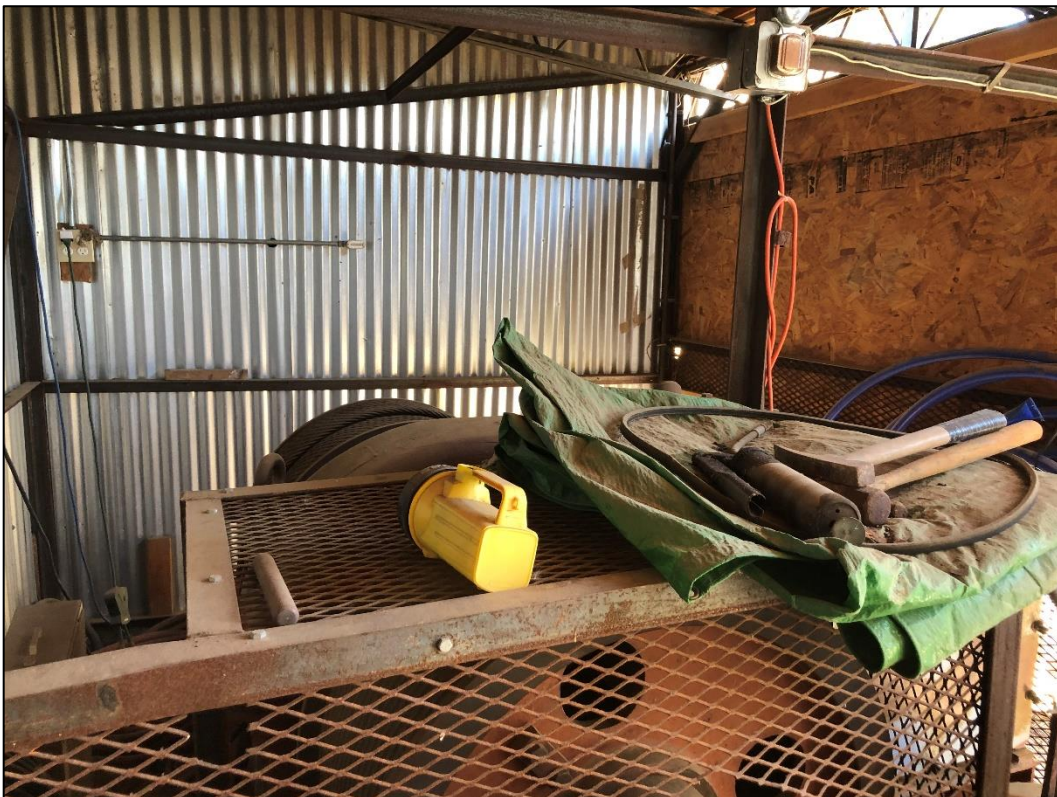
**Photo 12.** View inside winch house, showing mine winch (at bottom, center) that must be removed from site for reclamation, even if reclamation plan is revised to leave winch house.

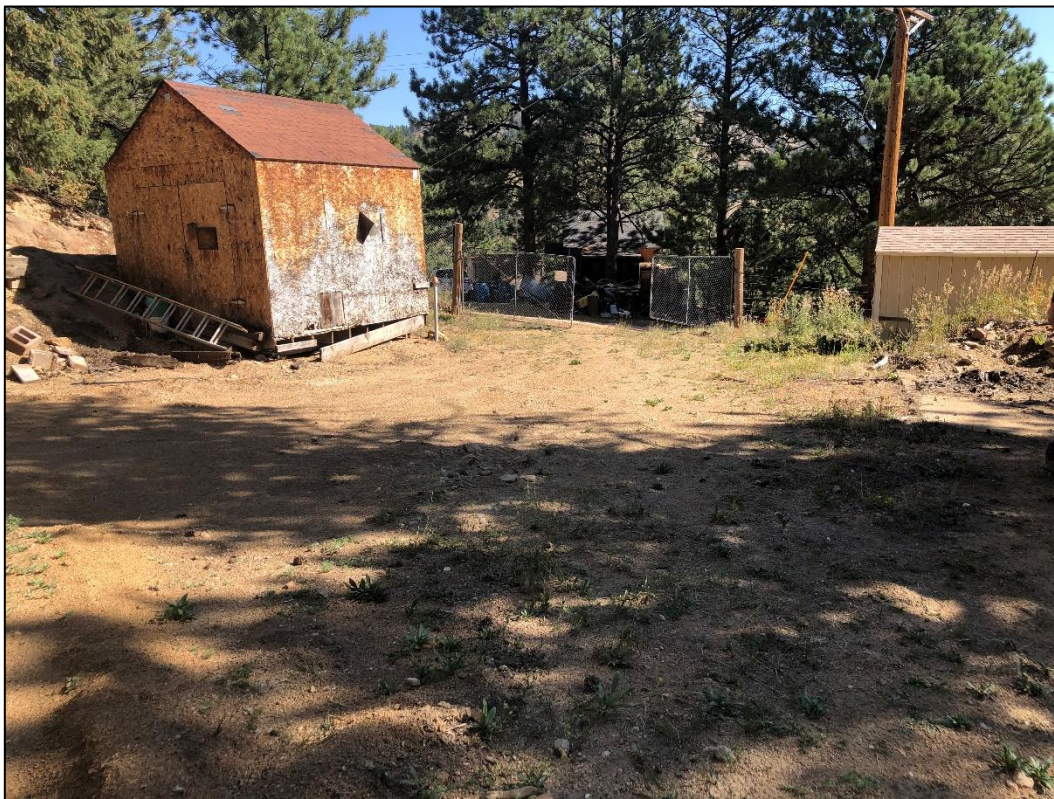
**Photo 13.** View looking northeast across eastern portion of mining area, showing access gate (at center), small particle board shed (at left), and Tuff Shed (at right) which will remain for reclamation. This area must be retopsoiled and revegetated for reclamation.

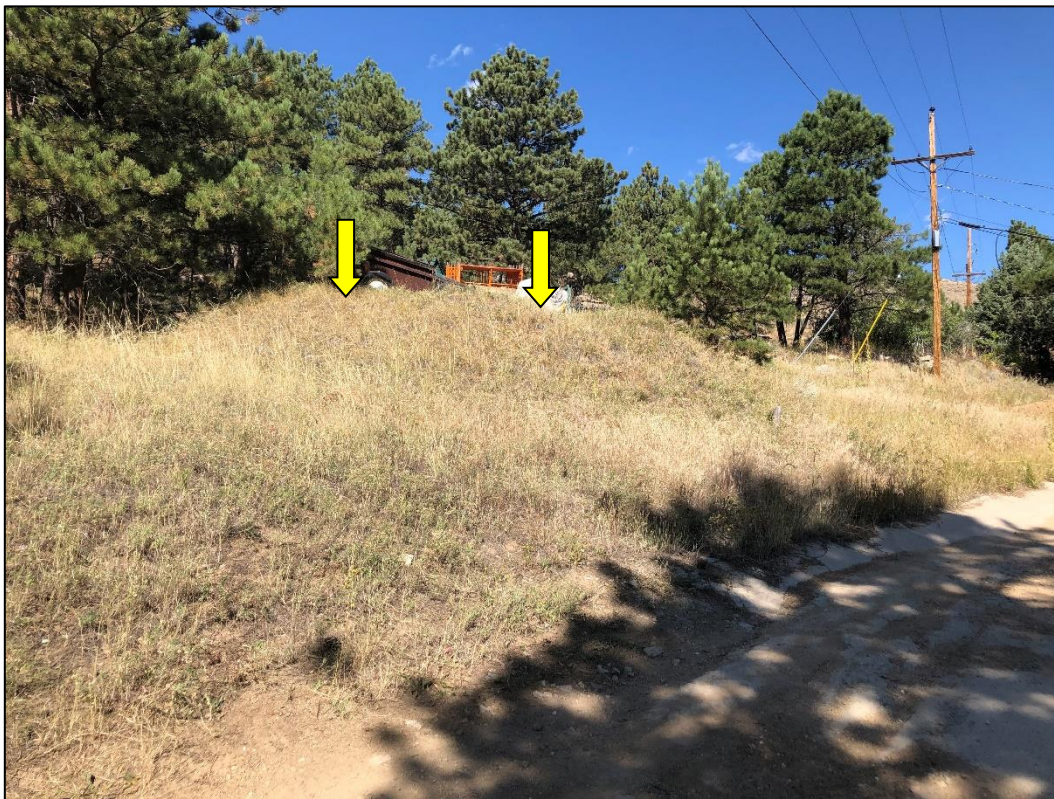
**Photo 14.** View looking northwest at grassed over topsoil stockpile (indicated) stored at northeastern edge of permit area. After this material is used for reclamation, the area underneath would need to be ripped and revegetated.
