MINERALS PROGRAM INSPECTION REPORT
PHONE: (303) 866-3567

MINE NAME: Sheep Mountain Ranch	MINE/PROSPECTING ID#: M-2017-022	MINERAL: Sand and Gravel	COUNTY: Huerfano
INSPECTION TYPE: Monitoring	INSPECTOR(S): Patrick Lennberg	INSP. DATE: October 12, 2021	INSP. TIME: 11:30
OPERATOR: Huerfano County Conservancy District	OPERATOR REPRESENTATIVE: Kent Mace	TYPE OF OPERATION: 112c - Construction Regular Operation

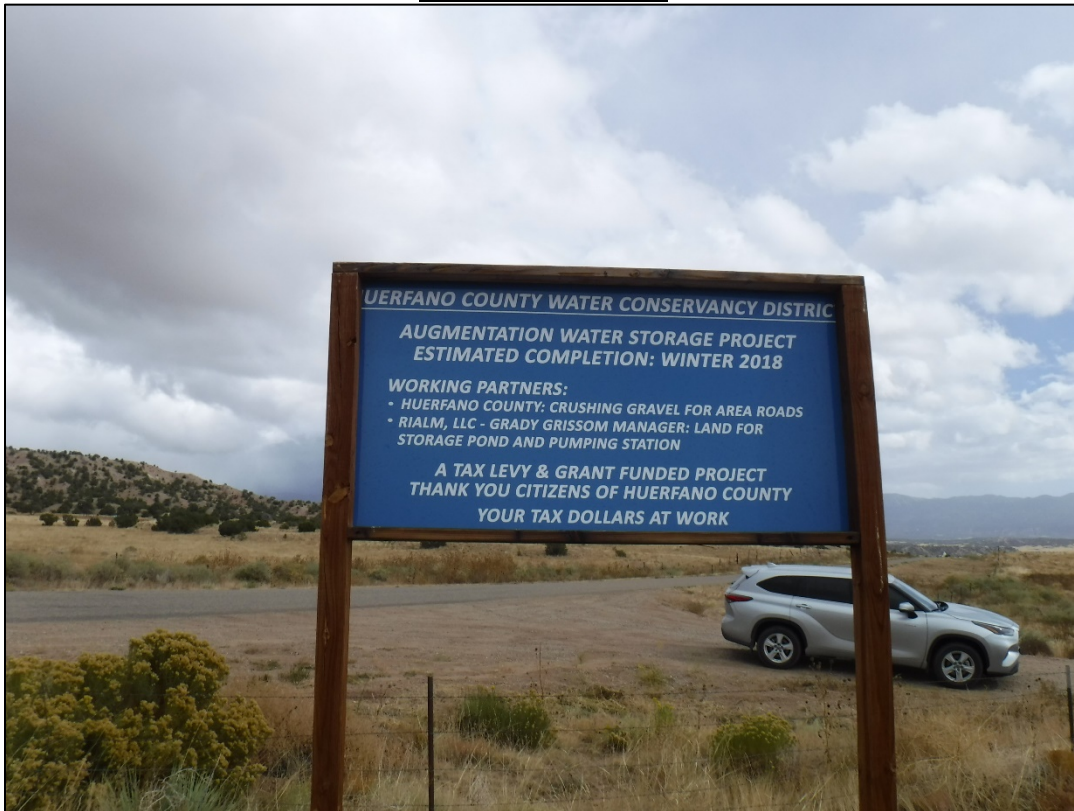
PROBLEM: The mine identification sign was not posted at the entrance of the mine site. This is a problem for failure to post a mine identification sign as required by Section 3.1.12(1) of the rule. The Operator shall, at the entrance of the mine site post a sign, which shall be clearly visible from the access road, with a minimum size equaling one hundred and eighty-seven (187) square inches, such as eleven (11) inches in height and seventeen (17) inches in width, with appropriate font size, with the following: the name of the Operator, a statement that a reclamation permit for the operation has been issued by the Colorado Mined Land Reclamation Board; and the permit number.

The entrance to the 112c, 23 acre, mine is off of County Road 550 approximately 1.4 miles west from the intersection of County Road 550 and State Highway 69 which is just west of Gardner, CO. The site is operated by Huerfano County Water Conservancy District. A mine sign was not posted at the mine entrance pursuant to Rule 3.1.12 and has been cited as a problem in this report.

Photo 1: Sign at mine entrance location

CORRECTIVE ACTIONS: The operator shall, at the entrance of the mine site, post a sign which shall be clearly visible from the access road. The operator shall submit photo documentation that a proper sign has been posted by the corrective action date.

CORRECTIVE ACTION DUE DATE: 12/14/21

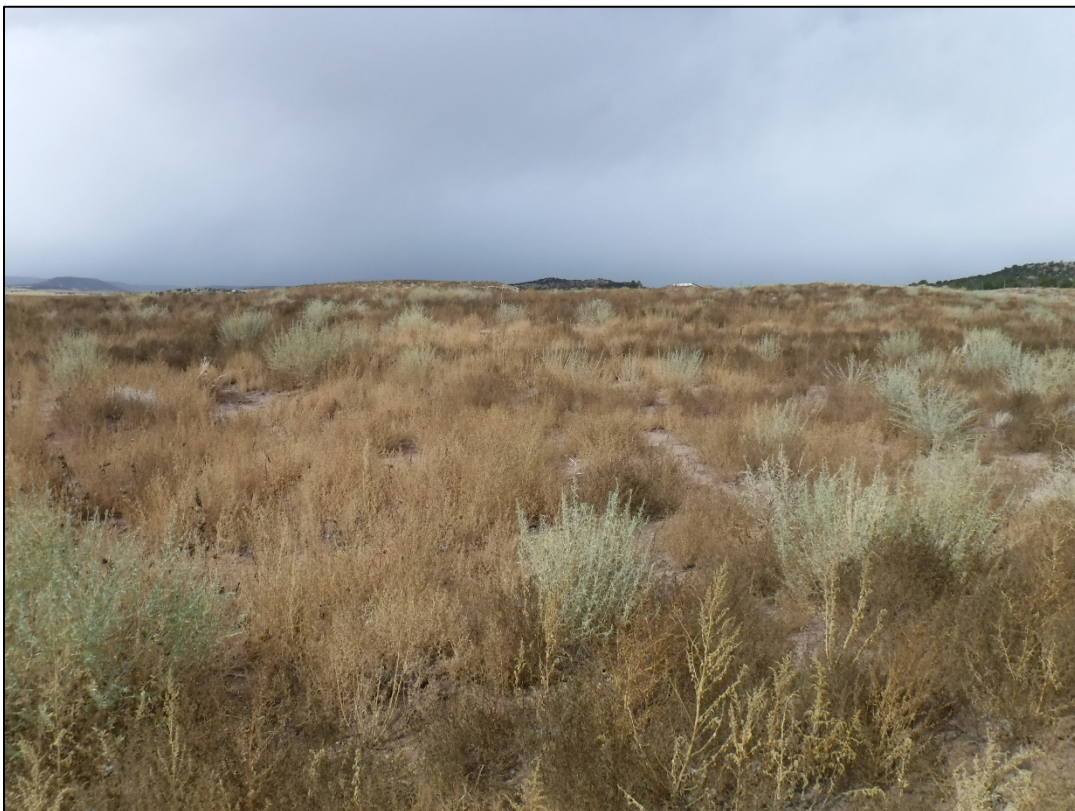
In speaking with Mr. Mace he indicated the site still needs some minor grading and topsoiling in areas. The disturbed areas of the site did have kochia growing on them. Mr. Mace indicated both he and the rancher working the site are prepared for this and will be planting additional seeds in the future Spring/Fall of 2022 as warranted.

Photo 2: Kochia growing in disturbed areas of the site, east of reservoir

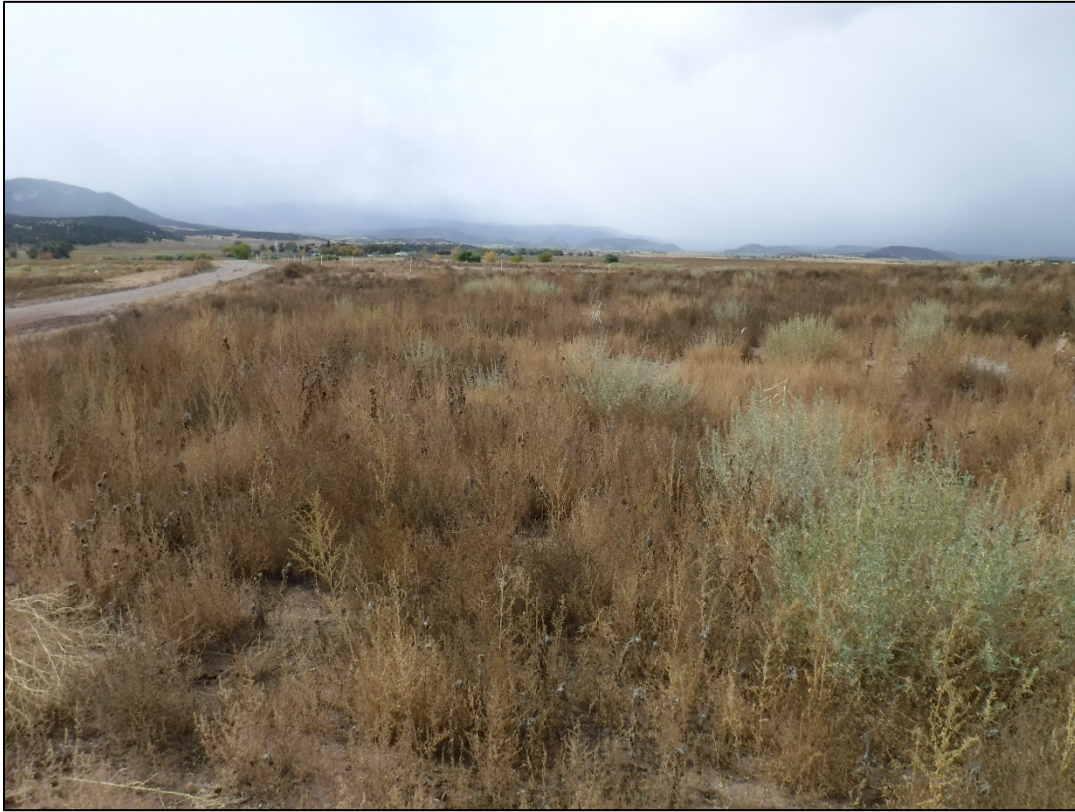
Photo 3: Looking from access road west towards reservoir

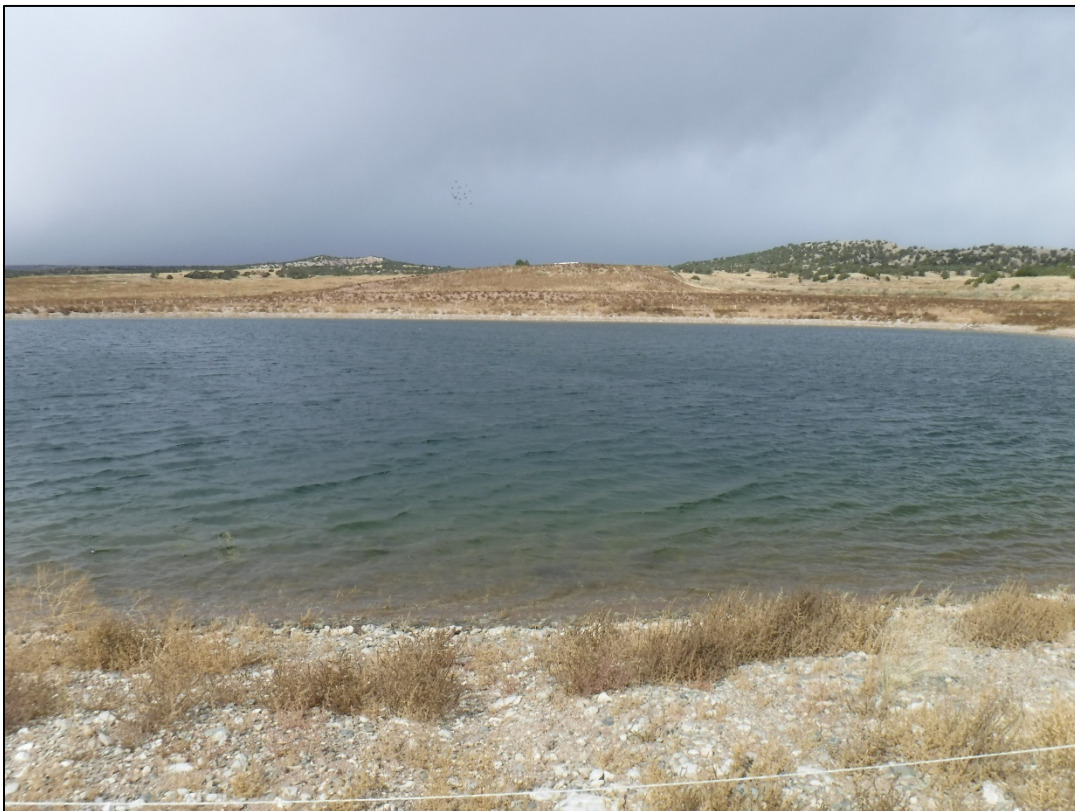
The mine was not active at the time of inspection. The site has entered into final reclamation. The water resources reservoir is filled with water and is operating as designed. The Division received a letter of compliance from DWR on September 16, 2021 showing the reservoir is in compliance with DWR standards.

Photo 4: Looking north across completed reservoir

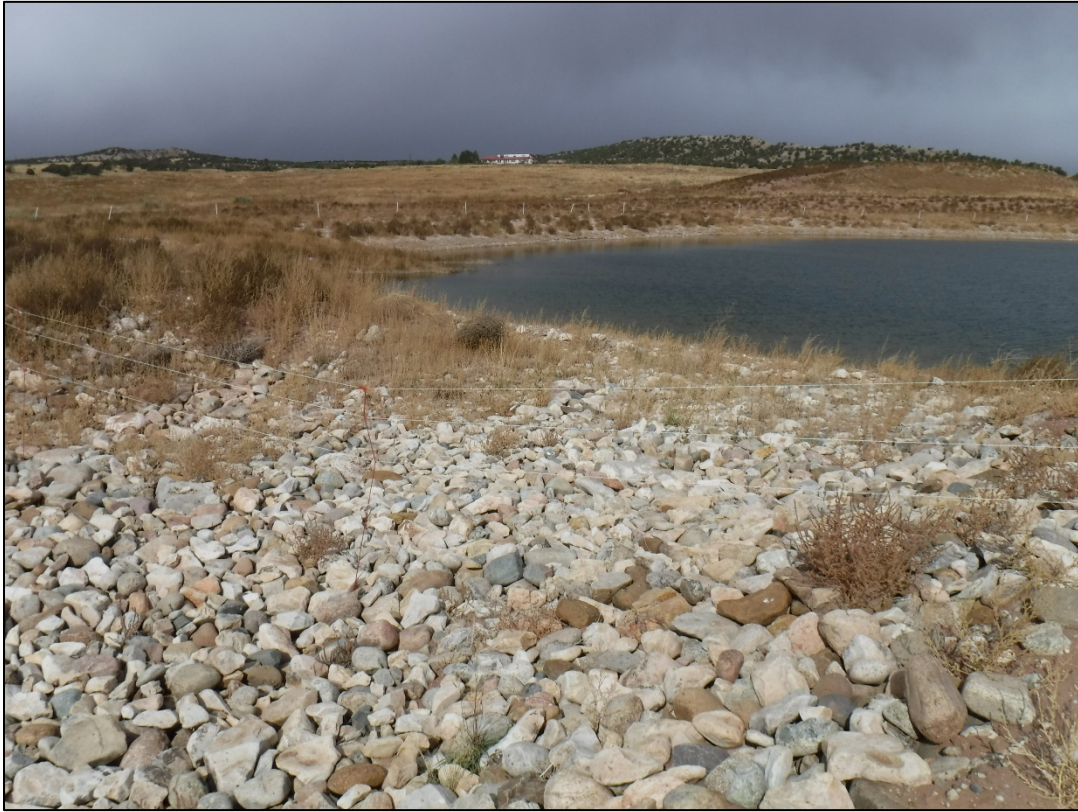
Photo 5: Spill way of reservoir

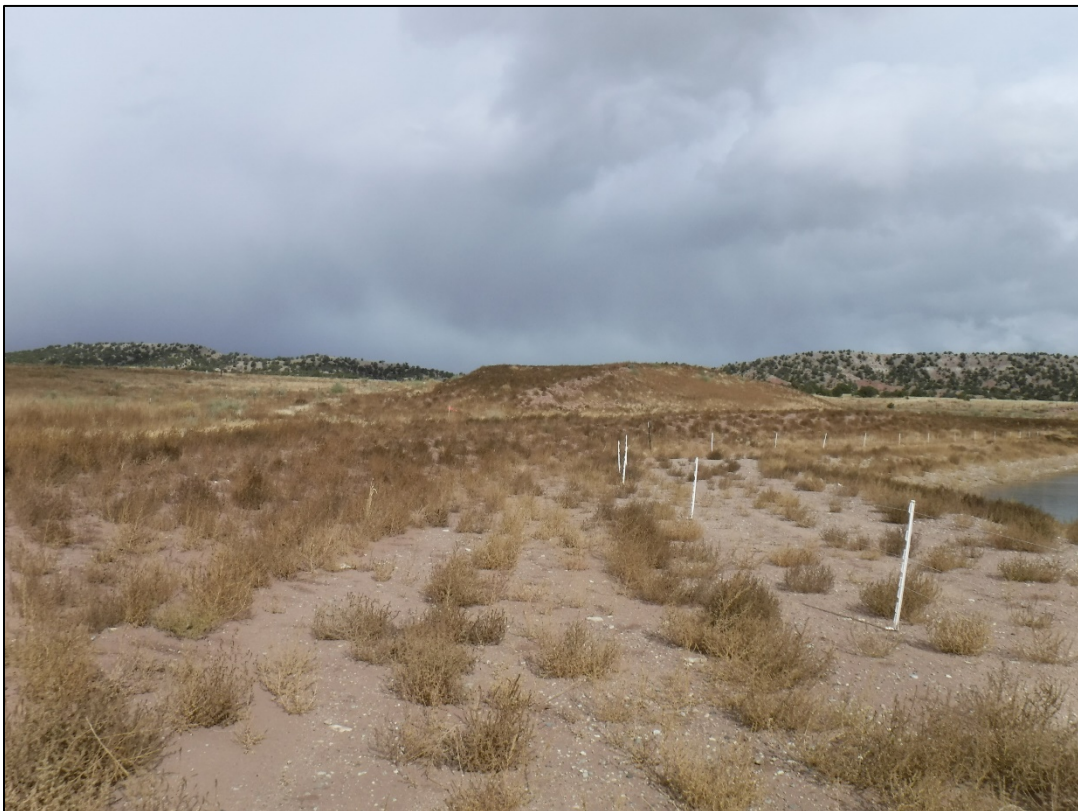
Photo 6: Remaining topsoil stockpile
