## MINERALS PROGRAM INSPECTION REPORT

<b>MINE NAME:</b> Lamar West Pit	<b>MINE/PROSPECTING ID#:</b> M-1981-132	<b>MINERAL:</b> Sand and gravel	<b>COUNTY:</b> Prowers
<b>INSPECTION TYPE:</b> Monitoring	<b>INSPECTOR(S):</b> Amy Eschberger	<b>INSP. DATE:</b> October 20, 2021	<b>INSP. TIME:</b> 13:30
<b>OPERATOR:</b> VALCO, Inc.	<b>OPERATOR REPRESENTATIVE:</b> Tom Brubaker	<b>TYPE OF OPERATION:</b> 112c - Construction Regular Operation

# M-1981-132 / Lamar West Pit / Valco, Inc.

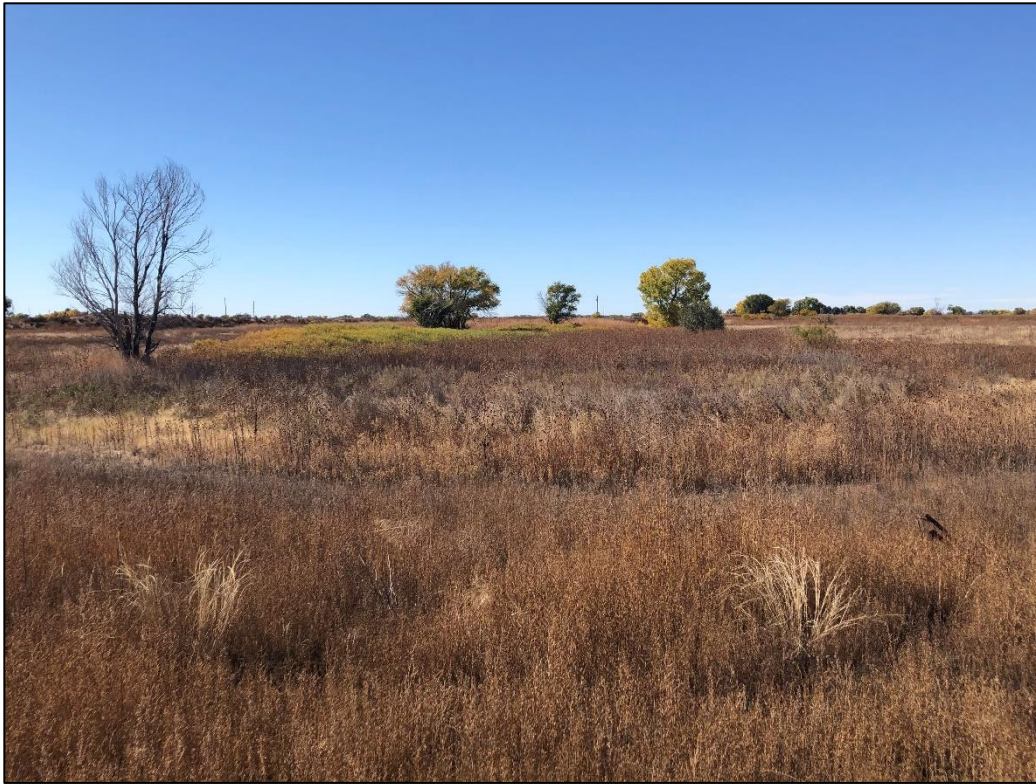
**Photo 1.** View looking west across disturbed area in southern portion of permit area, with slopes graded flatter than 3H:1V and good vegetative cover.

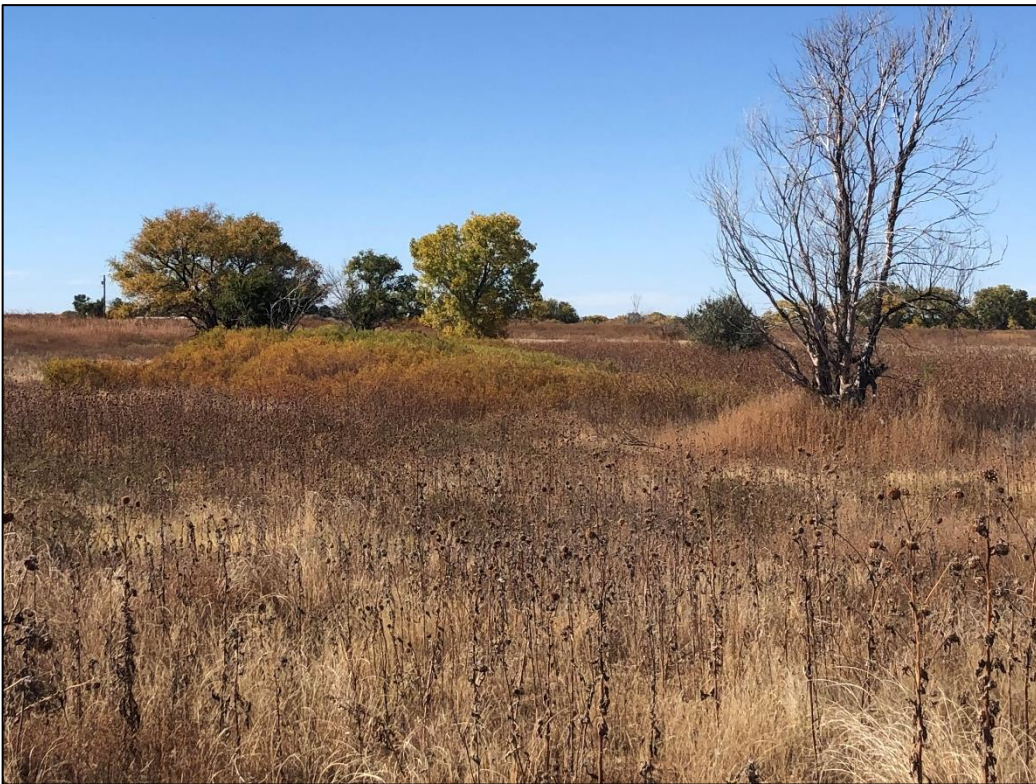
**Photo 2.** View looking northwest across disturbed area in southern portion of permit area, with slopes graded flatter than 3H:1V and good vegetative cover. Annual weeds (mainly kochia and wild sunflowers) did not appear to be hindering growth of desired vegetation.

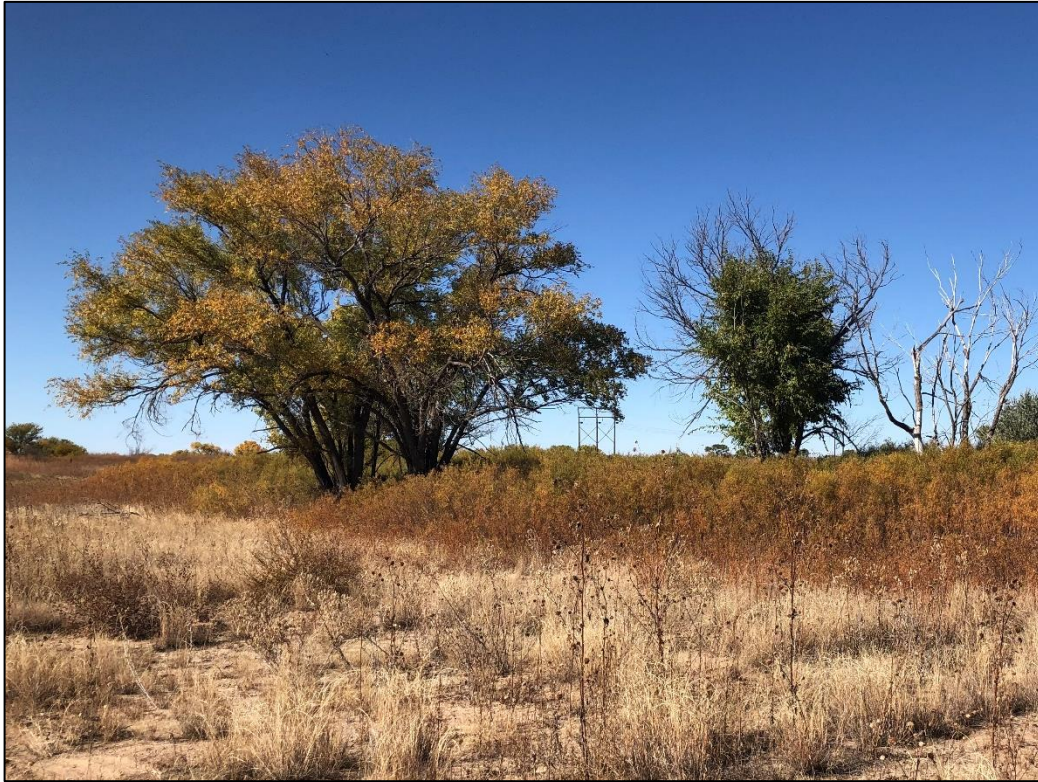
**Photo 3.** View looking north across disturbed area in southern portion of permit area, with slopes graded flatter than 3H:1V and good vegetative cover. Annual weeds (mainly kochia and wild sunflowers) did not appear to be hindering growth of desired vegetation.

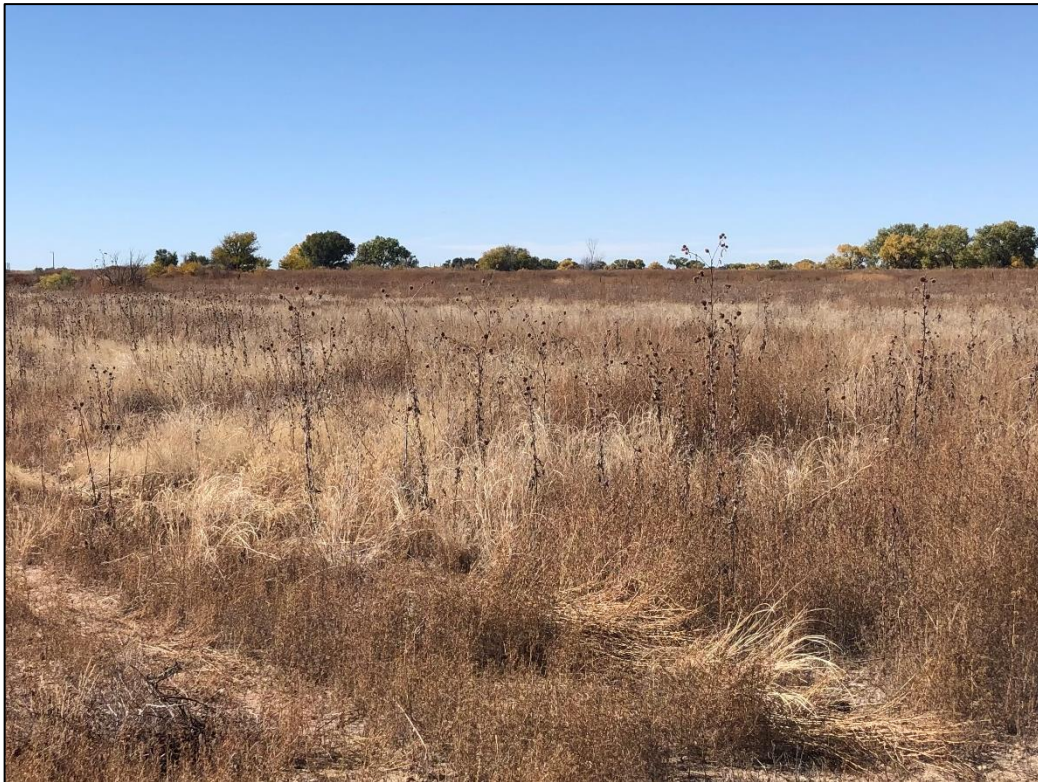
**Photo 4.** View looking northwest across northern edge of disturbance area where material was cut for backfilling pit. Note slopes graded flatter than 3H:1V and good vegetative cover. Annual weeds (mainly kochia and wild sunflowers) did not appear to be hindering growth of desired vegetation.
