MINERALS PROGRAM INSPECTION REPORT
PHONE: (303) 866-3567

MINE NAME: Ayers Pit	MINE/PROSPECTING ID#: M-1981-004	MINERAL: Sand and gravel	COUNTY: Morgan
INSPECTION TYPE: Monitoring	INSPECTOR(S): Brock Bowles	INSP. DATE: October 15, 2021	INSP. TIME: 12:00
OPERATOR: Dilleys Sand & Gravel	OPERATOR REPRESENTATIVE: Chris Monahan	TYPE OF OPERATION: 112c - Construction Regular Operation

INSPECTION TOPIC: Revegetation

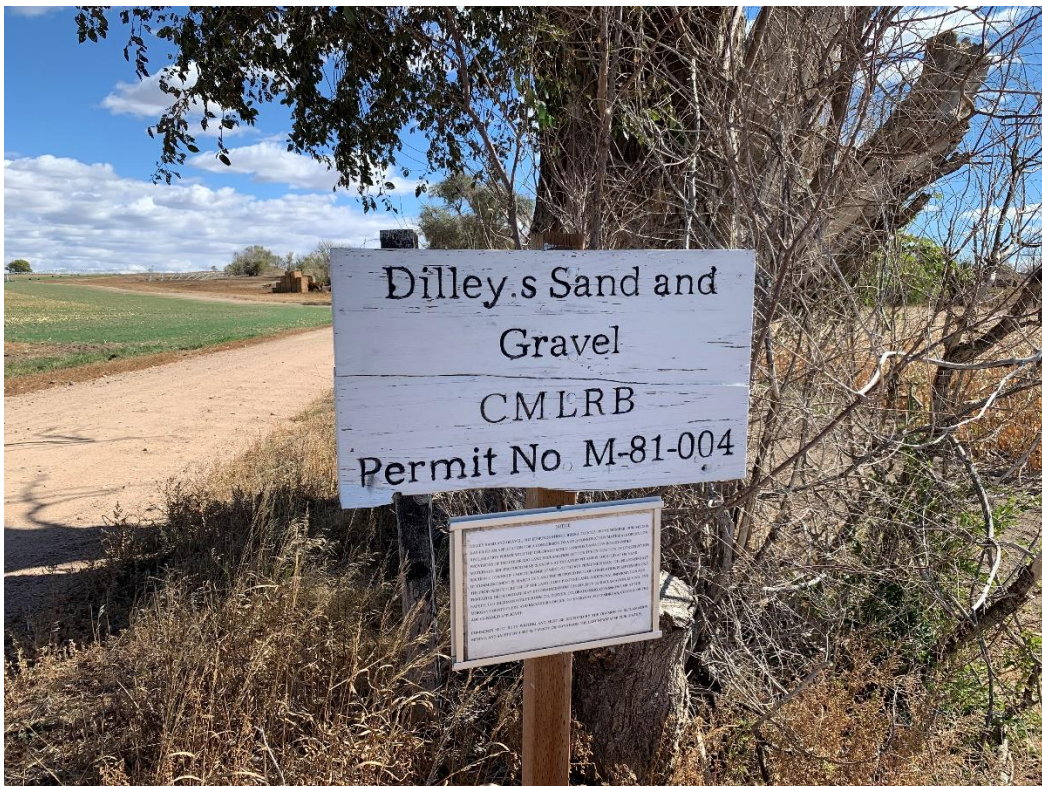
The permit entrance sign was in place (photo 1) and the permit boundary was marked with t-posts.

Photo 1 – Mine entrance sign facing CR 23

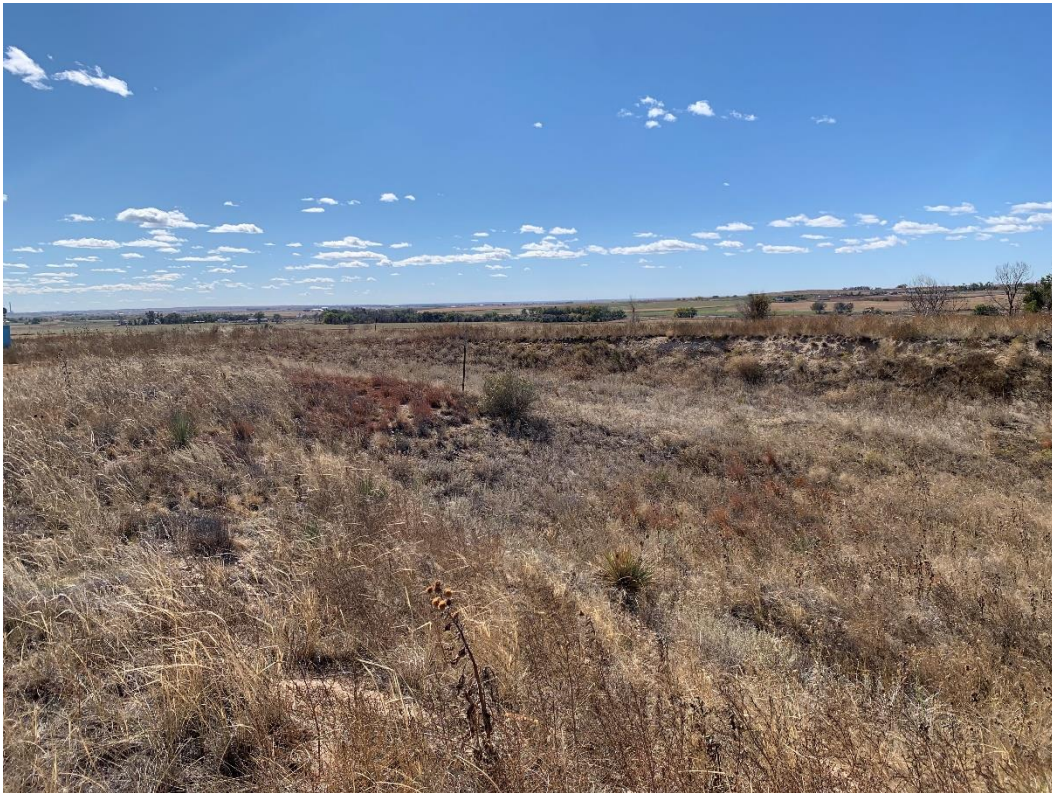
A front-end loader was on site but no mining was taking place during the inspection (photo 2). Several stockpiles were located on the pit floor. The topsoil was removed from the top of the highwall. Topsoil was stockpiled above the highwall in a long pile.

Photo 2 – Southeast corner post

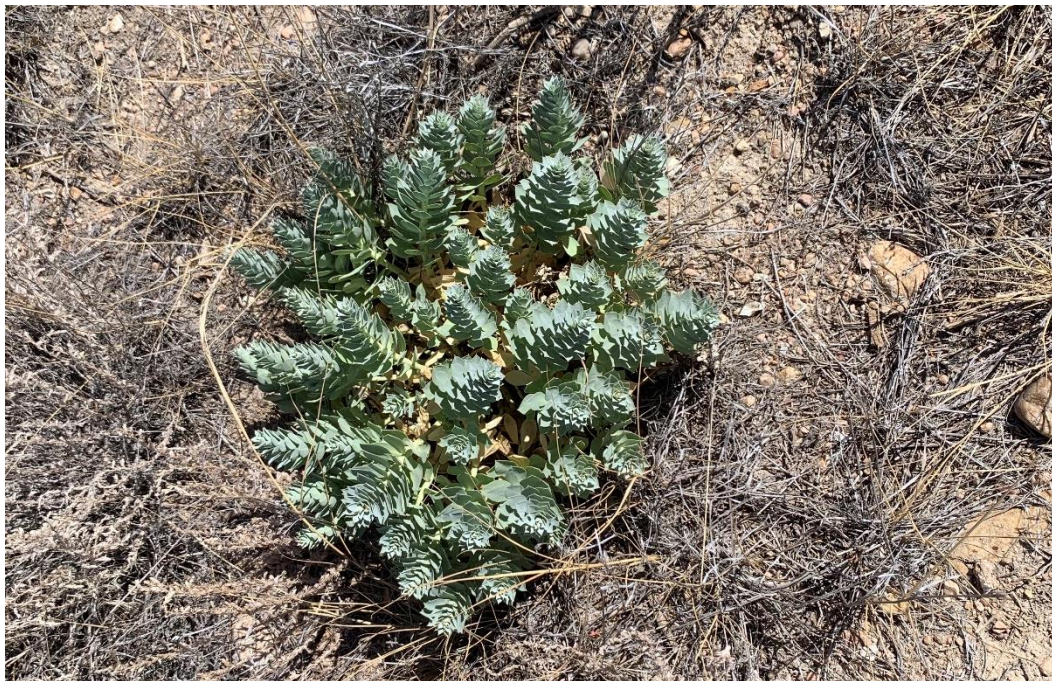
PROBLEM/POSSIBLE VIOLATION: Problem: Several plants of myrtle spurge were noted in the middle of the mined area. Myrtle spurge is a Class A state-listed noxious weed. This is a problem for failure to employ weed control methods for state listed noxious weed species within the permitted area, and to reduce the spread of weeds to nearby areas as required by Section 3.1.10 (6) of the rule.

Myrtle spurge plants were growing in a pond area in the middle of the pit area (photo 3). Myrtle spurge is a Class A state listed noxious weed and needs to be eradicated from the site. See the possible problem box above for more information. A Colorado Dept. of Agriculture fact sheet about myrtle spurge is attached to this report. It contains recommended management practices and additional resources.

Photo 3 – Myrtle spurge, Class A state listed noxious weed

CORRECTIVE ACTIONS: Implement the approved weed control plan in accordance with the county extension agency, or weed control district office. Provide photo documentation proof to the Division that the plan has been implemented. The photo documentation is due by November 30, 2021.

CORRECTIVE ACTION DUE DATE: 11/30/21

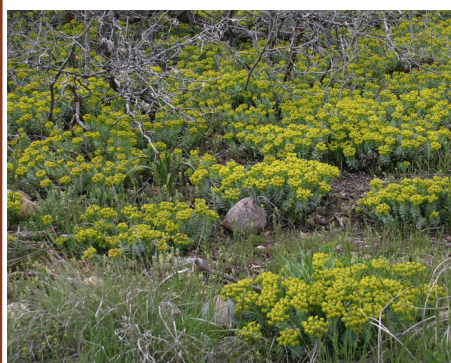
Myrtle spurge Identification and Management

1. Low growing plant with blue-green, waxy leaves.
2. Flowers are yellow-green petal like bracts that appear from March to May.

Myrrtle spurge (*Euphorbia myrsinites*) is a low growing perennial with trailing fleshy stems. The leaves are fleshy, blue-green and alternate. Flowers are inconspicuous with yellow-green, petal-like bracts that appear from March to May. Myrtle spurge spreads by seed and plants are capable of projecting seeds up to 15 feet. The plant grows from a taproot, with new stems emerging in early spring and dying back in the winter. Plants can grow up to 8-12 inches high and 12-18 inches in width.

The key to effective control of myrtle spurge is to remove plants prior to seed set and to detect and remove new populations in natural areas early on. Small areas can be easily removed by mechanical means but should be done early to prevent triggering seed launching. Details on the back of this sheet can help to create a management plan compatible with your site ecology.

Hand pull or dig when soil is moist. Make certain to pull all the roots and wear rubber gloves and eye protection to protect yourself from the toxic milky sap. Treatment follow up is important to check root fragment resprouts that will occur when the tap root is severed too shallow.
