Inspection report

MINERALS PROGRAM INSPECTION REPORT
PHONE: (303) 866-3567

MINE NAME: Pit No 2	MINE/PROSPECTING ID#: M-1983-106	MINERAL: Sand and gravel	COUNTY: Cheyenne
INSPECTION TYPE: Monitoring	INSPECTOR(S): Robert Zuber, P.E.	INSP. DATE: November 9, 2021	INSP. TIME: 10:50
OPERATOR: Cheyenne County	OPERATOR REPRESENTATIVE: Victor Gibbs	TYPE OF OPERATION: 112c - Construction Regular Operation

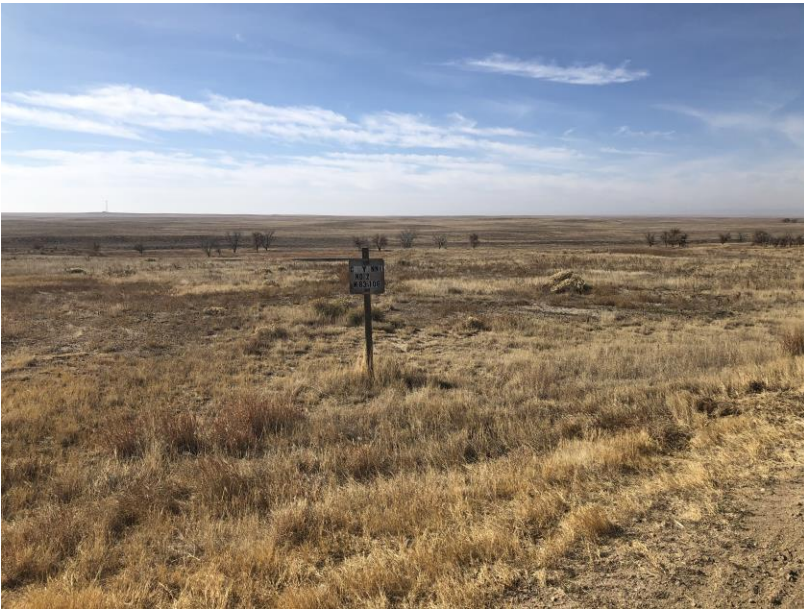
The entrance sign does not meet all of the requirements of Rule 3.1.12. If this sign is updated in the future, it should include a statement that the site holds a permit with the Division of Reclamation, Mining and Safety.

Entrance sign

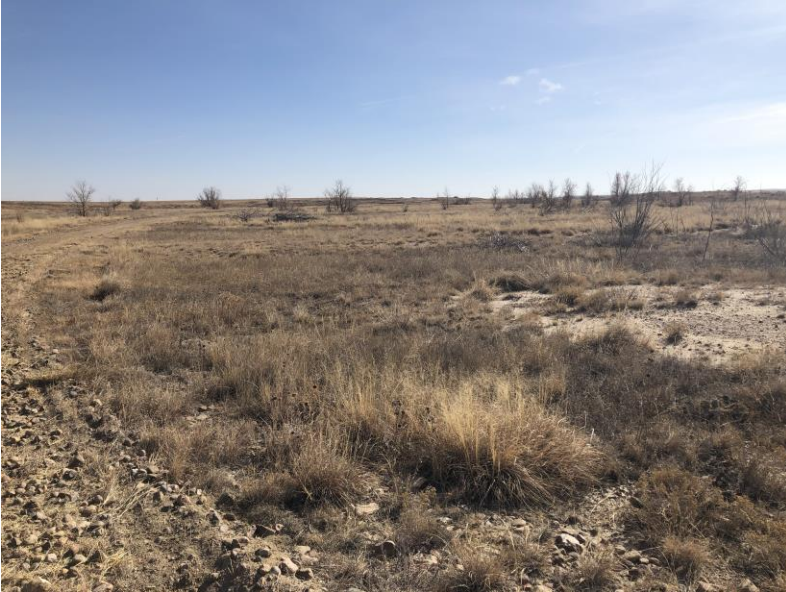
In the reclaimed areas, vegetation cover is good with grasses, sunflowers, rabbitbrush, and other desirable species. Several cottonwood trees were present. A few tamarisk trees were seen around the site. Victor Gibbs indicated that the County has treated tamarisk in the past. The County should continue to treat these trees per Rule 3.1.10(6).

Reclaimed area with small bare spot and trees in background (tamarisk, cottonwood)

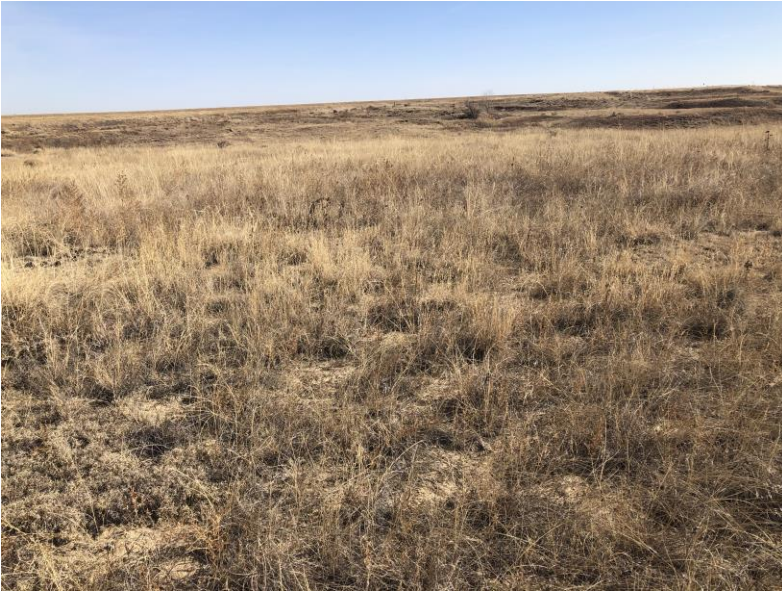
Grasses dominating reclaimed area

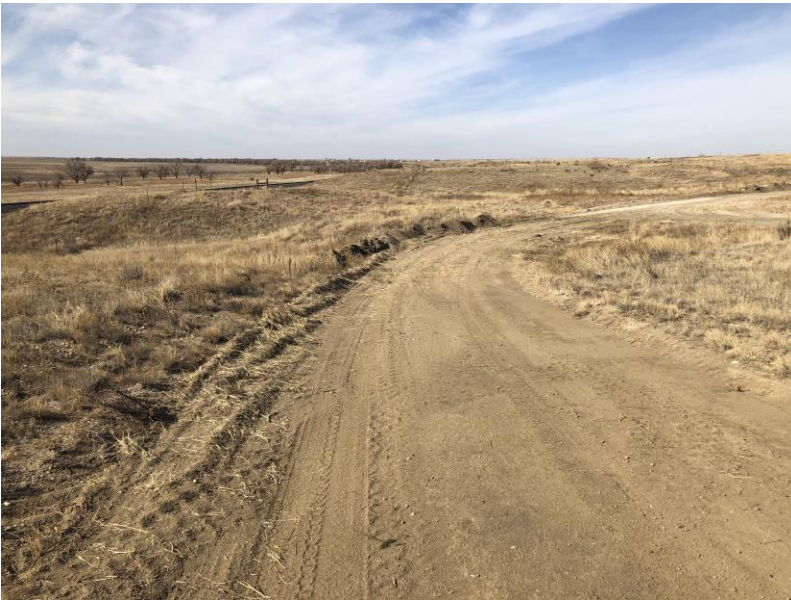
Area requiring improved drainage control in form of improved berm or BMPs

There was no indication that runoff from the site is causing problems in the nearby creek. Near the pit at the southeast end, it is recommended that the operator improve the berm that captures runoff from the area. A better solution would be the use of Best Management Practices (aka BMPs such as erosion logs or straw bales), as these trap sediment but allow water to pass through. However, BMPs require more maintenance than the berm.

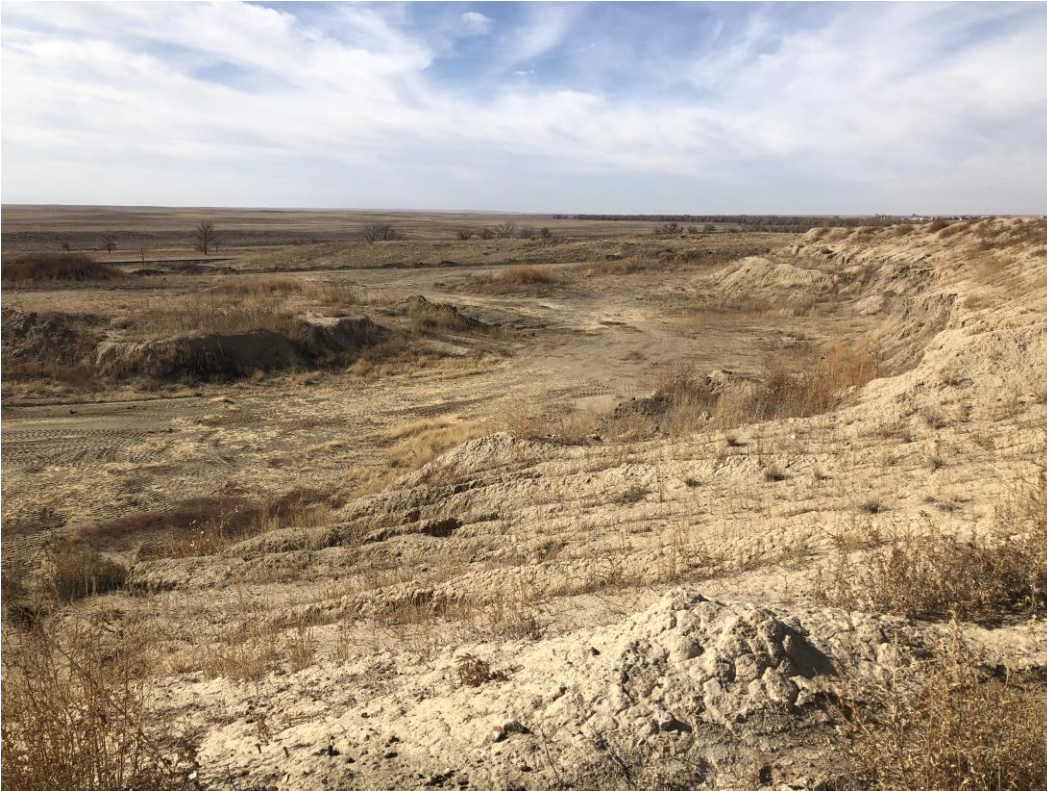
Active pit at southeast side of permit area
