## Inspection report for Ferris Pit

**MINERALS PROGRAM INSPECTION REPORT**  
**PHONE: (303) 866-3567**

<b>MINE NAME:</b> Ferris Pit	<b>MINE/PROSPECTING ID#:</b> M-1991-073	<b>MINERAL:</b> Gravel	<b>COUNTY:</b> Cheyenne
<b>INSPECTION TYPE:</b> Monitoring	<b>INSPECTOR(S):</b> Robert Zuber, P.E.	<b>INSP. DATE:</b> November 9, 2021	<b>INSP. TIME:</b> 13:15
<b>OPERATOR:</b> Kiowa County	<b>OPERATOR REPRESENTATIVE:</b> Shane Lessenden, Tim Wolf	<b>TYPE OF OPERATION:</b> 110c - Construction Limited Impact

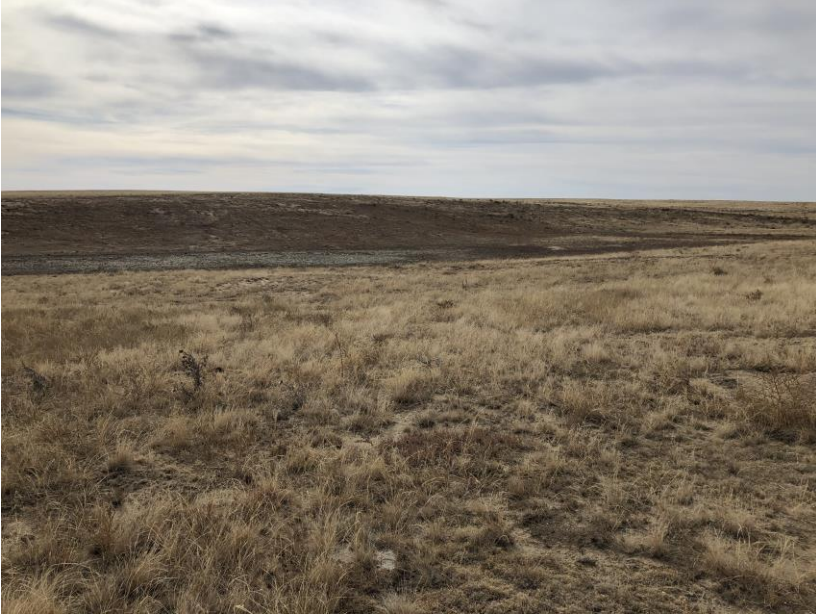
**Pond area (dry)**

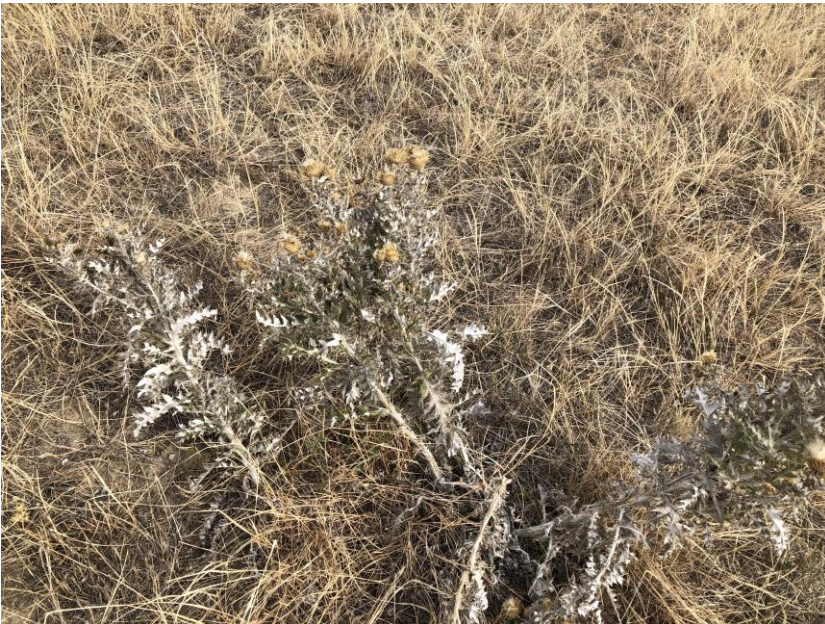
**PROBLEM/POSSIBLE VIOLATION:** Problem: There are state-listed noxious weeds present on site. This is a problem for failure to employ weed control methods for state listed noxious weed species within the permitted area, and to reduce the spread of weeds to nearby areas as required by Section 3.1.10 (6) of the rule.

Many thistle plants were seen around the site. They appear to be Canada thistle, and should be treated by the operator.

**Thistle plant – likely Canada thistle**

**CORRECTIVE ACTIONS:** Implement approved weed control plan and provide proof to the Division that this has been done. If a weed control plan is not already in place, the operator shall develop a weed control and management plan in accordance with Section 3.1.10 (6) of the Rule. This plan should be developed in consultation with the county extension agency, or weed control district office and should include specific control measures to be applied, a schedule for when control measures will be applied and a post-treatment monitoring plan. This weed control plan shall be submitted to the Division as a Technical Revision to the approved plan with the appropriate Technical Revision fee of \$216.00 by the corrective action date.

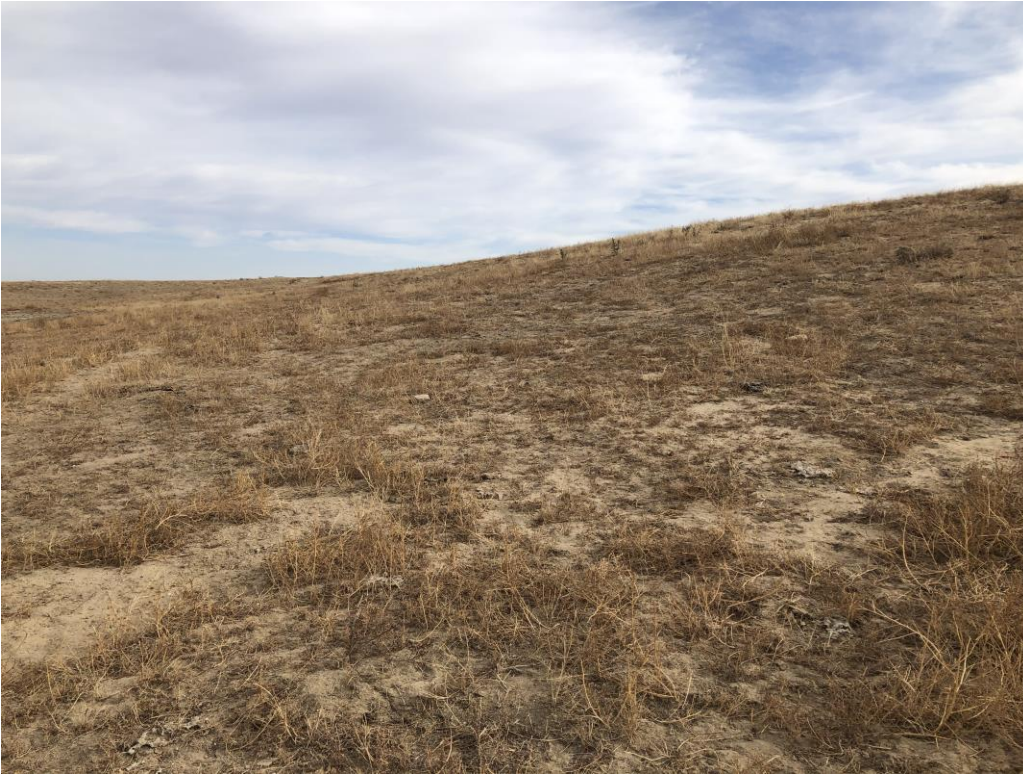
The reclaimed slope north of the pond contains good vegetation cover with grasses and other desirable species. The slope south of the pond is not as good; it is largely bare with plants such as Russian thistle.

**Reclaimed area south of the pond with poor revegetation success**
