**RE: Permit No. M-1980-244; Cripple Creek & Victor Gold Mining Company; Cresson Project;  
Schist Island Backfill Weekly Report**

Newmont Mining Corporation  
 Cripple Creek & Victor Gold Mine  
 VLF2 Phase 3 Site Support 2021  
 NewFields Job No. 475.0106.053  
 Week Ending Friday, October 29, 2021

## FIELD WEEKLY PROGRESS REPORT

**PROJECT:** VALLEY LEACH FACILITY (VLF2) PHASE 3 CQA HIGH COMPACTION BACKFILL  
**SITE:** CRIPPLE CREEK & VICTOR GOLD MINE (COLORADO)  
**CONTRACTOR:** NEWMONT CC&V MINING OPERATIONS  
**WEEK ENDING:** FRIDAY, OCTOBER 29, 2021

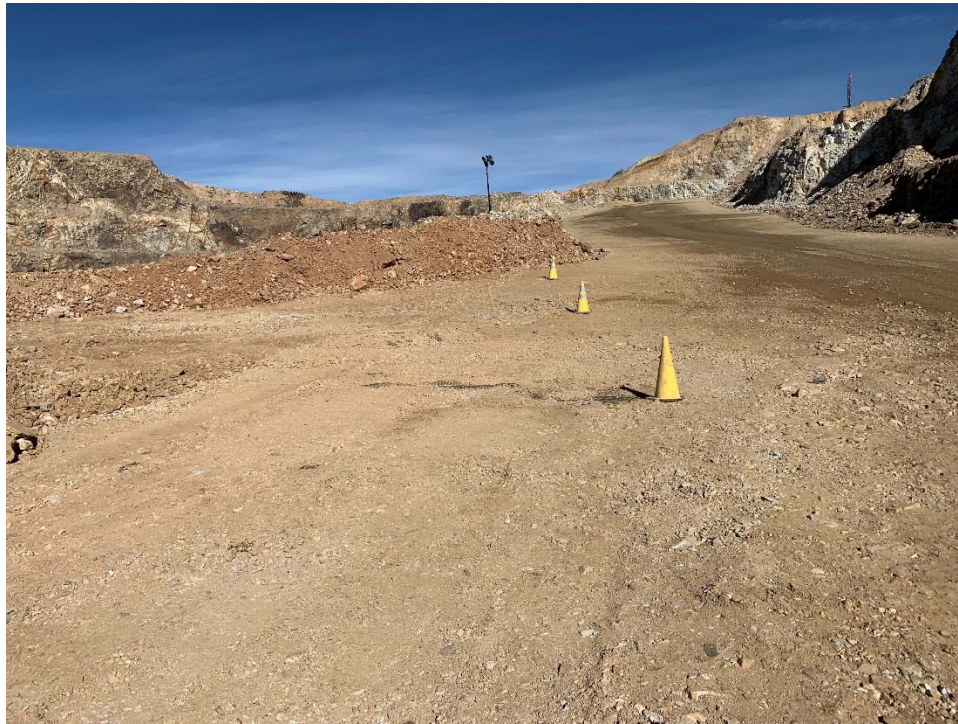
The Chevy Underground Working Remediation was damaged on Sunday, October 24, 2021. Newmont Mine Technical Services informed NewFields of the damage and an inspection was scheduled for Monday, October 25<sup>th</sup>, 2021. A D10 dozer had removed the select structural fill while cutting in a ramp for the 9910' lift and exposed the geogrid damaging it. The extents of the damage were inspected and surveyed. The area was not covered and is scheduled to be repaired on Monday, November 1, 2021.

**October 25, 2021 – Chevy Underground Working remediation exposed geogrid (TW)**

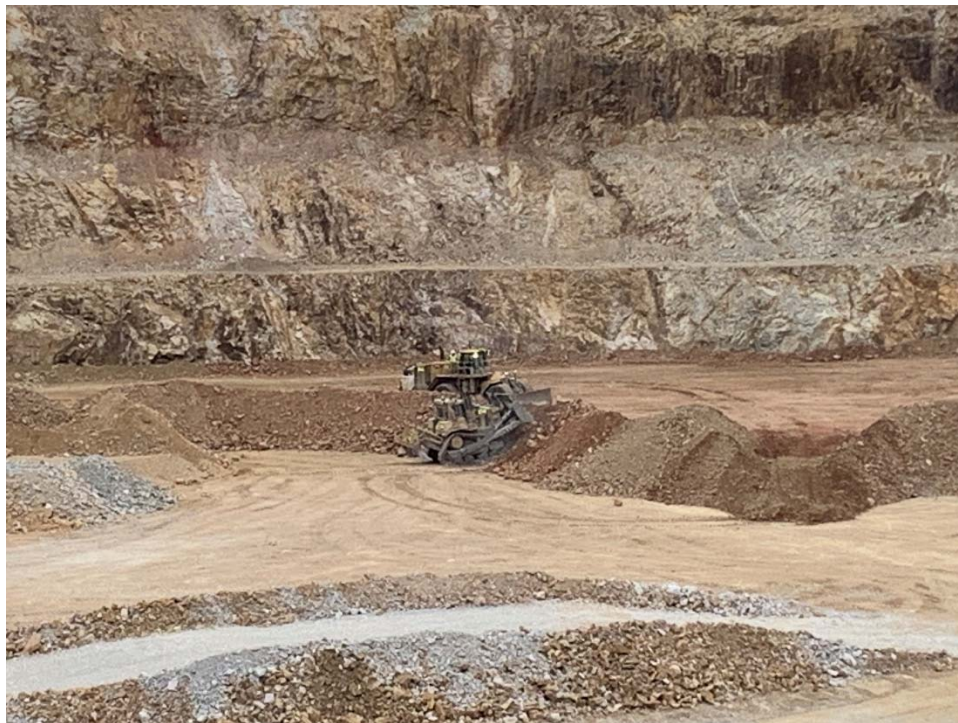
CC&V shovel and loader operators monitored the material size being sent to the high compaction backfill. Out of specification loads containing 2 foot plus sized material were sent to the ECOSA stockpile. 2 foot plus sized material that was not removed at the dig-face by the shovel or loader operators was removed by a D10 dozer during material placement. The oversize material was stockpiled by the dozer out of the way above the current lift on the haul road against the pit high wall. A 993 loader loaded a 777 haul truck with the unsuitable material and it was then hauled to the ECOSA stockpile.

**October 26, 2021 – High Compaction Backfill oversized material removal (TW)**

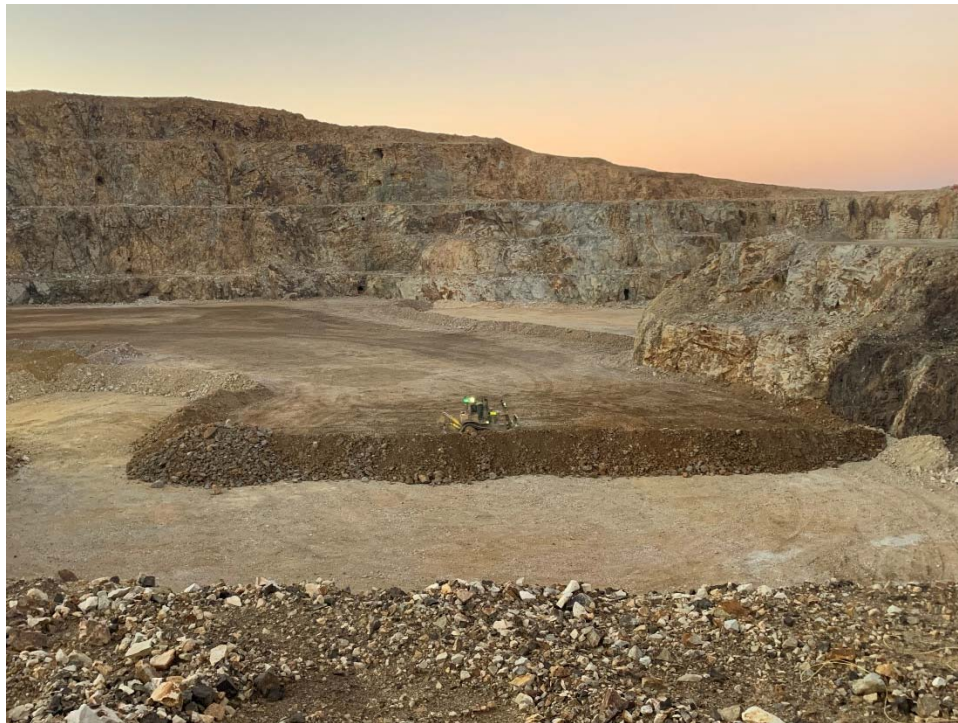
**October 29, 2021 – High Compaction Backfill Progress (TW)**
