**MINERALS PROGRAM INSPECTION REPORT**  
**PHONE: (303) 866-3567**

<b>MINE NAME:</b> 25th Avenue Site	<b>MINE/PROSPECTING ID#:</b> M-2002-020	<b>MINERAL:</b> Sand and gravel	<b>COUNTY:</b> Weld
<b>INSPECTION TYPE:</b> Monitoring	<b>INSPECTOR(S):</b> Peter Hays	<b>INSP. DATE:</b> October 6, 2021	<b>INSP. TIME:</b> 13:00
<b>OPERATOR:</b> City of Greeley	<b>OPERATOR REPRESENTATIVE:</b> Adam Jokerst, William Schenderlein	<b>TYPE OF OPERATION:</b> 112c - Construction Regular Operation	
<b>REASON FOR INSPECTION:</b> Normal I&E Program	<b>BOND CALCULATION TYPE:</b> None	<b>BOND AMOUNT:</b> \$0.00	
<b>DATE OF COMPLAINT:</b> NA	<b>POST INSP. CONTACTS:</b> None	<b>JOINT INSP. AGENCY:</b> None	
<b>WEATHER:</b> Clear	<b>INSPECTOR'S SIGNATURE:</b>

October 6, 2021 Inspection Map

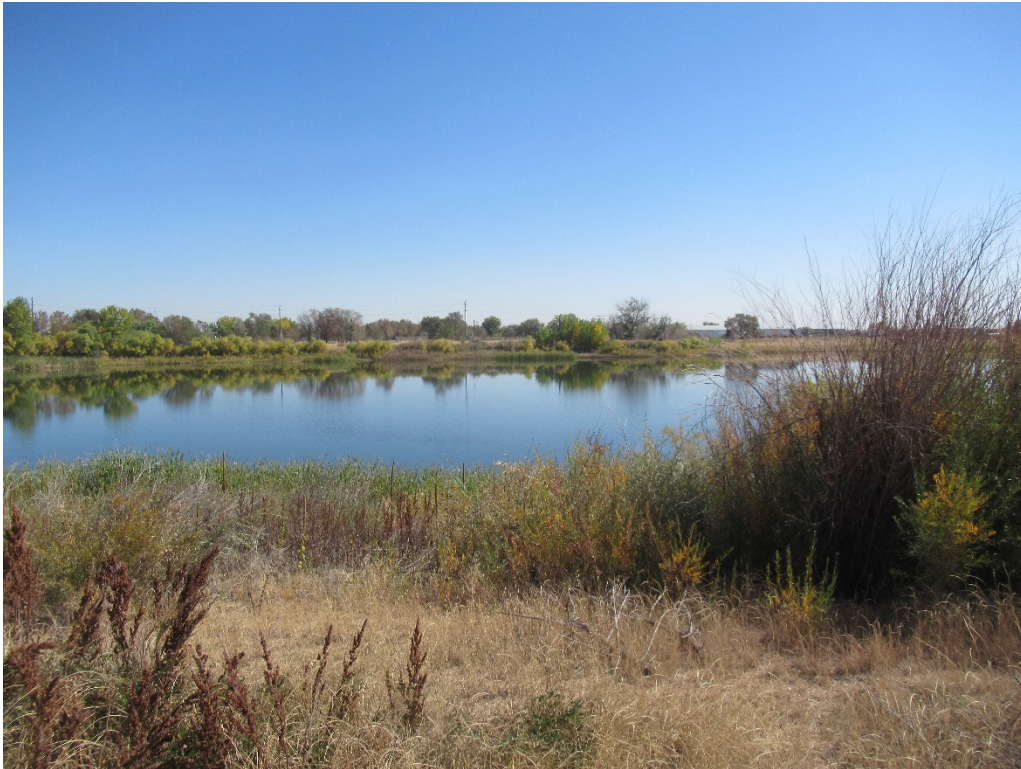
The NE Area contains an open water pond excavated by the Operator of the Greeley West Pit. The area has remained the unchanged since being incorporated into the 25<sup>th</sup> Avenue Site permit. The Reclamation Plan states the area would be backfilled to an upland/wetland land use. A large stockpile of material is located on the south side of the pond. The stockpiled material will be used to backfill the pond to upland and wetland elevations during final reclamation of the site.

View of the NE Area pond from the west shoreline looking east

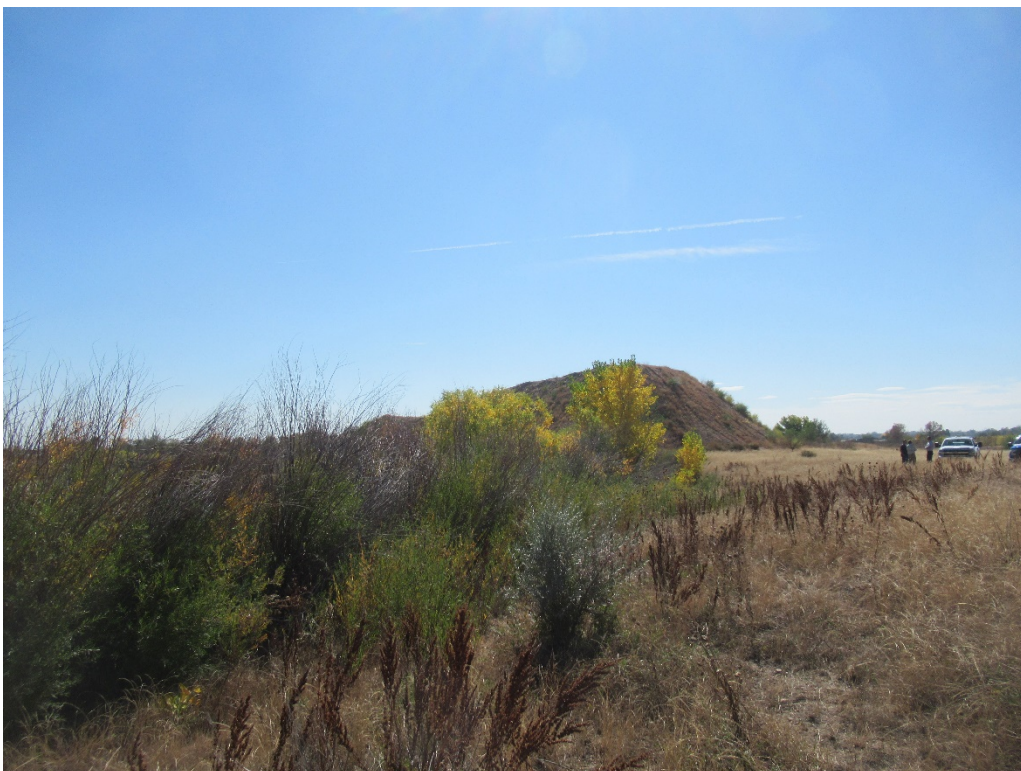
View of the backfill material located on the south end of the NW Area pond

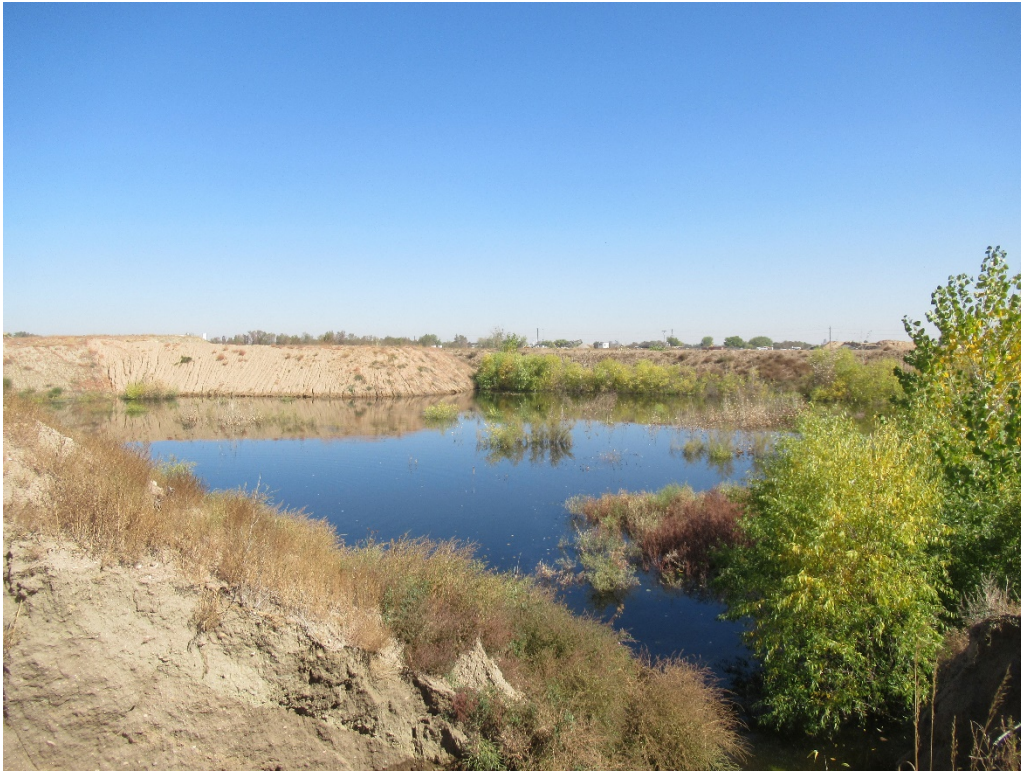
The SE Area previously contained an open water pond. The Reclamation Plan states the area would be backfilled to an upland/wetland land use. The area was backfilled with waste material from the SW Pond mining operation. A small pond remains in the southeast corner of the area. The Division estimated the size of the remaining pond at 2 acres and approximately 15 feet in depth. The remaining pond area will be backfilled to an upland elevation by the Operator in the future.

View of the remaining 2 acre pond in the SW Area from the southwest corner looking northeast

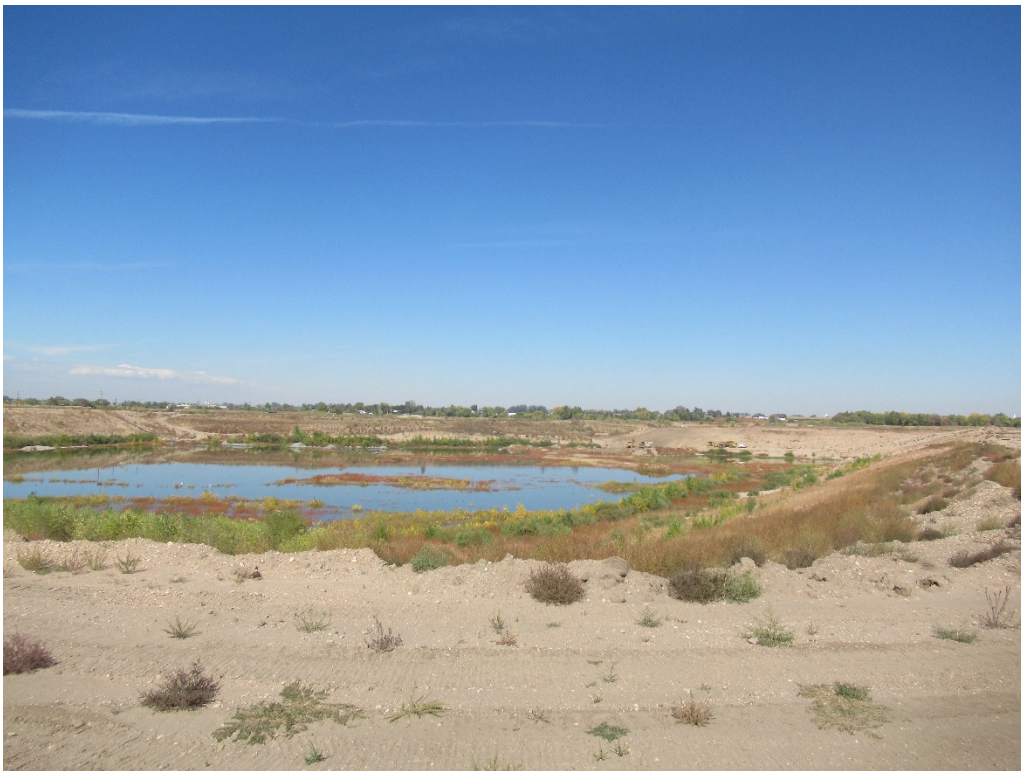
View of the SW Pond from the southeast corner looking northwest

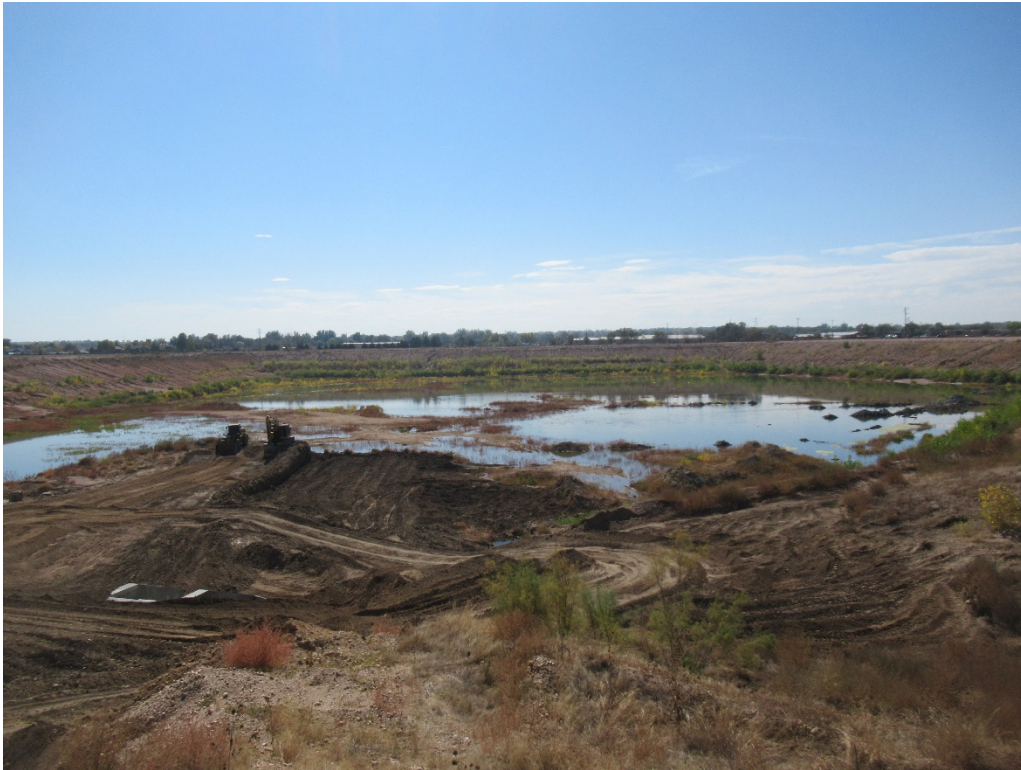
View of the SW Pond from the north shoreline looking south

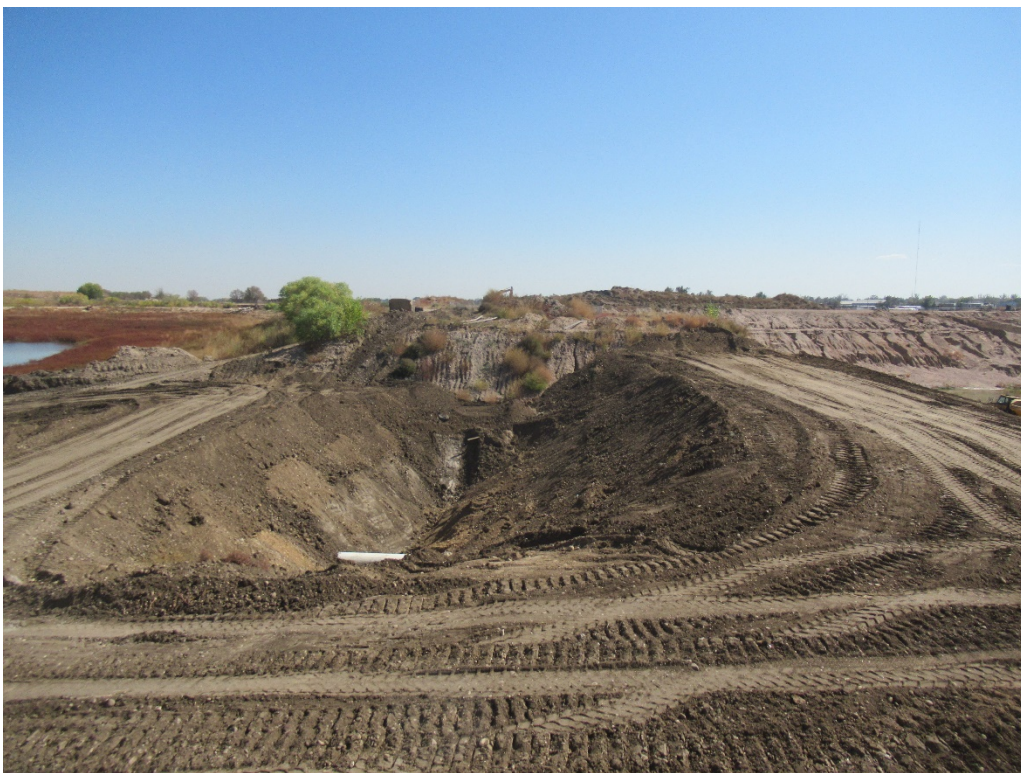
The majority of the slurry wall was installed in April-May of this year. An interconnection structure between Pond A and the SW Pond was under construction at the time of this inspection. The structure is located in the northeast corner of the reservoir. The slurry wall will be finished once construction of the structure is complete and the area is backfilled.

View of the interconnection structure between SW Pond and Pond A

**CORRECTIVE ACTIONS:** The Operator shall submit a Technical Revision, with the required \$216 revision fee, to update and clarify the current approved Mining Plan to reflect existing and proposed activities by the corrective action date.

As cited as a problem on Page 1, the Division will require the Operator to submit a technical revision to update the Mining and Reclamation Plans to include the interconnection structure. The Operator was aware of the requirement and stated the revision would be submitted to the Division soon. The revision has not been received as of the signature of this report.

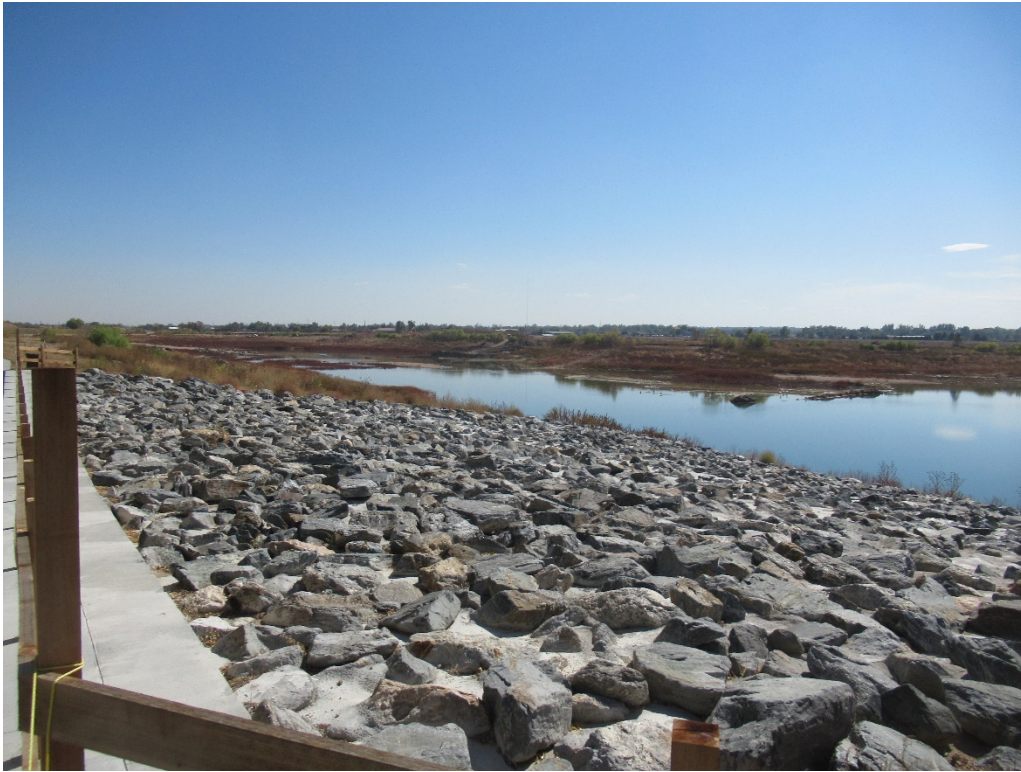
The inlet/outlet structure approved under technical revision no. 1 was observed during the inspection and appeared to be constructed in accordance with the approved design.

View of the inlet/outlet structure and Pond A looking southeast
