**MINERALS PROGRAM INSPECTION REPORT**  
**PHONE: (303) 866-3567**

<b>MINE NAME:</b> Penrose Pit	<b>MINE/PROSPECTING ID#:</b> M-1987-131	<b>MINERAL:</b> Sand and gravel	<b>COUNTY:</b> Fremont
<b>INSPECTION TYPE:</b> Surety Release Inspection	<b>INSPECTOR(S):</b> Timothy Cazier, P.E.	<b>INSP. DATE:</b> December 2, 2021	<b>INSP. TIME:</b> 14:05
<b>OPERATOR:</b> Fremont Paving & Redi-Mix, Inc.	<b>OPERATOR REPRESENTATIVE:</b> John Paul Ary & Jodi Schreiber	<b>TYPE OF OPERATION:</b> 112c - Construction Regular Operation	
<b>REASON FOR INSPECTION:</b> Surety Release Requested	<b>BOND CALCULATION TYPE:</b> None	<b>BOND AMOUNT:</b> \$320,000.00	
<b>DATE OF COMPLAINT:</b> NA	<b>POST INSP. CONTACTS:</b> None	<b>JOINT INSP. AGENCY:</b> None	
<b>WEATHER:</b> Clear	<b>INSPECTOR'S SIGNATURE:</b>

# M-1987-131 Penrose Pit AR-2 ~~Pre-Inspection~~ Map Post

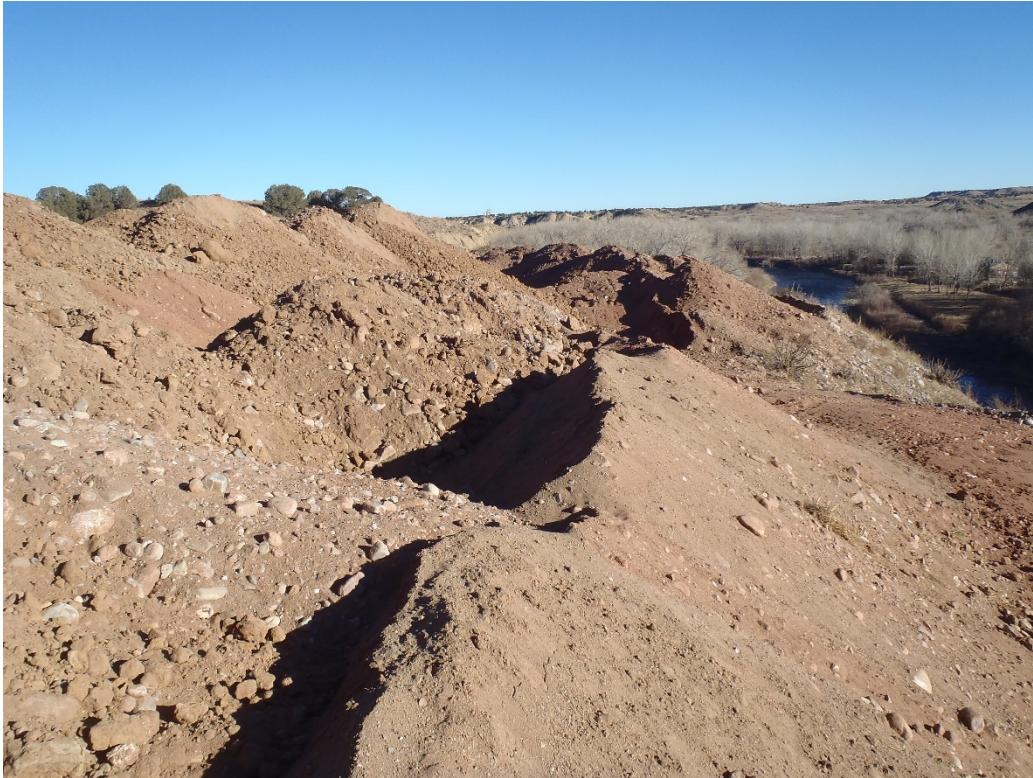
Area A: This area was observed to be mined already, extending to the edge of the unnamed gulch bounding the east side (see **Photos 1 and 2**). Fremont Paving was in the process of constructing the visual berm (see **Photo 3**) in the southeast corner of this area, as required by the County's conditional use permit. As this area has been mined, the DRMS required the Permittee to submit revised maps for AR-2 removing this area from the request. Revised maps were received by DRMS on December 16<sup>th</sup>.

Photo 1. Area A (looking ESE – stockpiles for visual berm construction).

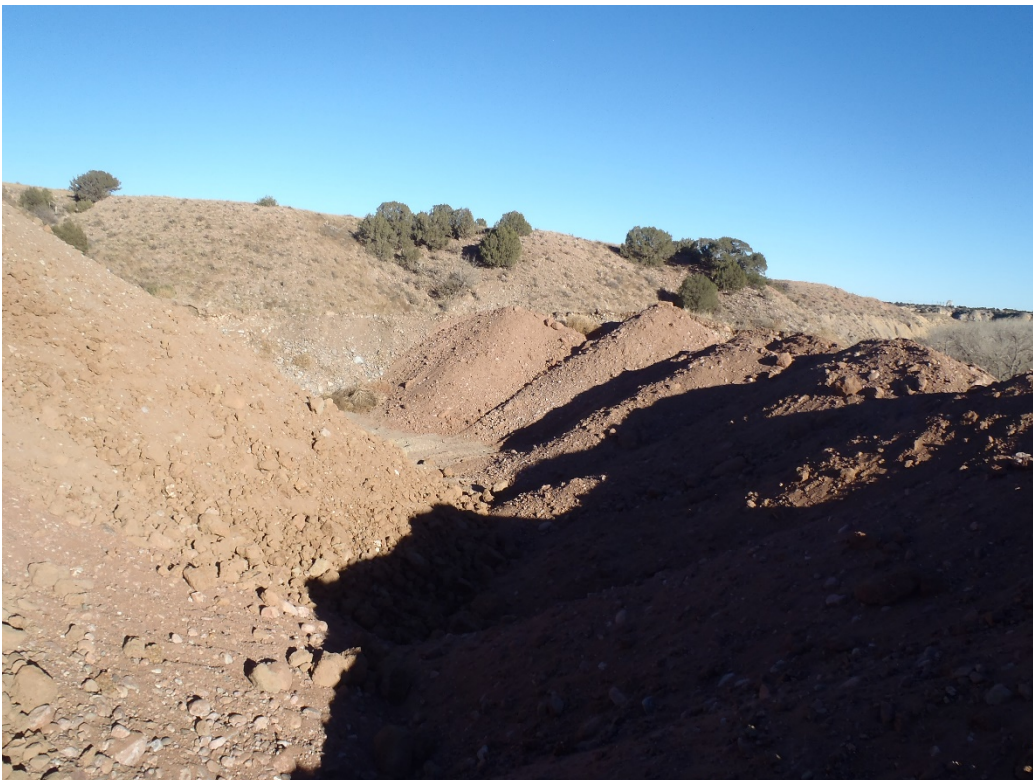
Photo 2. Area A (looking ENE – stockpiles for visual berm construction).

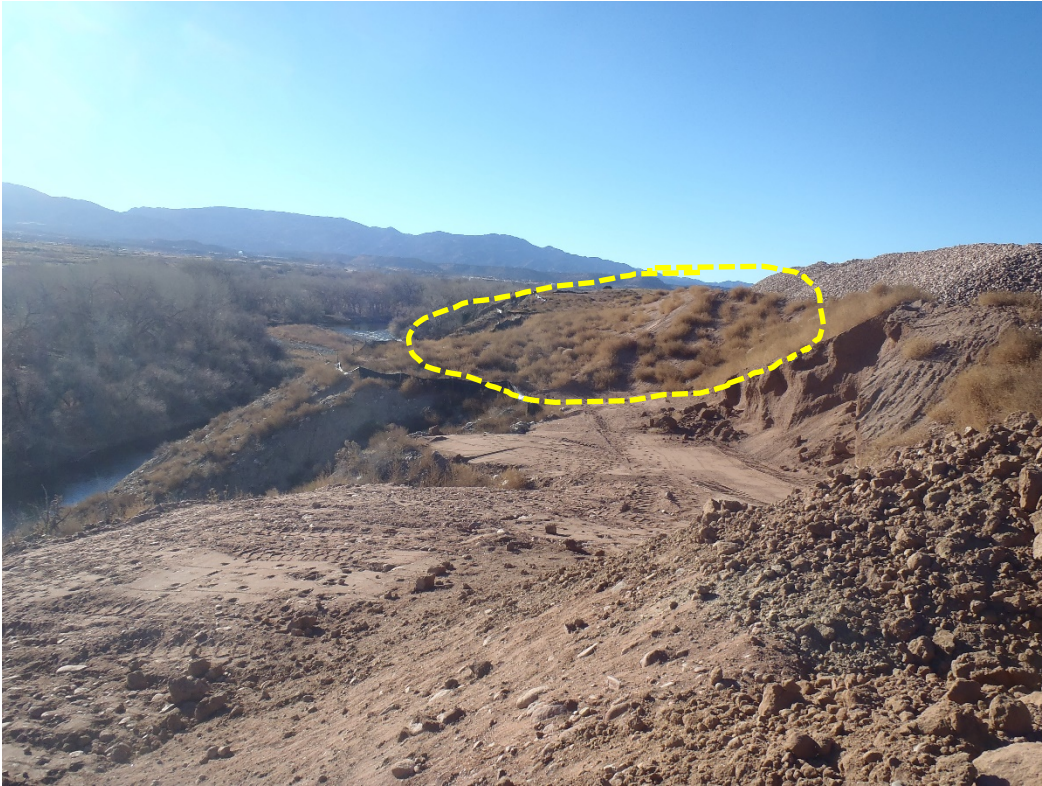
Photo 3. Area A (looking west –visual berm constructed beyond).

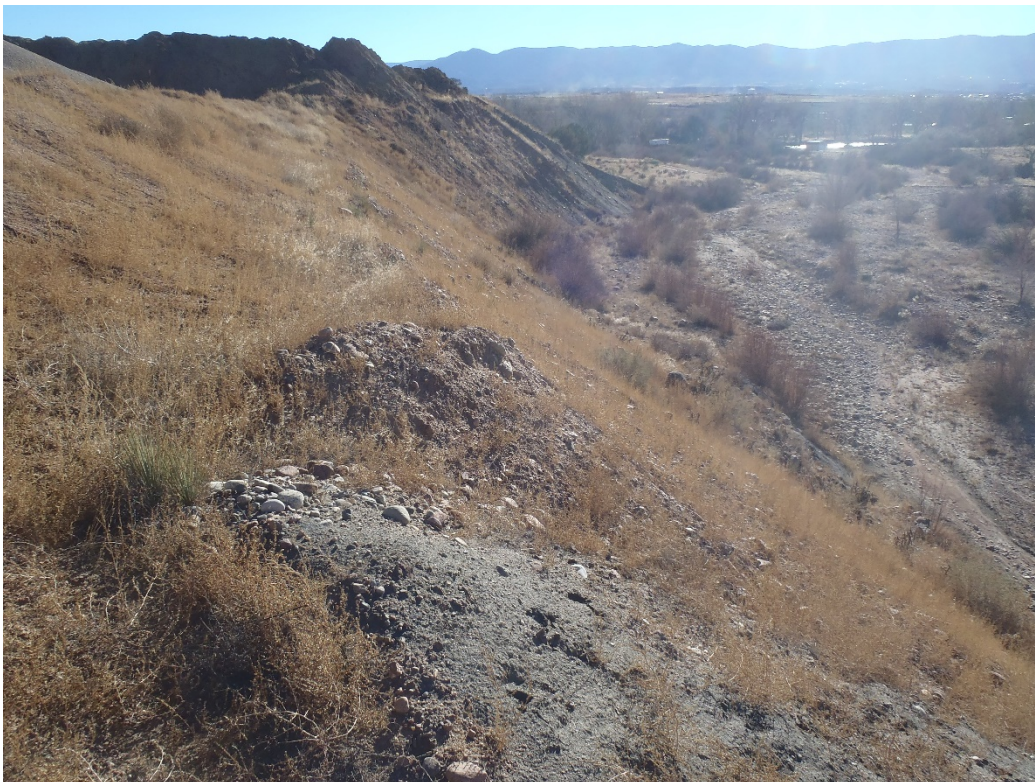
Area B: This area was observed to be either undisturbed or naturally revegetated (see **Photos 4 and 5**) and deemed acceptable for release.

Photo 4. Area B (looking south, Eightmile Creek at toe of slope).

The DRMS recommends approval of AR-2 as revised by the maps received on 12/16/2021. You will be notified under separate cover of the approval for AR-2. Please contact Tim Cazier (303)328-5229 or email at [tim.cazier@state.co.us](mailto:tim.cazier@state.co.us) if you have any questions regarding this report.

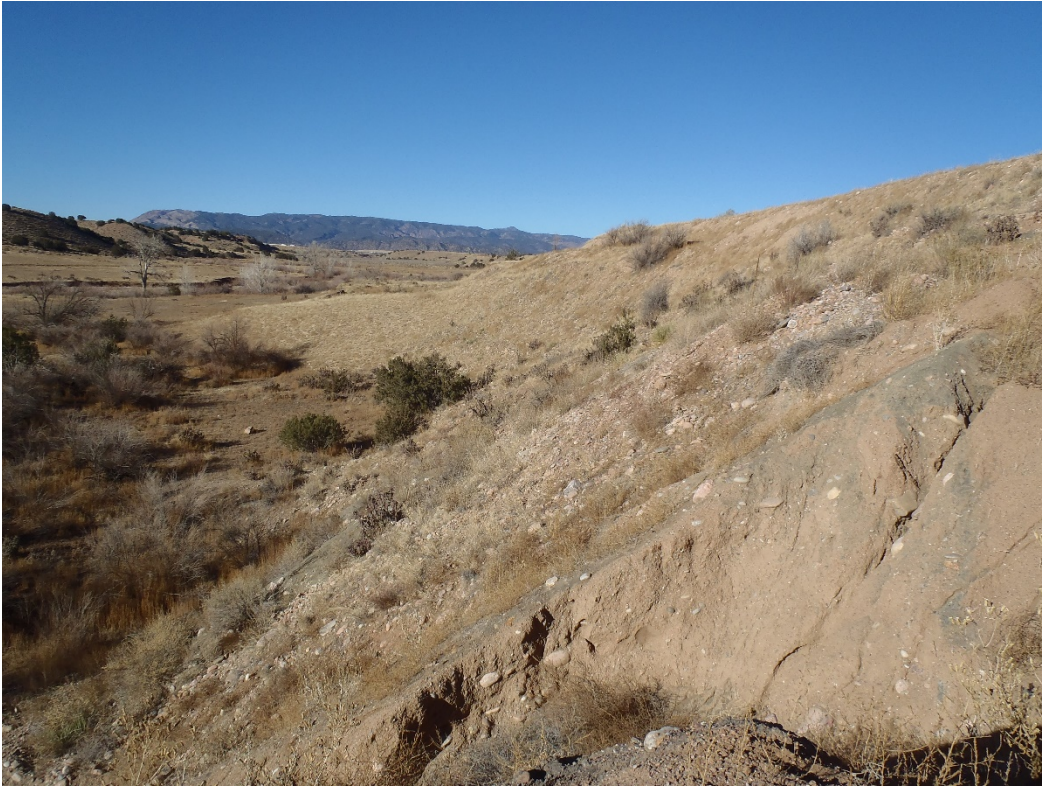
Photo 5. Area B (looking north, Eightmile Creek at toe of slope).

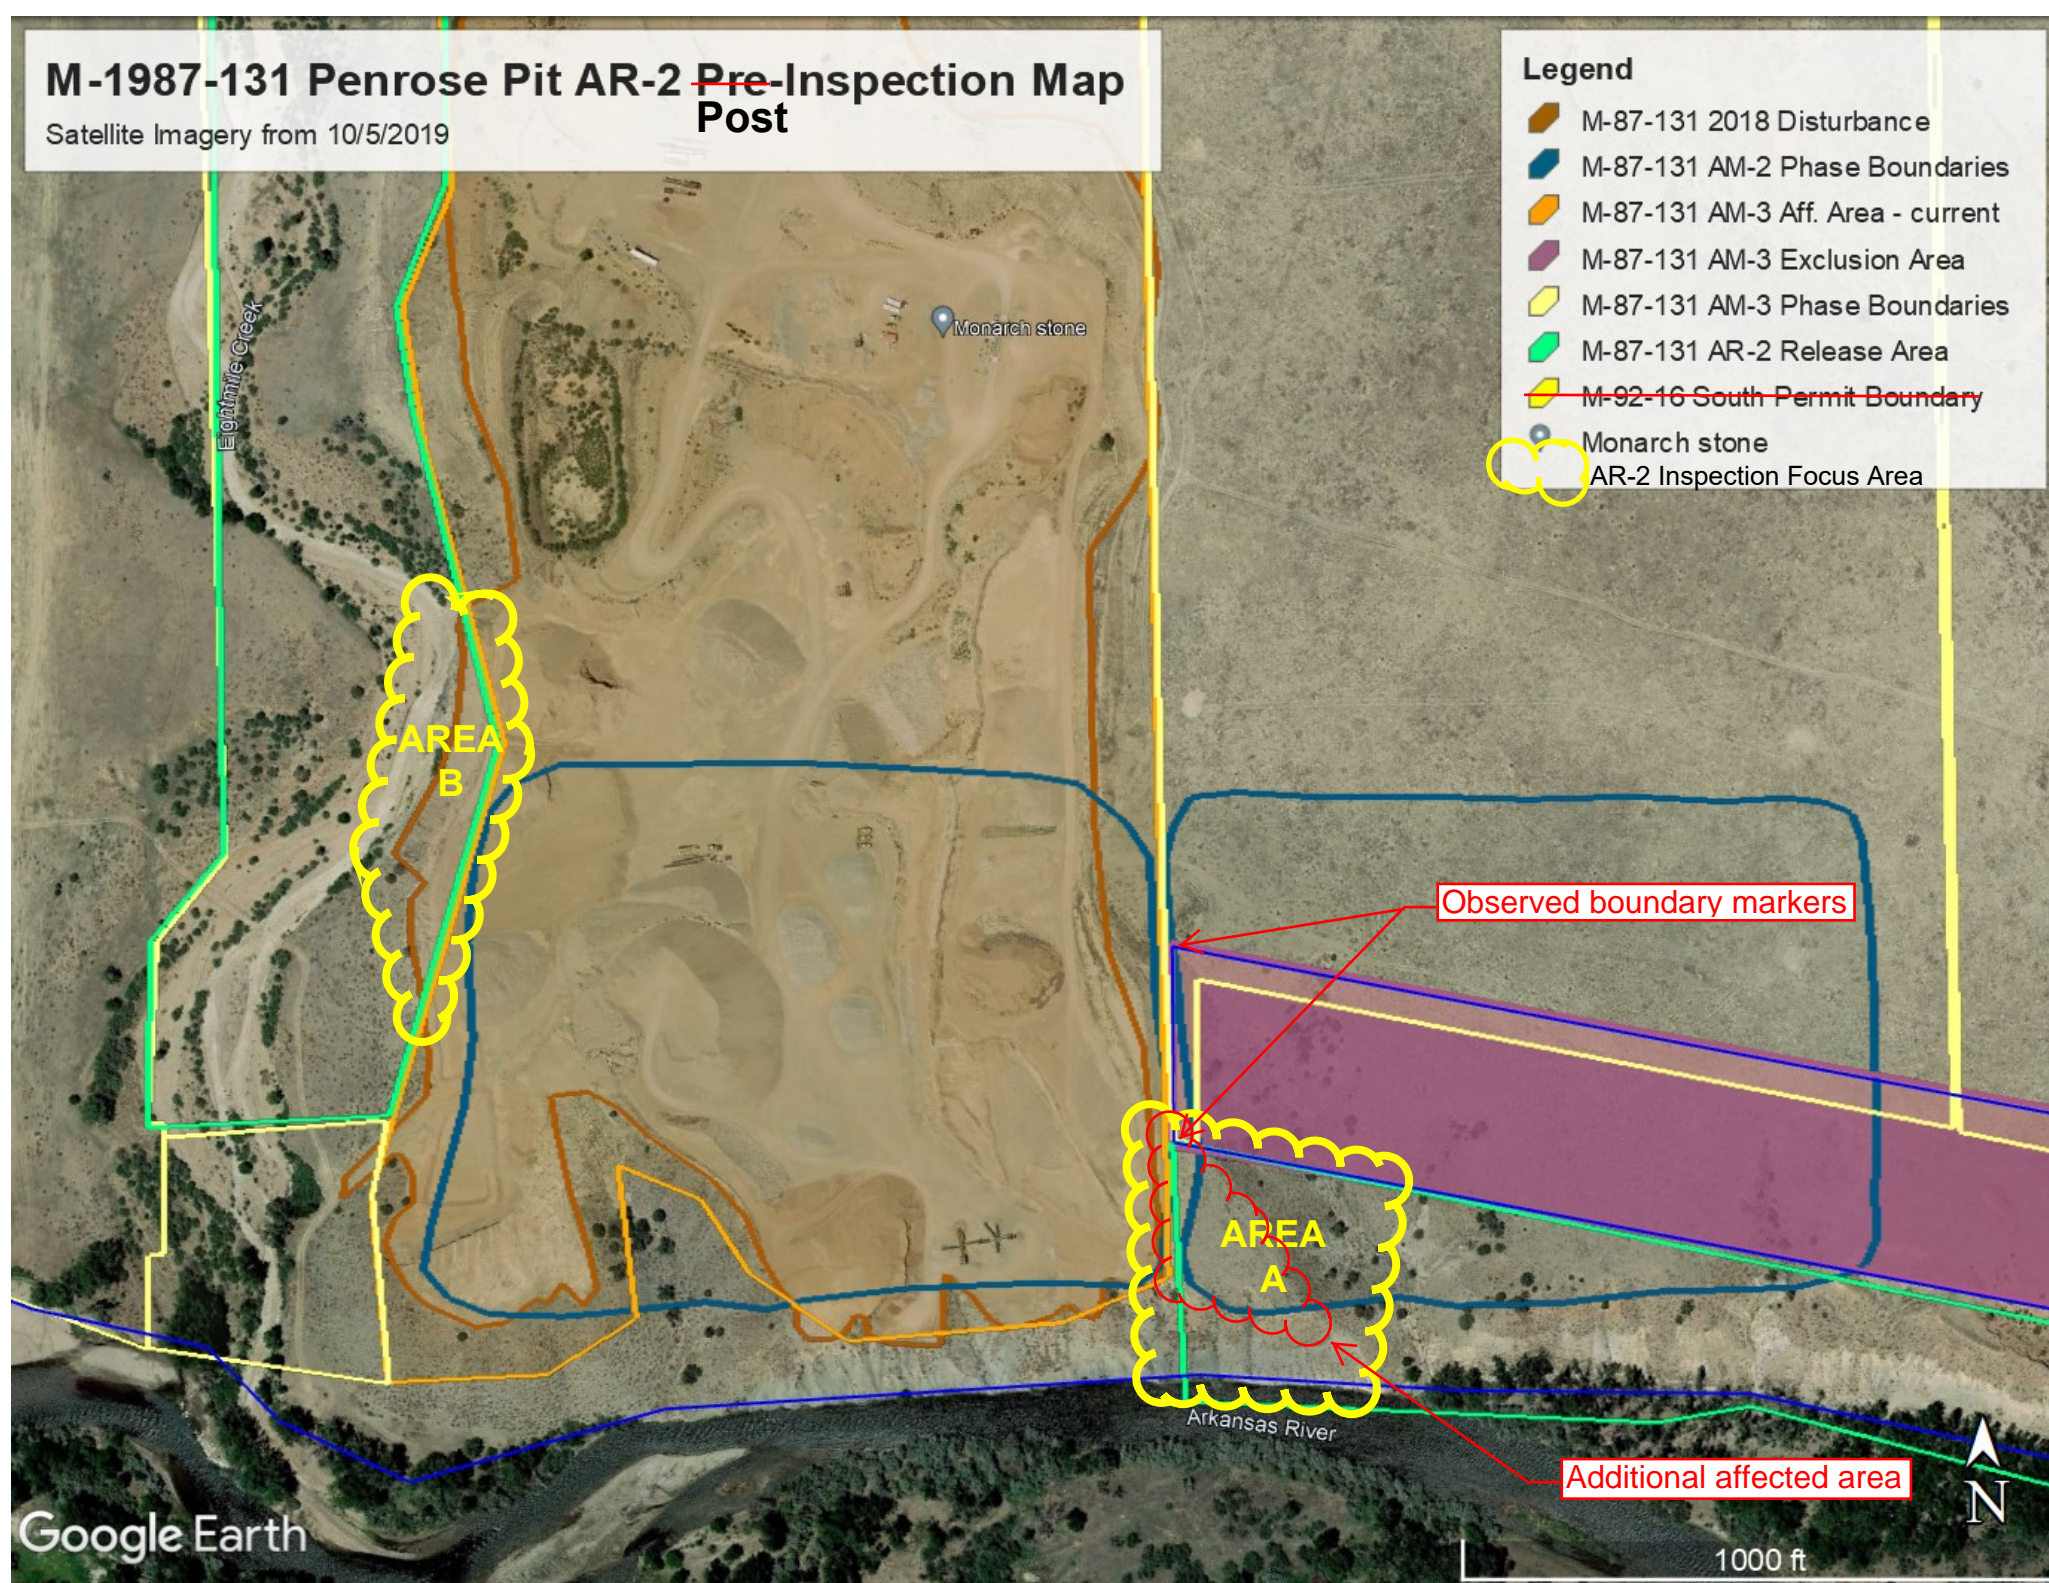
This inspection was conducted by Tim Cazier (DRMS) as part of an acreage reduction request (AR-2). The Permittee (Fremont Paving & Redi-Mix) was represented by Mr. John Paul Ary and Ms. Jodi Schreiber during the inspection. The focus of this inspection was on two areas (see **attached Map**):

- Area A - immediately south of the southwest corner of the excluded area owned by Fountain Hills Land & Equipment LLC; and
- Area B – west of the active pit area nearest Eightmile Creek.
