RE: J&J Stone Pit #1 Permit No. M-2011-004 TR-2
Response to Preliminary Adequacy Review Dated December 22, 2021

FOURMILE SANDSTONE QUARRY BLASTING PLAN

KrauthCo Dimension Stone Property

Geological Reconnaissance Report

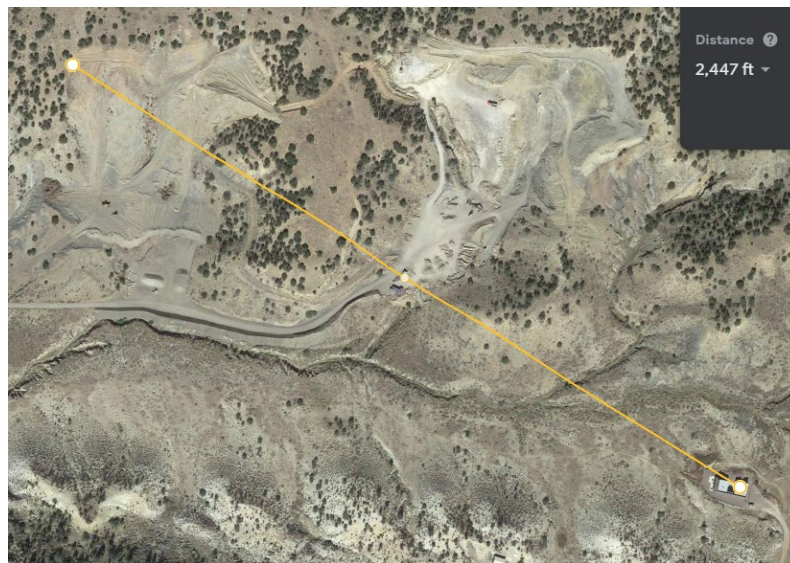
Figure 1: John Waters residence and nearest structure

- f. The Fourmile quarry site has only one neighbor adjoining the property to the east (Figure 1). The quarry foreman always notifies the neighbor, days in advance, and prior to initiation of the limited use of explosives. All employees are notified by quarry manager and a review of emergency protocols is conducted. The pre-blast survey, of this site, suggests that explosive use should be minimum energy use, and use of delays, for the fracturing of stone to maximize the products and limit the air and sound vibrations. This method results in sound discharge similar to machine gun fire, which is often heard at the local gun range one-mile from this site. A notification to EMS and local officials is the responsibility of the explosives professional when necessary and or in accordance with any state and local guidelines.

- b. The only structure within one half-mile, (.4634 miles), is the John Waters residence, to the east of the property. The quarry manager has visited the residence and discussed the purpose and use of explosives with the owner. We reviewed the pre-existing conditions and issues that the structure has had, prior to use of any explosives. The residence has had some settling issues that have been addressed, by the homeowner. Given the distance and separation of the residence and quarry by a large canyon and ravine, which is likely a snap-joint in the deposit plate, it is unlikely that any vibration damage would occur, with limited yield and delayed charges. This report and conclusion was concurred with, by the explosives professional.
- c. No structures or contents were identified as sensitive to blasting.

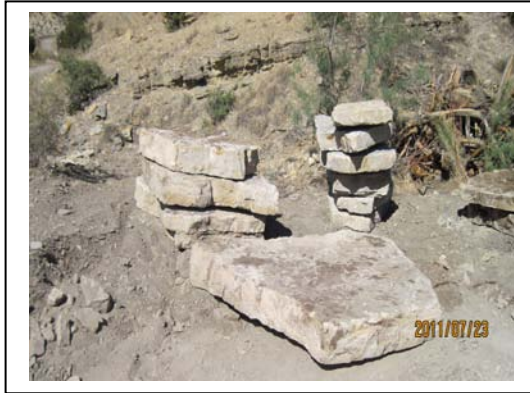
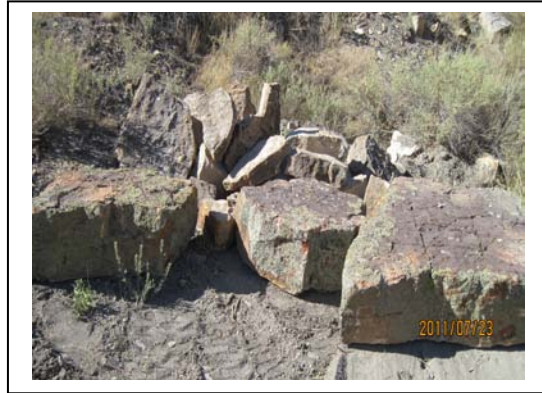
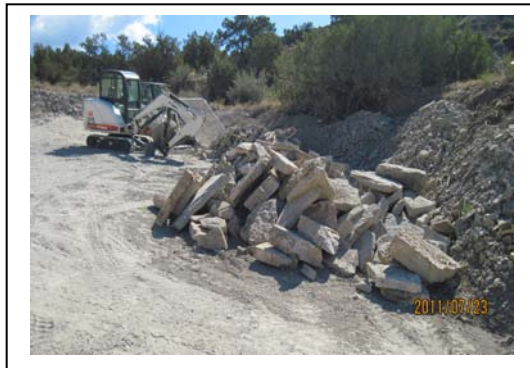
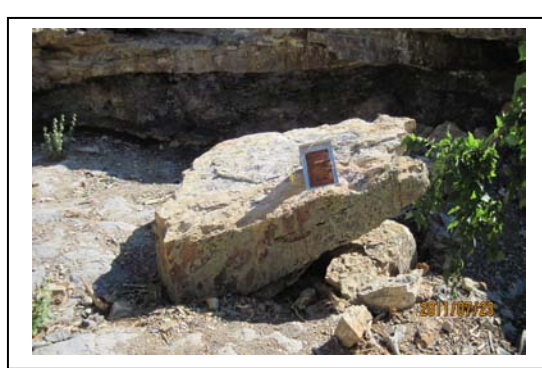
J&J Pit Dimension Stone Photographs

Historic and current dimension stone production from the J&J Pit is from bedded, fractured sandstone within the Cretaceous Dakota Group. Beds range in thickness from a fraction of an inch up to a maximum resource thickness of 3 ft. Beds less than 2 inches are considered waste while beds greater than 3 ft. are considered massive sandstone and currently lie outside of the definition of mineable resource.

These Dakota sandstone beds are comprised of tan to light gray, moderately well sorted, very fine to fine grained, rounded, frosted quartz sand. The sandstone is generally non-friable and bound by clay and silica cement with moderate porosity and permeability. Sandstone beds are irregularly bleached with mottled and banded iron and manganese staining. Mafic mineral grains and black organic plant material are common. Occasional marble to golf ball size sand, pyrite and iron nodules are found, along with numerous empty casts of eroded nodules. Weathered surfaces demonstrate various colors and shapes, with ripple marks, filled fractures, and worm burrows/tracks found on select surfaces.

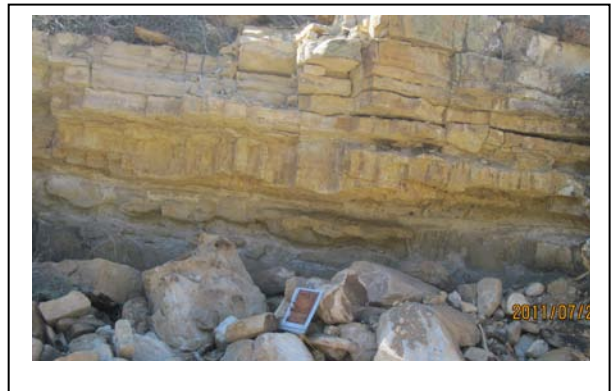
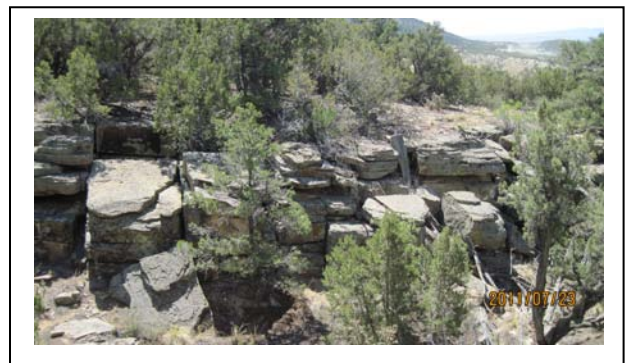
The Primary Continuous Facies appears to be overbank sheet sands which are somewhat variable in extent laterally, but relatively consistent in thickness over greater distance. Individual beds can be traced for up to 200 ft before fading away and being replaced by one or more similar sheet sands. Measured sections of the PCF in multiple drainages across the property indicate the PCF ranges from a minimum thickness of 8 ft to a maximum of 15 ft. This facies appears to thin northward and eastward due to changes in deposition and erosion. Average PCF thickness across the property is estimated to be approximately 11 ft. Of this 11 ft. partings are generally quite thin ranging from about 1mm to 1inch. Using a recovery factor of 95%, one can estimate a recoverable resource thickness of approximately 10.5 ft. Photos below show the nature and variation in the PCF across the property..

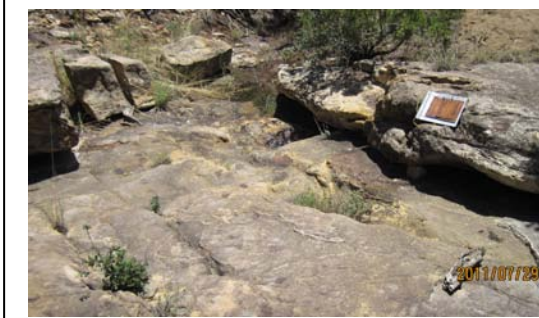
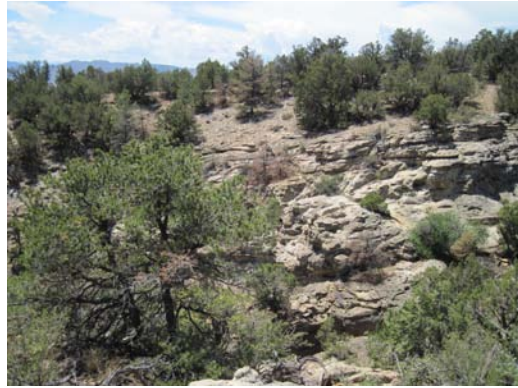
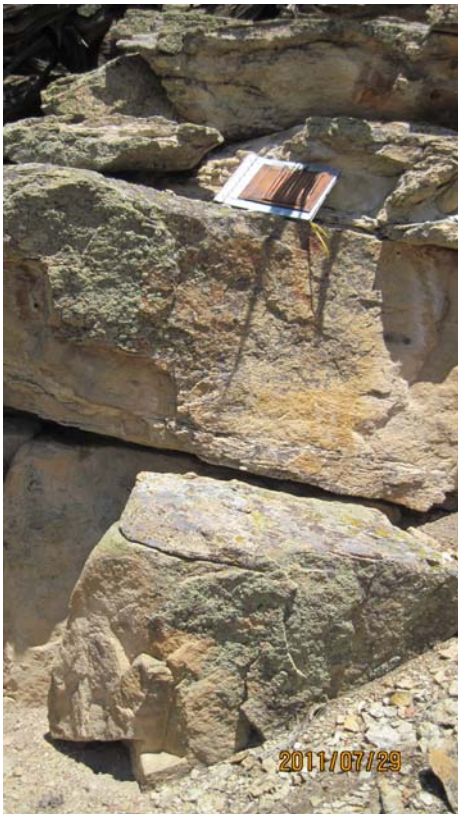
Below are photos showing the nature and variability of the Secondary Intermittent Facies on and near the Krauth Property.
