MINERALS PROGRAM INSPECTION REPORT
PHONE: (303) 866-3567

MINE NAME: Schneller Clay Pit	MINE/PROSPECTING ID#: M-1989-095	MINERAL: Clay (general)	COUNTY: Phillips
INSPECTION TYPE: Monitoring	INSPECTOR(S): Brock Bowles	INSP. DATE: December 17, 2019	INSP. TIME: 11:00
OPERATOR: Phillips County	OPERATOR REPRESENTATIVE: Mike Salyards	TYPE OF OPERATION: 112c - Construction Regular Operation

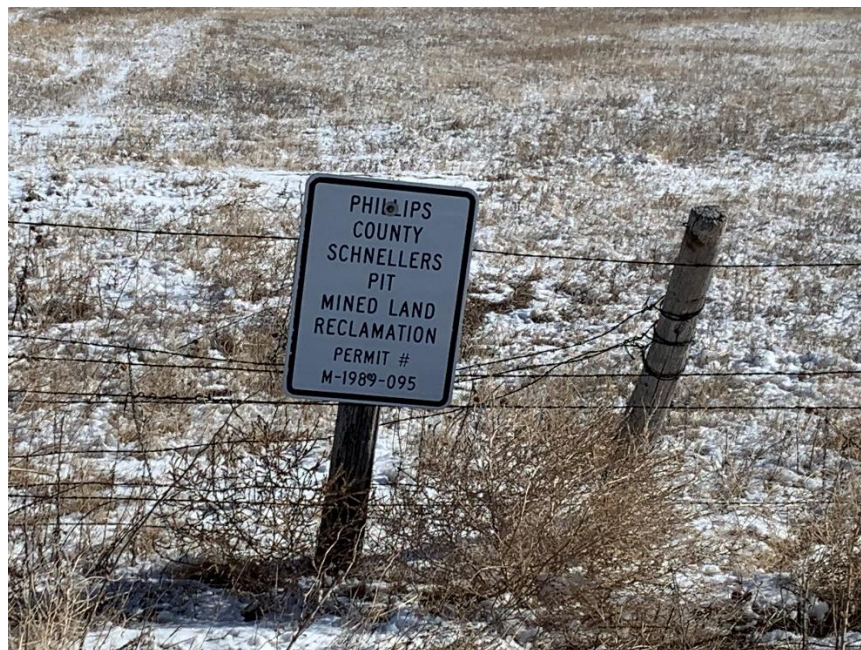
The mine entrance sign was in place. The permit boundary markers were in place along the eastern and southern boundaries. The permit boundary along the west and northern boundaries was a fence that was in good condition.

Entrance sign from County Road 49

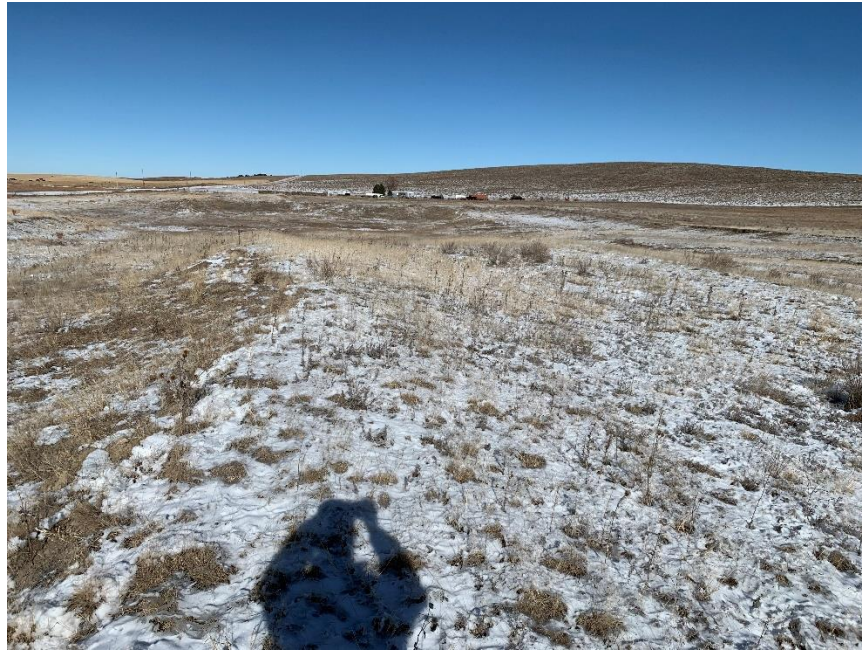
Multiple topsoil stockpiles were located south and west of the pit. The piles were well vegetated.

No mining activities were occurring during the time of the inspection and no equipment was on site. There was no evidence of recent mining or reclamation activities observed. The pit appears to have not been active for a long time due to the abundance of volunteer vegetation growing on the pit slopes and floor. The November 2019 annual report notes that the last excavation was March 2012. As per Rule 3.1.3, all reclamation shall be carried to completion within 5 years from the date the operator has ceased mining. Please see the corrective action section of this report for more information. The Division requires the Operator to submit a Reclamation Schedule to the Division within 60 days of this report and that all reclamation activities be completed no later than June 30, 2020. For details of the reclamation plan, refer to Exhibit E of the 2014 version of the permit.

Looking north, one topsoil pile in foreground, pit in background

CORRECTIVE ACTIONS: The Operator shall submit a Reclamation Schedule to the Division within 60 days of this report (March 16, 2020), with all reclamation scheduled to be completed by June 30, 2020. Please see the inspection narrative for specific requirements of this Reclamation Schedule.
