**PERMIT INFORMATION**

<b>Permit Number:</b> C-1982-056 <b>Mine Name:</b> Foidel Creek Mine <b>Operator:</b> Twentymile Coal, LLC <b>Operator Address:</b> Ms Miranda Kawcak 29515 Routt County Road No. 27 Oak Creek, CO 80467	<b>County:</b> Routt <b>Operation Type:</b> Underground <b>Permit Status:</b> Active <b>Ownership:</b> Private
	<b>Operator Representative Present:</b>  None
<b>Operator Representative Signature: (Field Issuance Only)</b>

<b>Inspection Start Date:</b> January 10, 2022 <b>Inspection Start Time:</b> 10:00 <b>Inspection End Date:</b> January 10, 2022 <b>Inspection End Time:</b> 10:30		<b>Inspection Type:</b> Aerial Inspection <b>Inspection Reason:</b> Normal I&E Program <b>Weather:</b> Clear	
<b>Joint Inspection Agency:</b>  None		<b>Joint Inspection Contacts:</b>  	
<b>Post Inspection Agency:</b>  None		<b>Post Inspection Contacts:</b>  	
<b>Inspector(s):</b>  Tabetha Lynch  Brock Bowles	<b>Inspector's Signature:</b>  		<b>Signature Date:</b>  1/19/2022

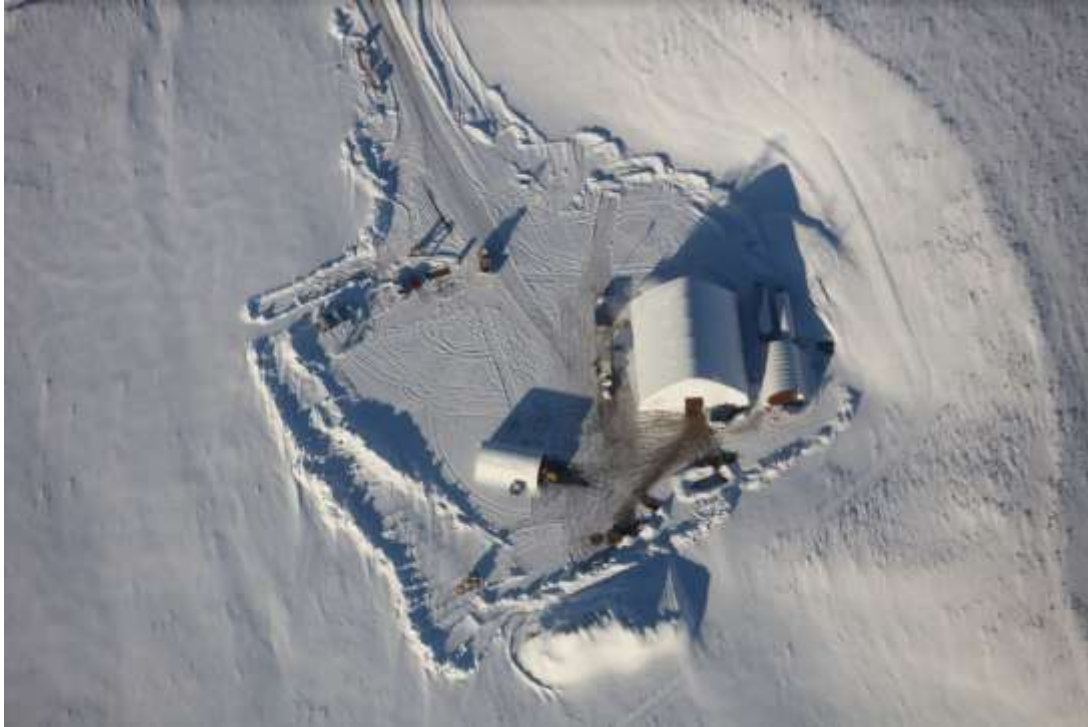
As noted in the on ground December 20, 2021 inspection; multiple structures were noted by the Division at the 7E, cement drop pad, permitted by the Division under TR97. Per the operator these are temporary structures owned by the contractor for the required cement work required. However these structures are not currently accounted for within the Divisions reclamation cost estimate. Any mine related structures (include those utilized by mine contractors) regardless of the duration of use are required to be bonded. **Please address this issue within 10 days of this inspection report, dated 1/19/22.** Aerial photos of the 7E pad are provided below.

7E cement drop pad, temporary structures, and fuel tanks.

**Please address the issue at the 7E cement drop pad as noted above within 10 days of this inspection report, dated 1/19/22.**

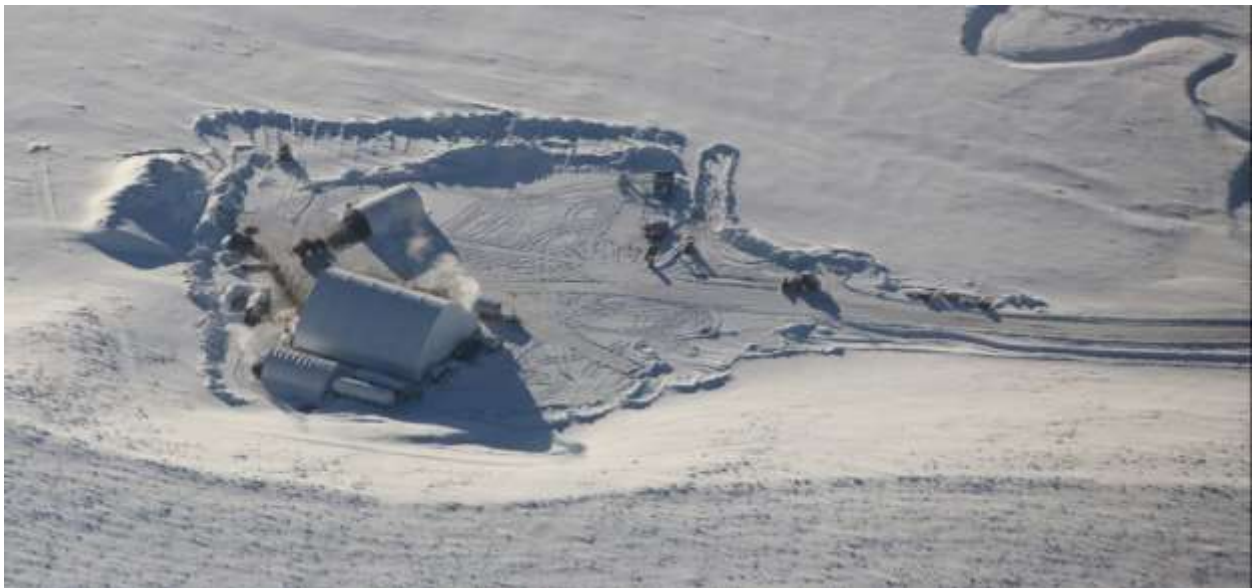
7E cement drop pad, temporary structures, and fuel tanks.
