MINERALS PROGRAM INSPECTION REPORT

MINE NAME: Iron & Wm. Richardson Lode Claims	MINE/PROSPECTING ID#: M-2014-066	MINERAL: Gold and silver	COUNTY: Gilpin
INSPECTION TYPE: Monitoring	INSPECTOR(S): Amy Eschberger, Michael Cunningham	INSP. DATE: January 12, 2022	INSP. TIME: 10:30
OPERATOR: Nevadaville Encore, LLC	OPERATOR REPRESENTATIVE: Wesley Williams	TYPE OF OPERATION: 110d - Designated Limited Impact

M-2014-066 / Iron & Wm. Richardson Load Claims / Nevadaville Encore, LLC (110d)

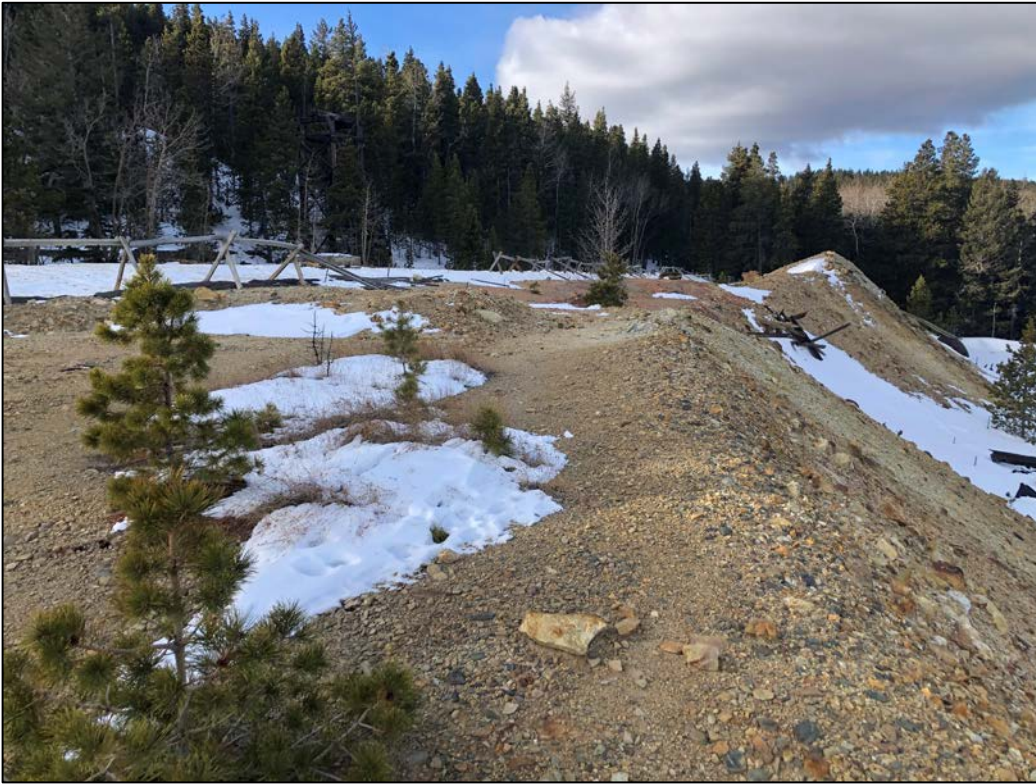
Photo 1. View looking southwest across top of historic mine dump in central portion of permit area on Wm. Richardson claim.

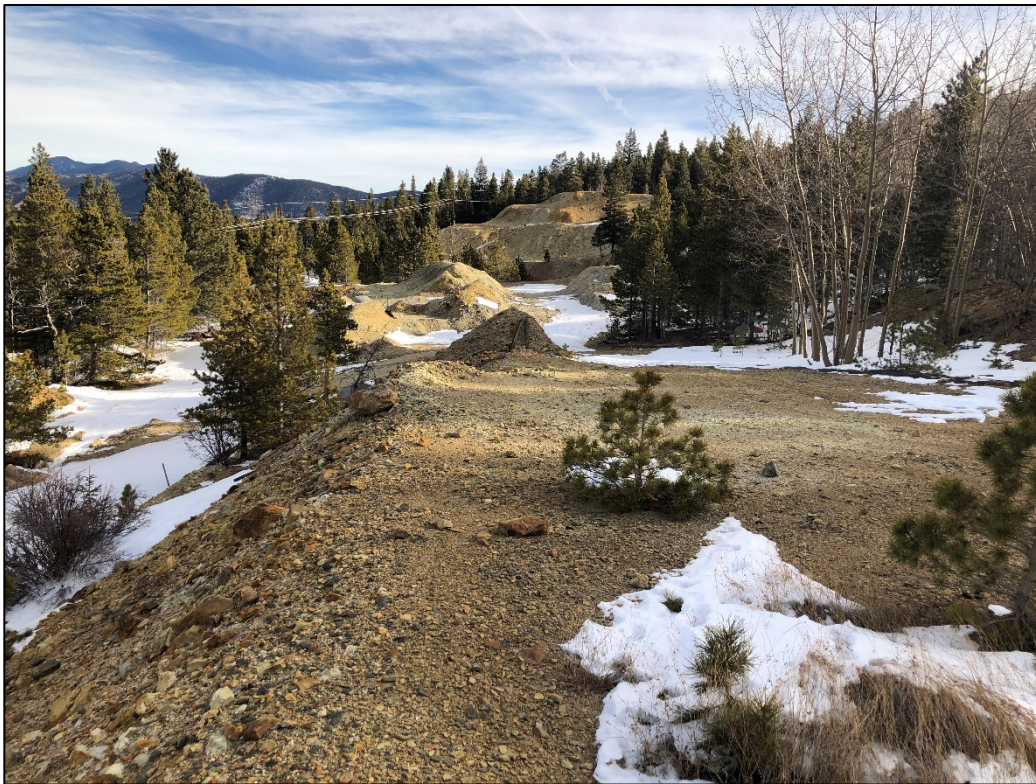
Photo 2. View looking northeast across top of historic mine dump in central portion of permit area on Wm. Richardson claim.

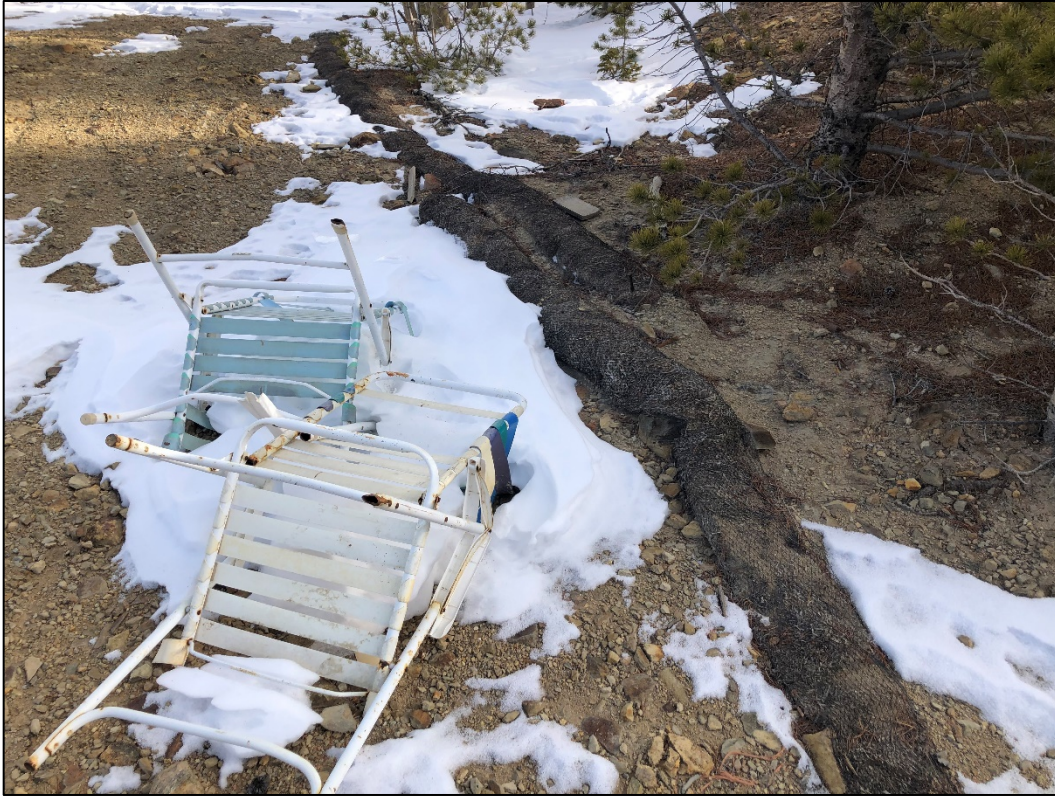
Photo 3. View of straw wattles installed along southern edge of permit area on Wm. Richardson claim. These wattles may need maintenance.

The operator committed to maintaining silt fencing along the down-slope side of the disturbed area and placing straw wattles along the upslope edge of the disturbed area. The existing dump will be mined from the lowest edge in the northeast toward the southwest corner. Trucks will be loaded on the surface of the unmined existing dump to prevent any spillage occurring off-site. No new buildings or roads will be constructed for the operation. The operator will utilize existing roads to access the affected lands. An historic headframe and stone foundation are present on the Iron claim (south of Druid Mine Rd), which will not be disturbed by the operation.

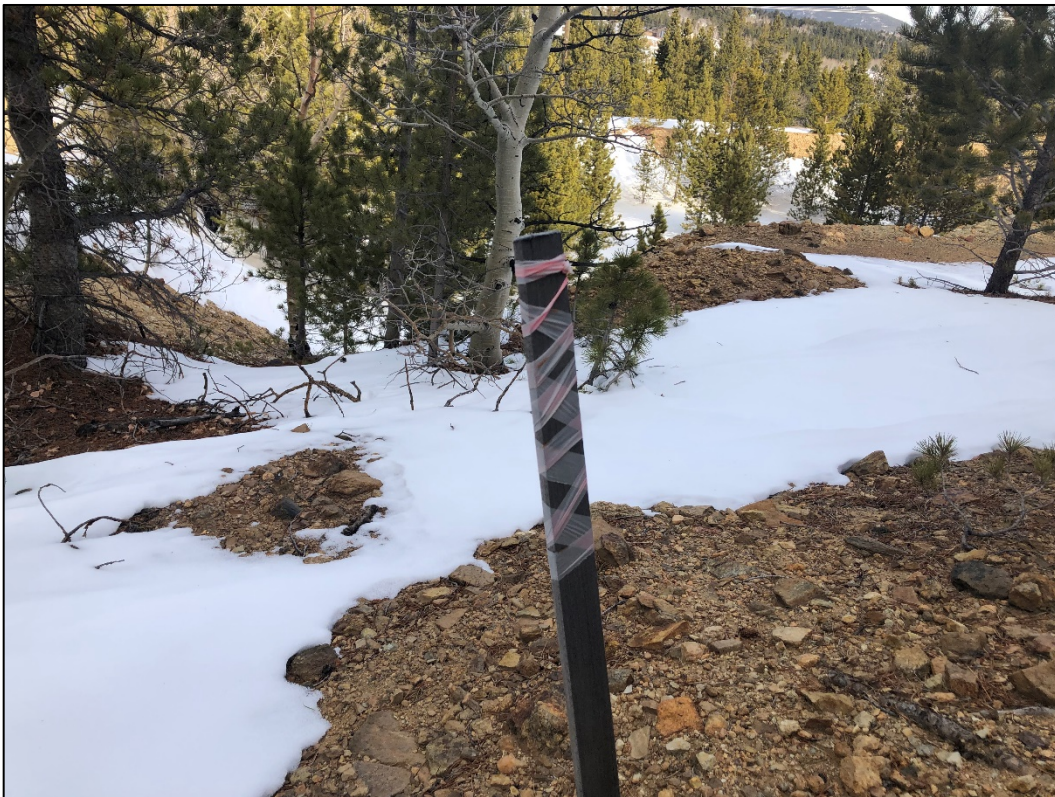
Photo 4. View looking north/northwest at post marking southeastern corner of permit area on Wm. Richardson claim.

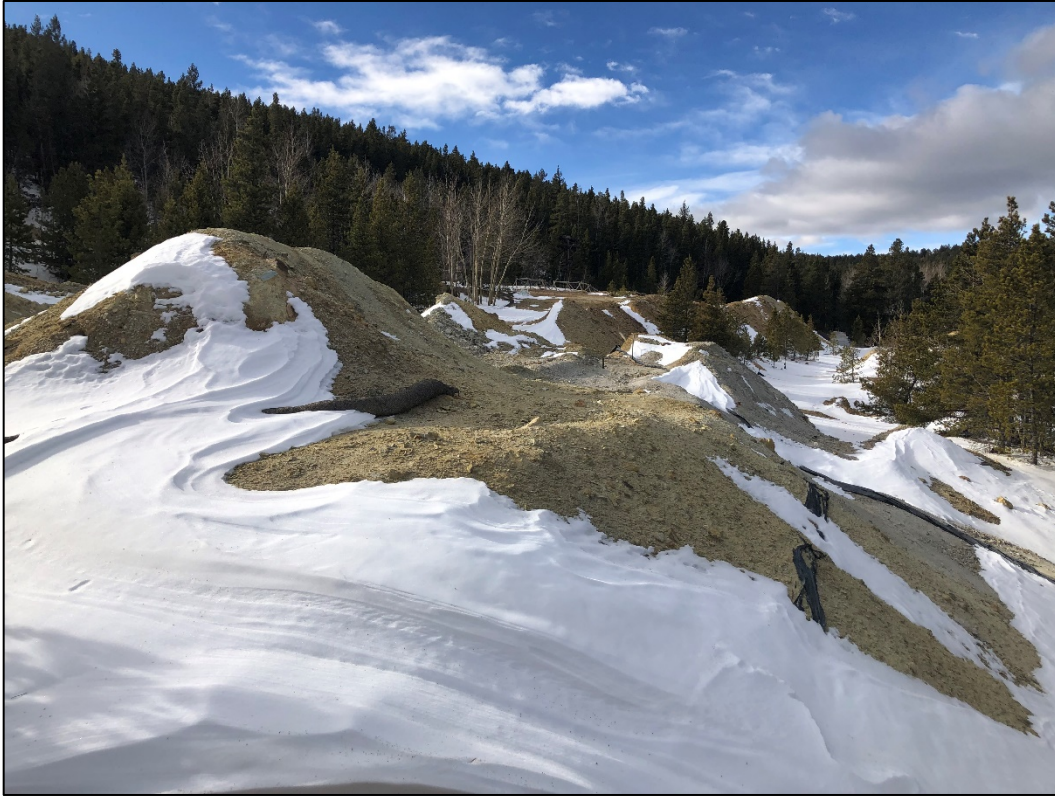
Photo 5. View looking southwest along northern boundary of permit area on Wm. Richardson claim.

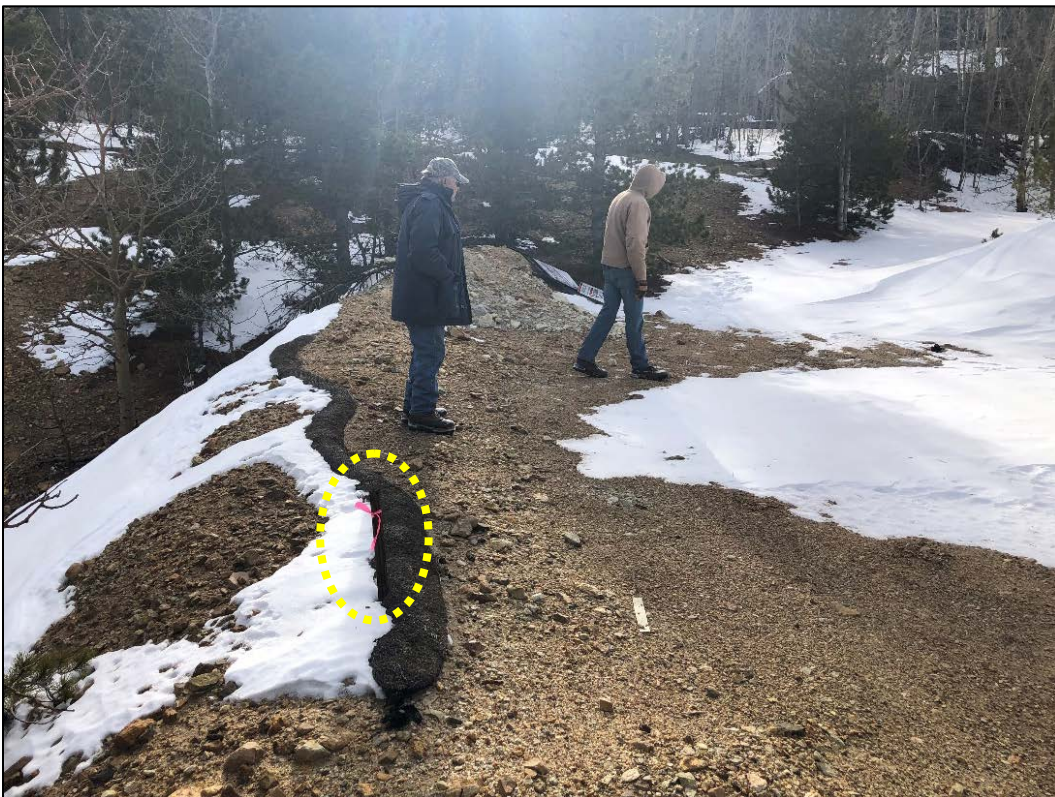
Photo 6. View looking south/southeast at post (circled) marking northeastern corner of permit area on Wm. Richardson claim.

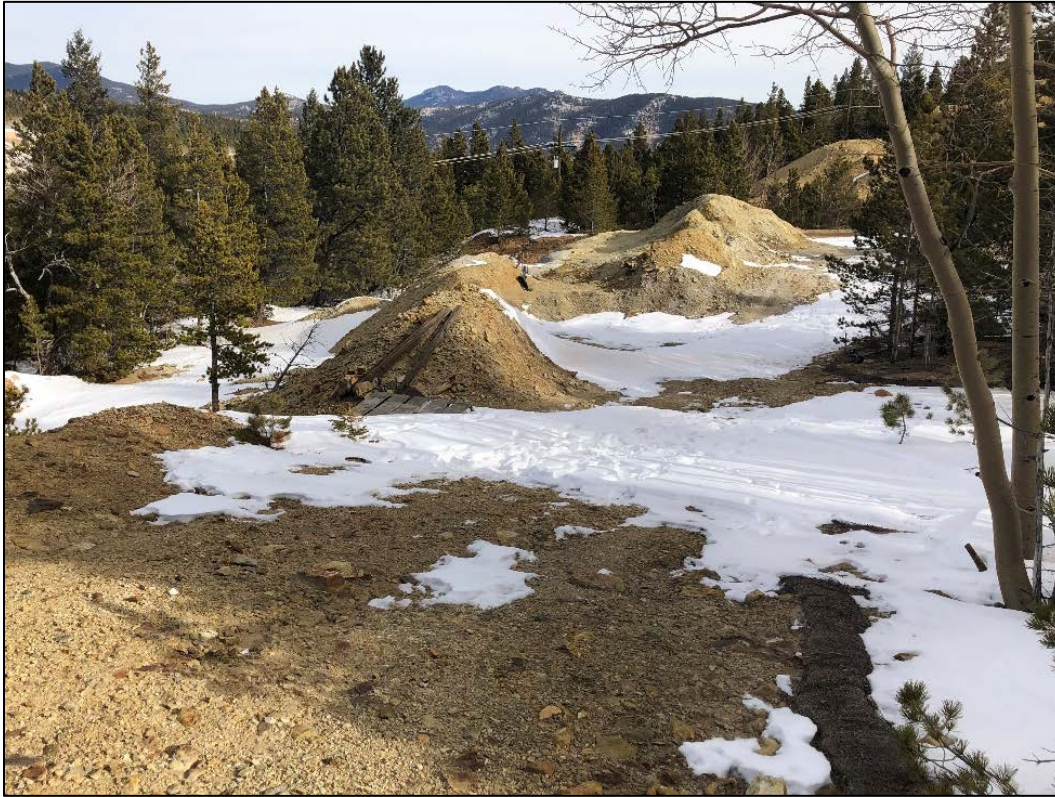
Very little disturbance has occurred at this site overall. The most recent excavation activities occurred in the eastern portion of the Wm. Richardson claim. The Division did not observe any disturbances by this operation on the Iron claim. It should be noted, on April 6, 2020, the operator formally requested the Division's approval

Photo 7. View looking northeast across eastern portion of permit area on Wm. Richardson claim where most recent excavation activities occurred.

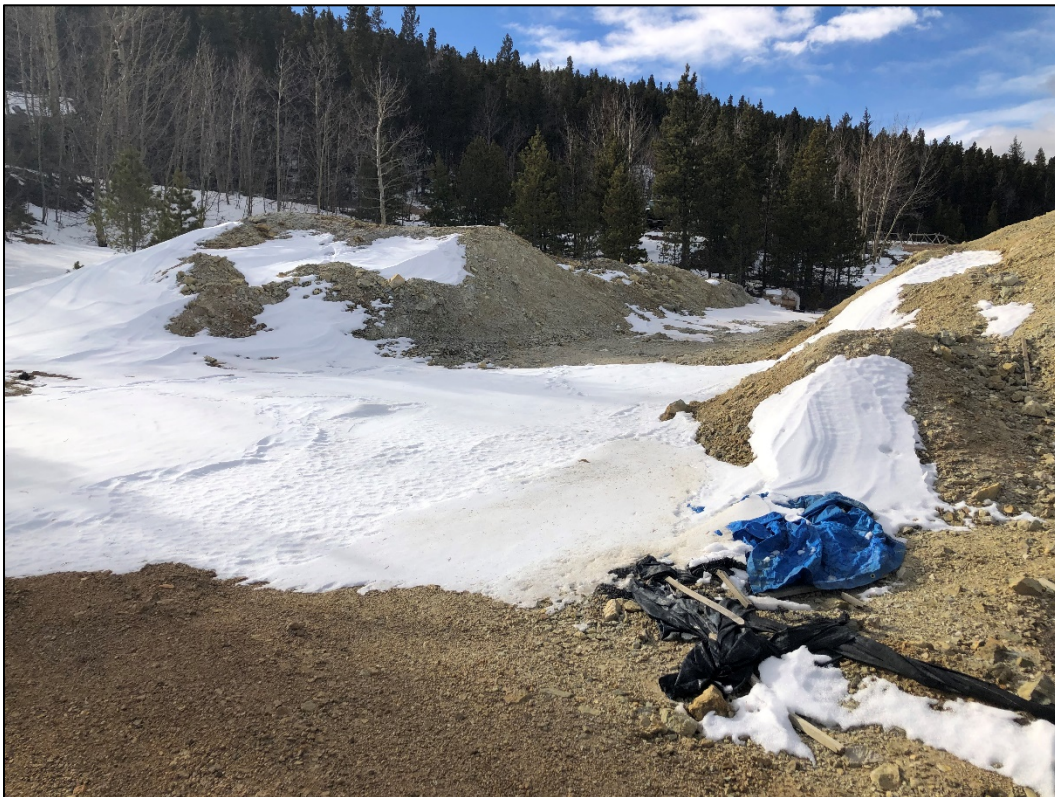
Photo 8. Closer view (looking southwest) of eastern portion of permit area on Wm. Richardson claim where most recent excavation activities occurred.

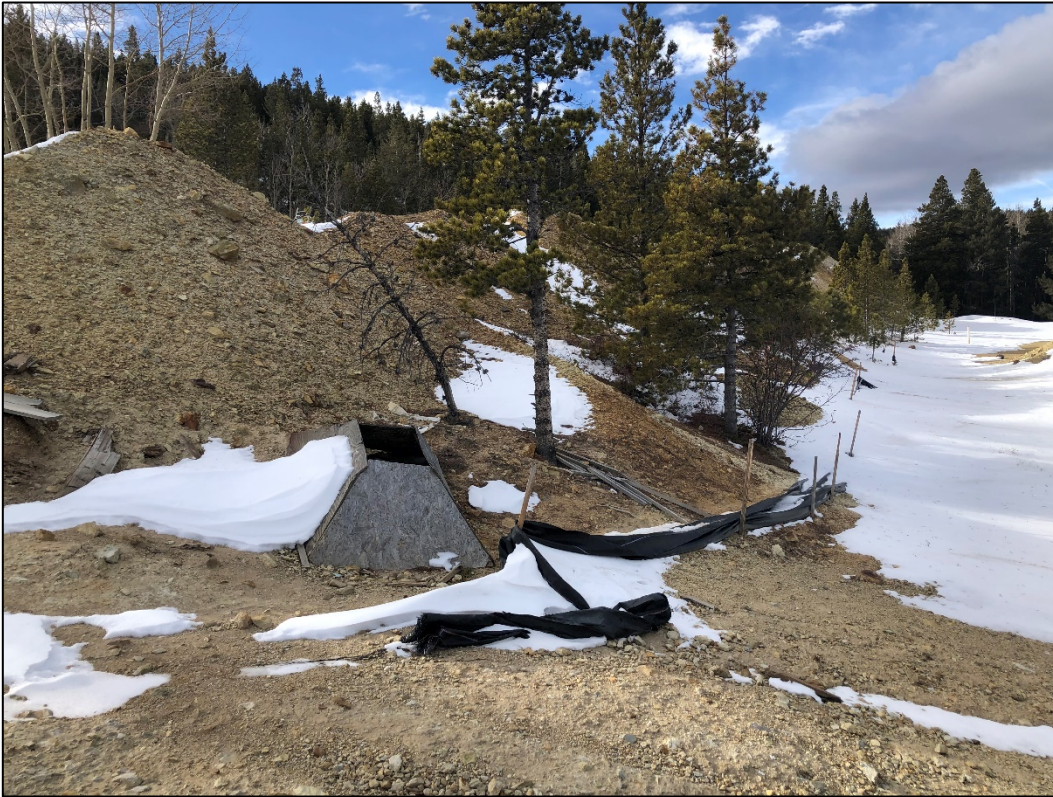
Photo 9. View looking southwest along northern boundary of permit area on Wm. Richardson claim. Note silt fencing (at right) which requires maintenance.

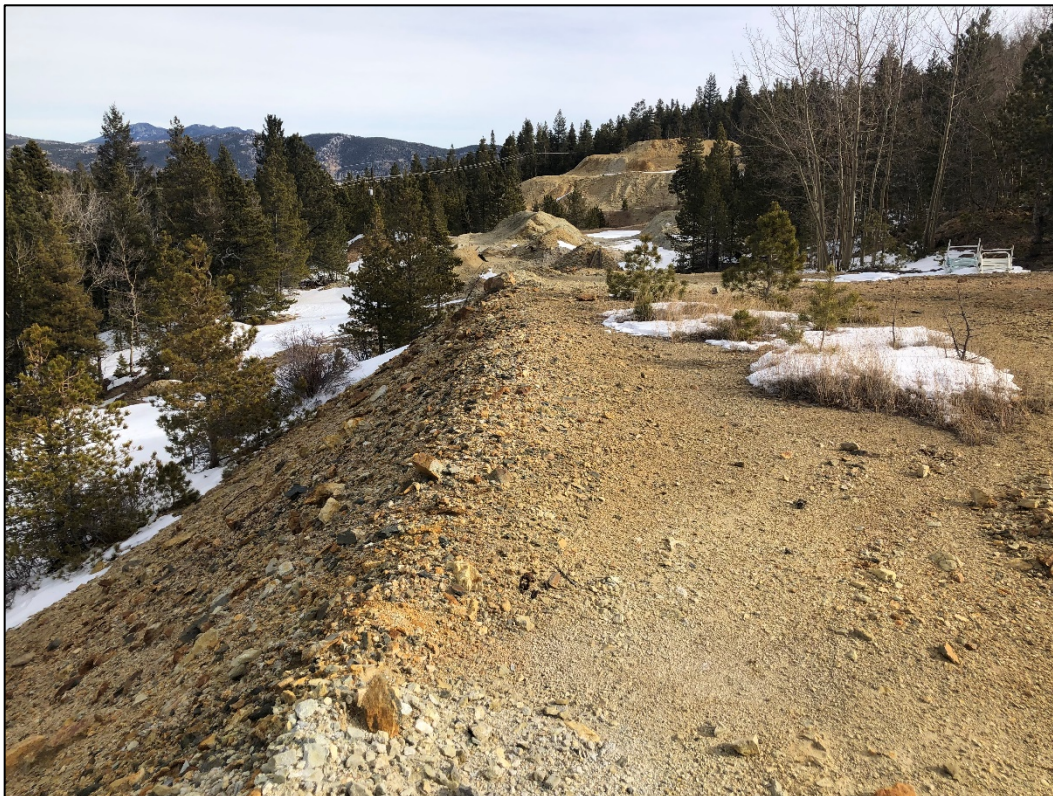
Photo 10. View looking northeast across top of historic mine dump in western portion of permit area on Wm. Richardson.

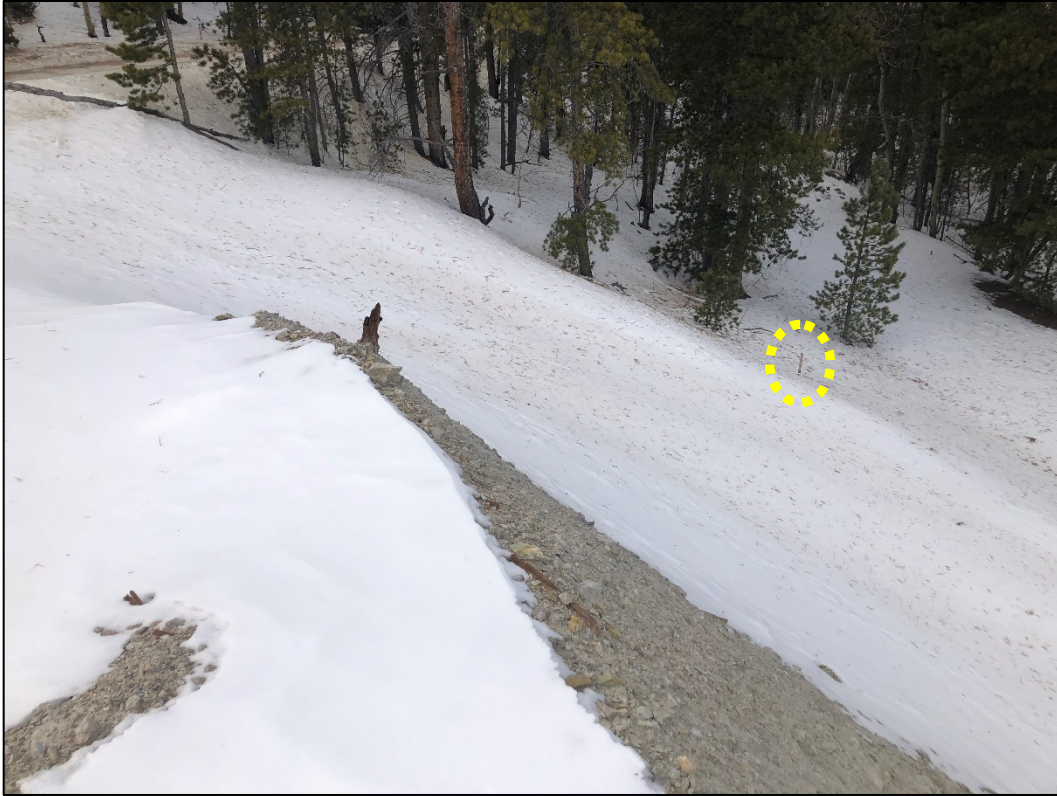
Photo 11. View looking west at post (in background; circled) marking northwestern corner of permit area on Wm. Richardson claim.

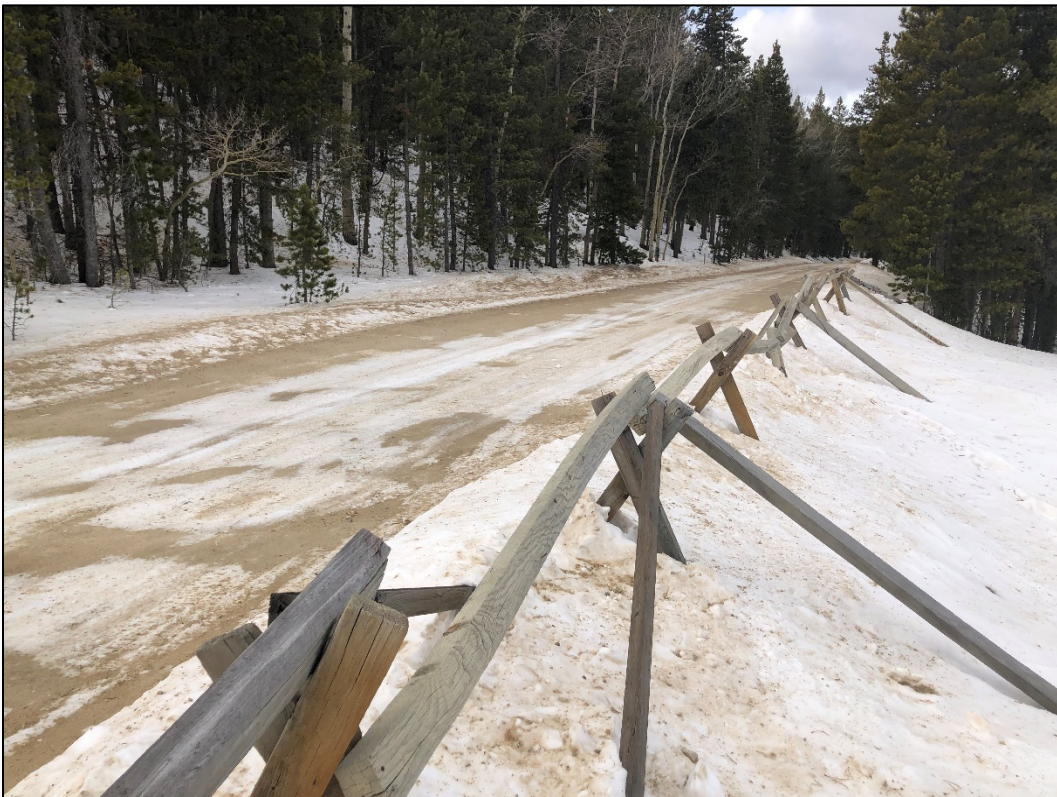
Photo 12. View looking west across Druid Mine Rd which separates the north permit area (on Wm. Richardson claim) from the south permit area (on Iron claim). The southwestern corner of the permit area on Wm. Richardson claim is located at the center of the road in this area.

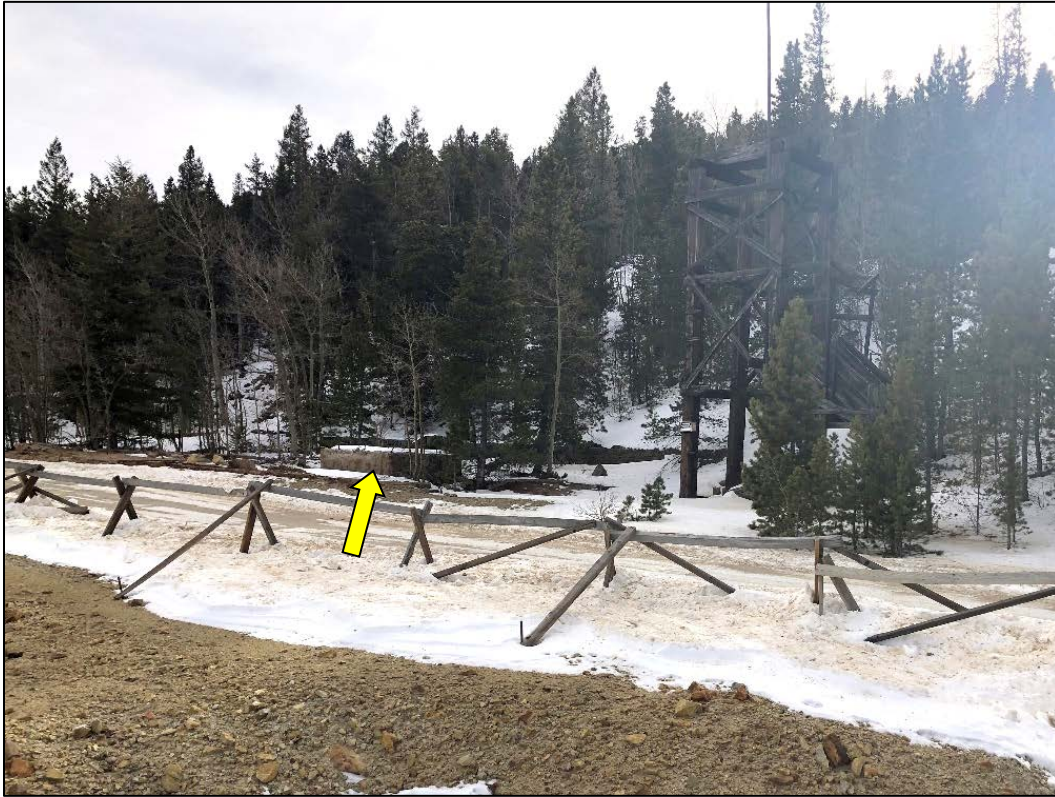
Photo 13. View looking south/southeast at western portion of permit area on Iron claim (south of Druid Mine Rd). Note historic headframe and stone foundation (indicated) present in this area.

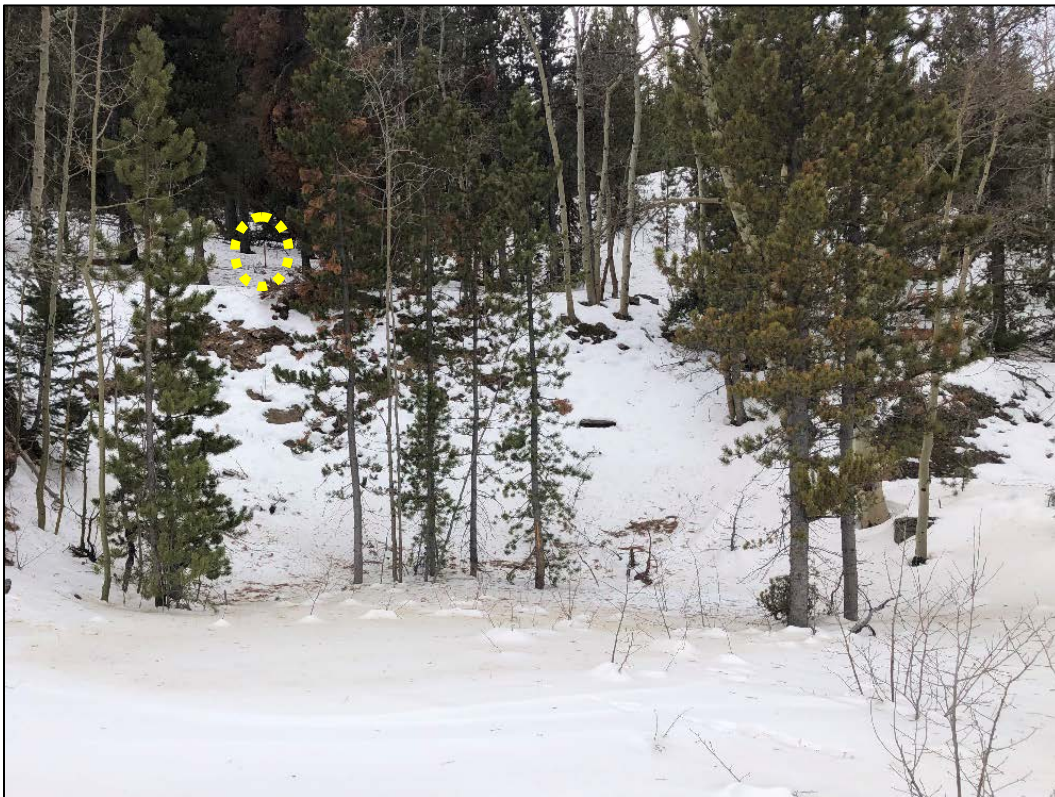
Photo 14. View looking south across eastern portion of permit area on Iron claim (south of Druid Mine Rd). Note post (in background; circled) marking northeastern corner of this permit area.

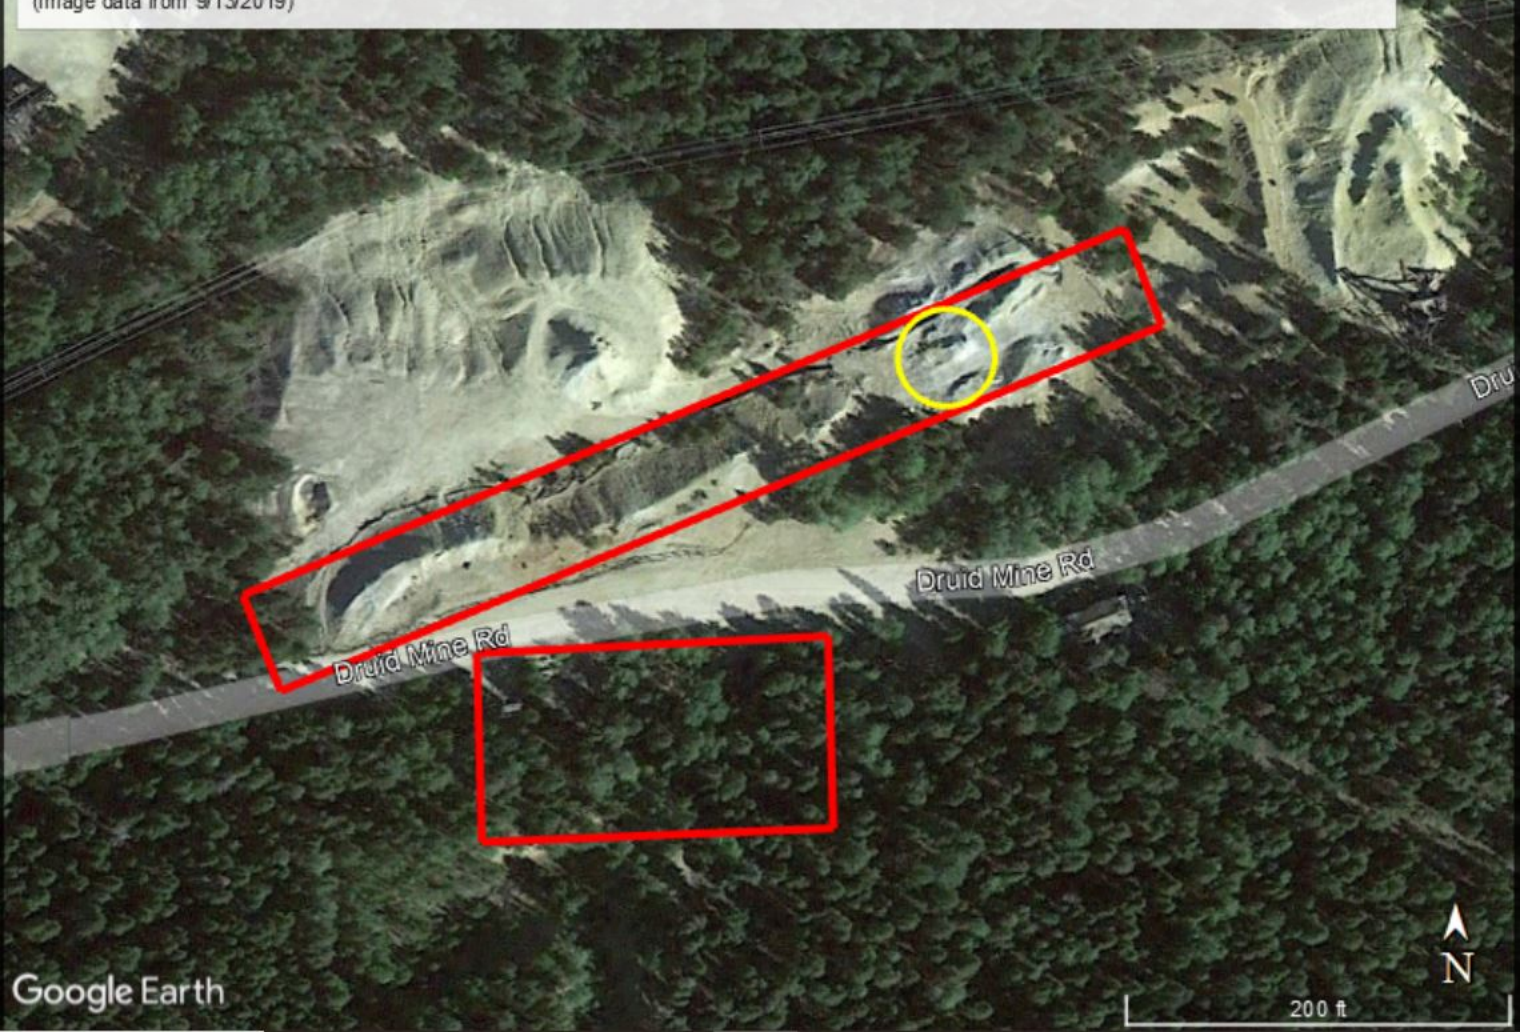
Red outline = 1 acre = Permit area (location approx. based on permit maps; N Area = 0.6 acre on Wm. Richardson + S Area = 0.4 acre on Iron)
Yellow outline = Approximate area of recent activities (based on 1/12/2022 inspection)
(Image data from 9/13/2019)
